LOWER LAKE DAM

NDI - PA 00306

PHASE I INSPECTION REPORT

NATIONAL DAM INSPECTION PROGRAM

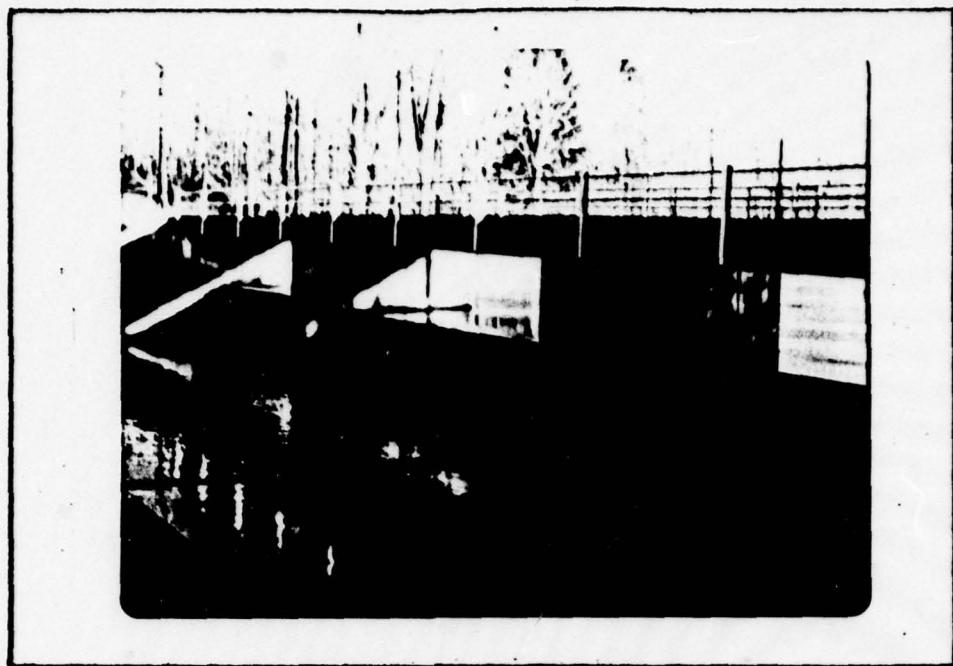
**VIEW OF THE SPILLWAY, STILLING BASIN
AND BRIDGE STRUCTURE**

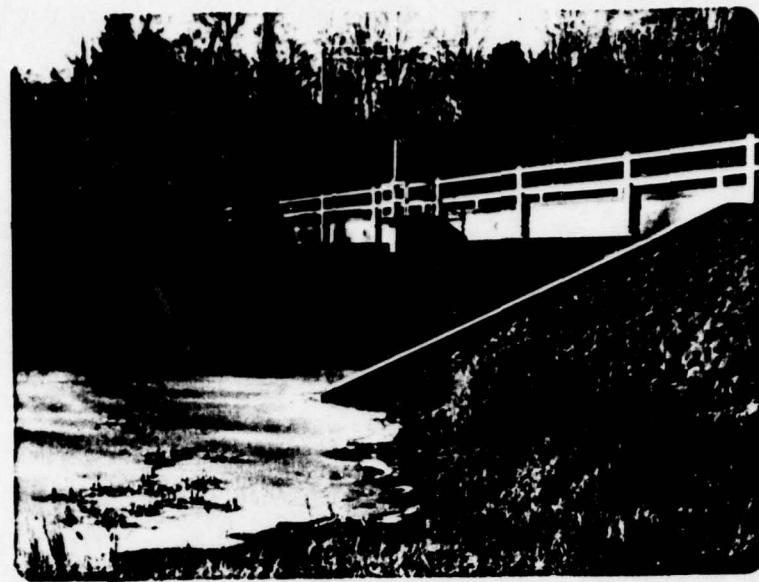
THE UPSTREAM SIDE OF THE DAM SHOWING THE SPILLWAY STRUCTURE, BRIDGE, AND THE EMBANKMENT

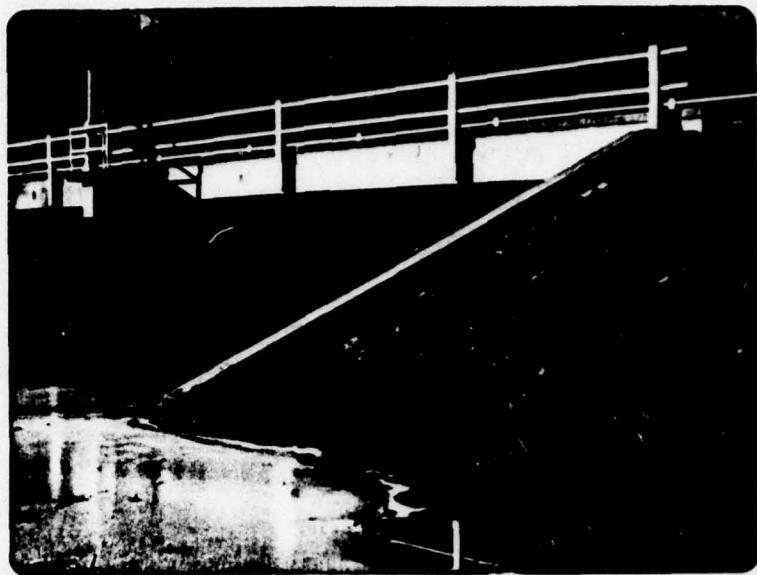
- a. Visual Observations. Riprap facing on the upstream slope of the embankment is missing or covered by grass and earth. Minor settlement of up to 3 inches of the embankment adjacent to the downstream right wingwall tie-in could be due to poor compaction of earth adjacent to wingwall.

VIEW OF THE UPSTREAM SLOPE OF THE RIGHT ABUTMENT SHOWING EROSION ALONG THE WINGWALL

1. Eroded areas on the upstream face of the embankment should be filled; graded filter and riprap should be provided where wave protection is inadequate.
2. The area of settlement adjacent to the right wingwall on the downstream side should be excavated several feet and the backfill

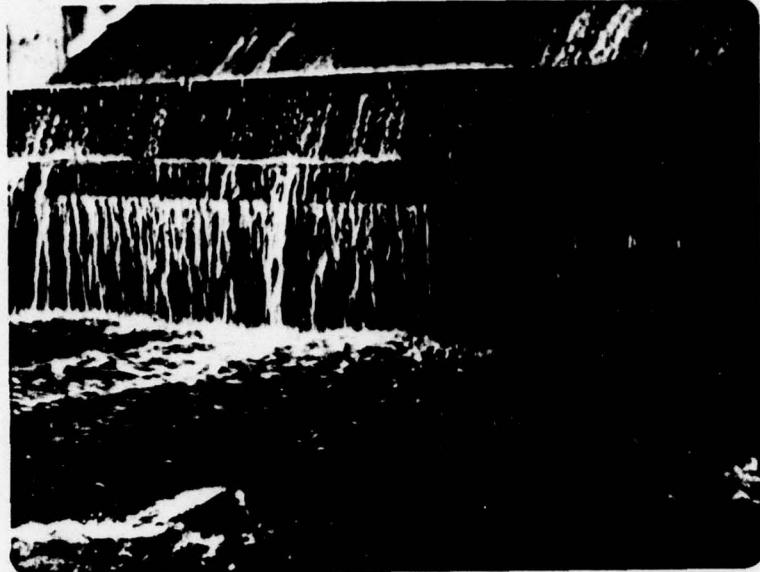
**OUTLET CONDUIT
EMBEDDED IN THE ENDSILL**

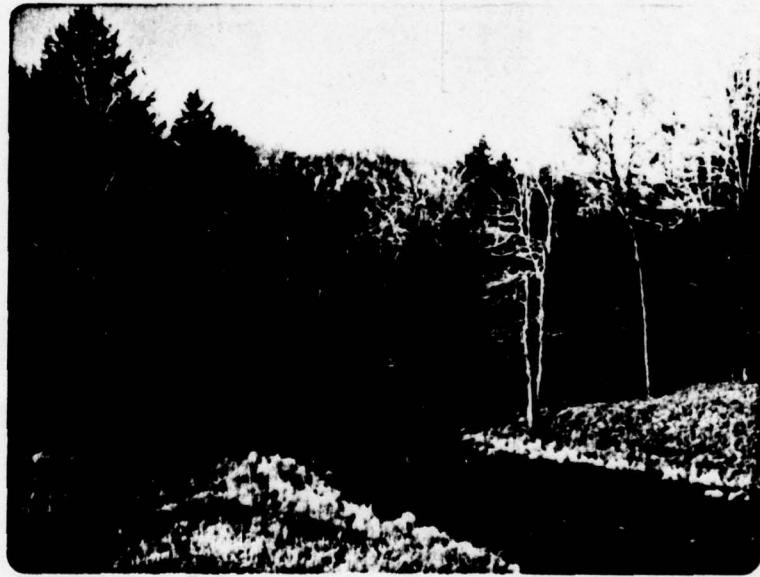
**WALLENPAUPACK CREEK
DOWNSTREAM OF THE DAM**

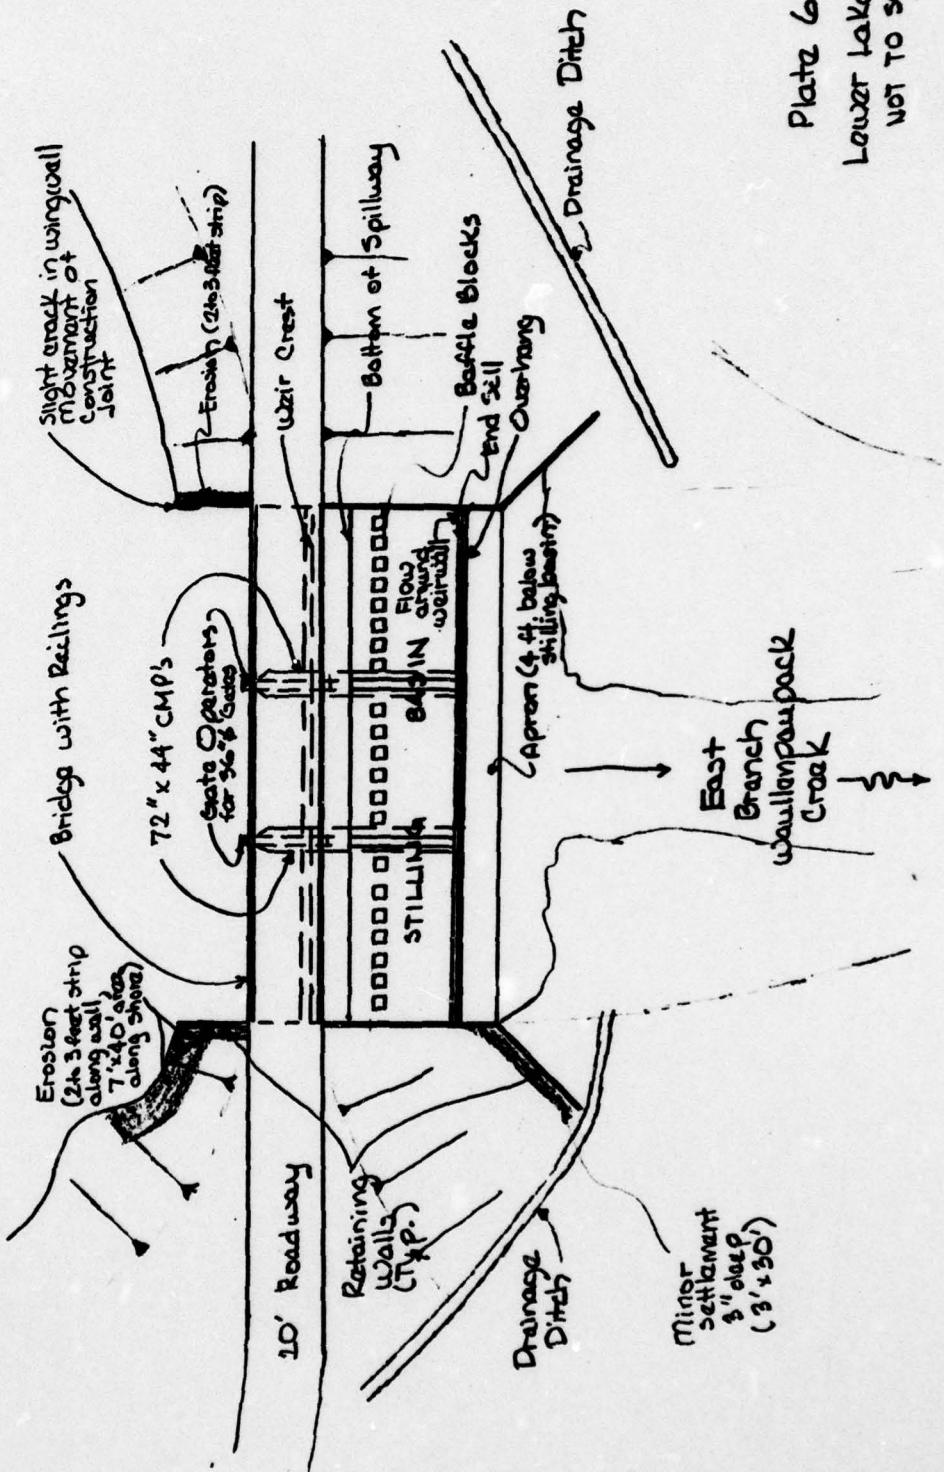
Plate 6
Lower Lake Dam
NOT TO SCALE

- b. Dam. The riprap on the upstream side of the embankment is missing or covered by grass and earth. There is an area of minor settlement of up to 3 inches in the embankment adjacent to the downstream right wingwall tie-in. This area is approximately 3 feet wide and 30 feet long. Erosion has created depressions up to 12 inches deep along both upstream wingwalls and depressions up to 3 inches deep on the lower half of the upstream slope on the right side of the embankment. The depressions along the wingwalls cover a 2 to 3 feet wide strip from the top of the dam to the waterline. The eroded area of the embankment covers a 7 foot wide strip starting at the wingwall and extending approximately 40 feet.

- c. Appurtenant Structures. A crack at the upstream end of the left wingwall at the tie-in was observed as well as a differential movement of approximately 1/4 inch of an adjacent construction joint. Occasional hairline cracking and spalling of the wingwalls were noted.

1. Eroded areas on the upstream face of the embankment should be filled; graded filter and riprap should be provided where wave protection is inadequate.
2. The area of settlement adjacent to the right wingwall on the downstream side should be excavated several feet and the backfill material compacted. Monthly observations should be made to check for settlement.
3. The crack in the upstream side of the left wingwall and the adjacent construction joint should be monitored for further movement.
