PA 474  
(PA NO NAME No. 35)  
MERCER COUNTY, COMMONWEALTH OF PENNSYLVANIA  
NDI No. PA 00249  
PennDER No. 43-50  
SCS No. PA 474

PHASE I INSPECTION REPORT  
NATIONAL DAM INSPECTION PROGRAM

PA 474 (PA No Name No. 35), Mercer County, Pennsylvania  
NDI No. PA 00249, PennDER No. 43-50, SCS No. PA 474  
Saw Mill Run  
Inspected 9 May 1979

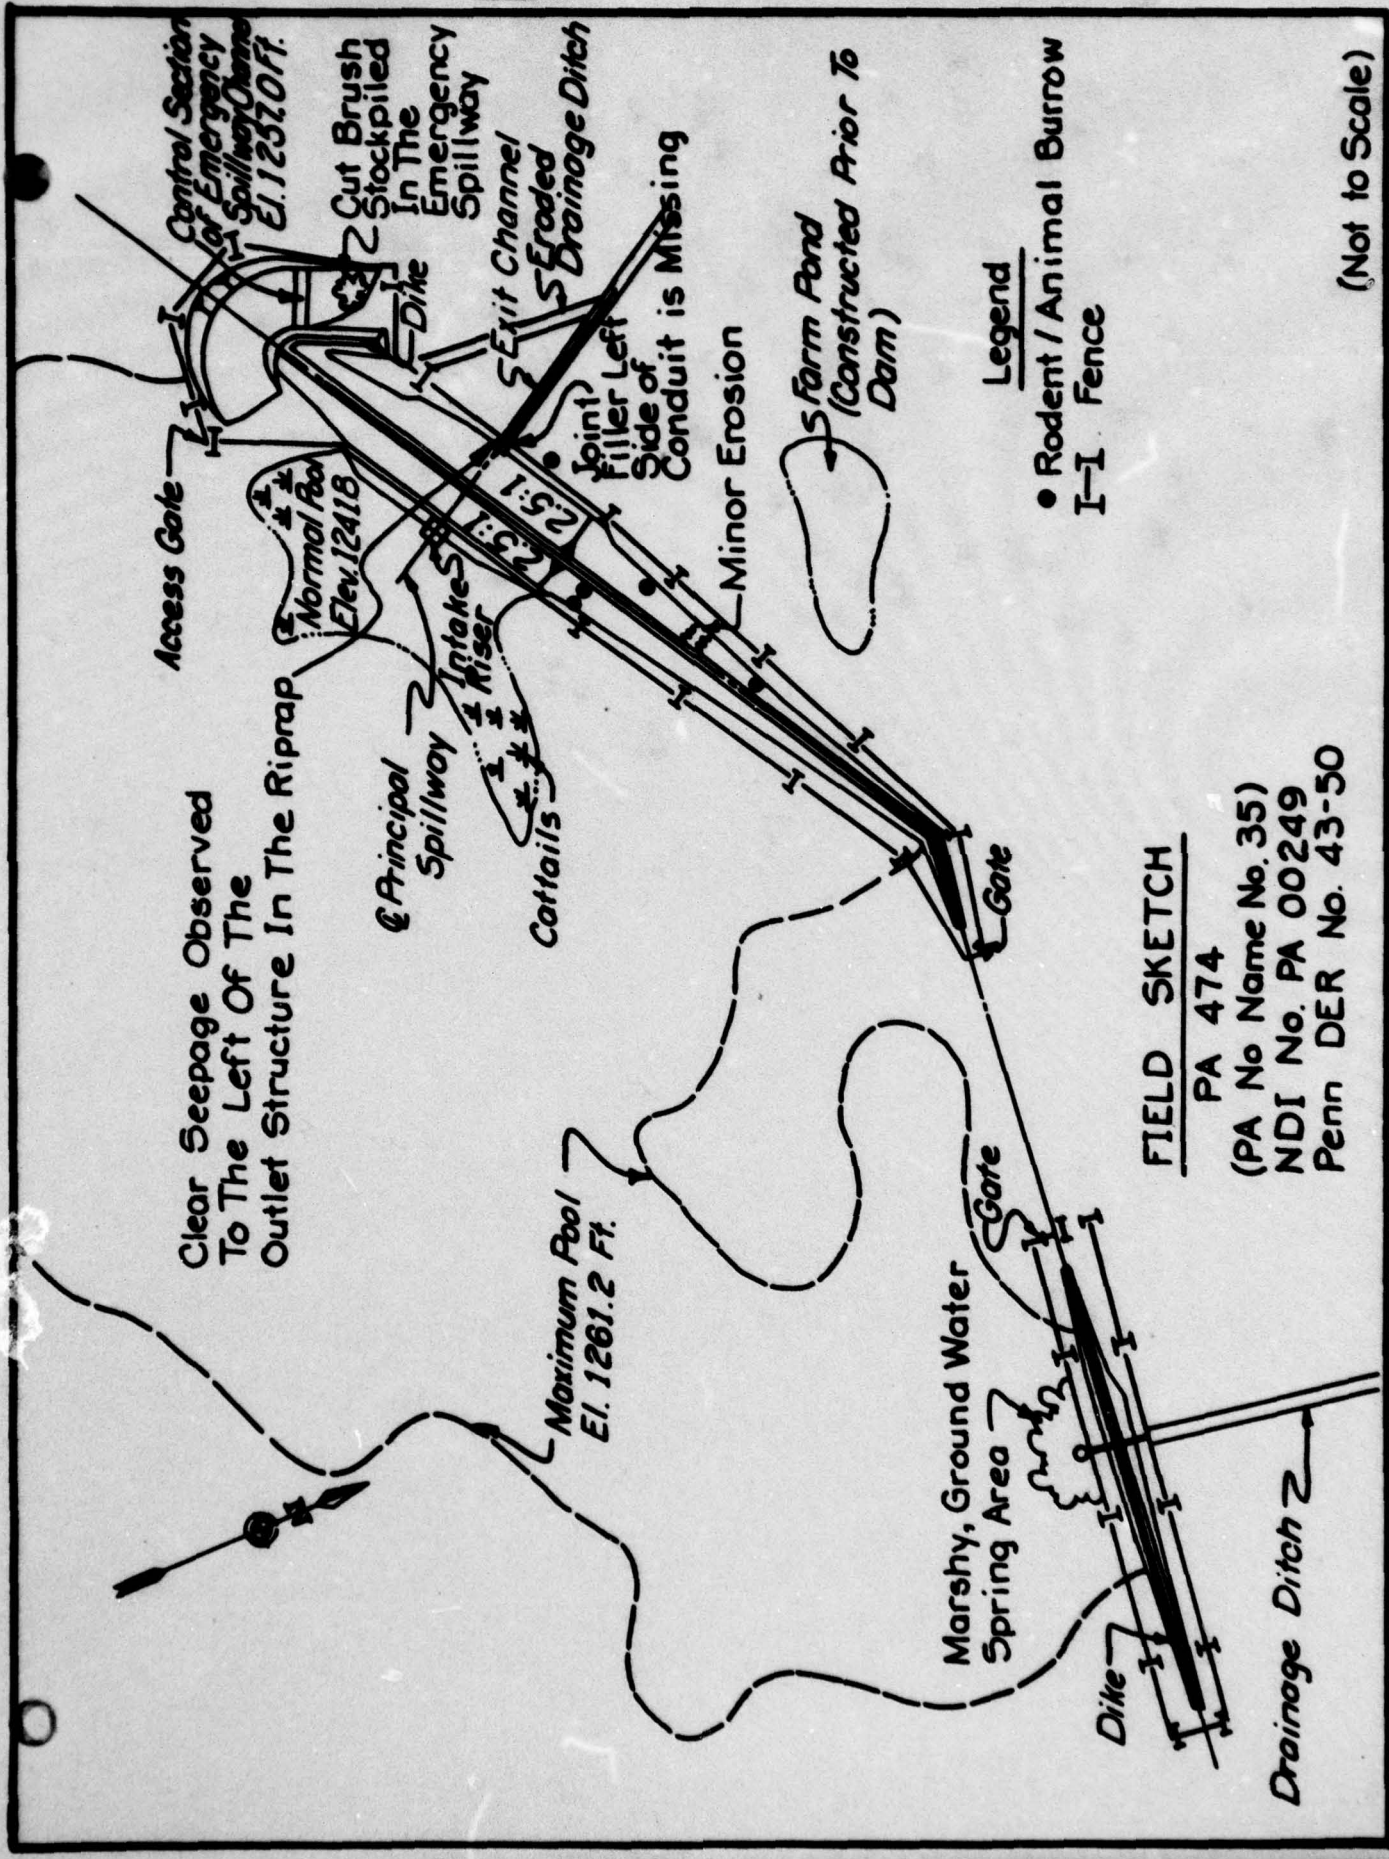
Several rodent/animal burrows were observed in the embankment. The locations of these holes are shown on the field sketch.

Clear Seepage Observed To The Left Of The Outlet Structure In The Riprap

Joint Filler Left Side of Conduit is Missing

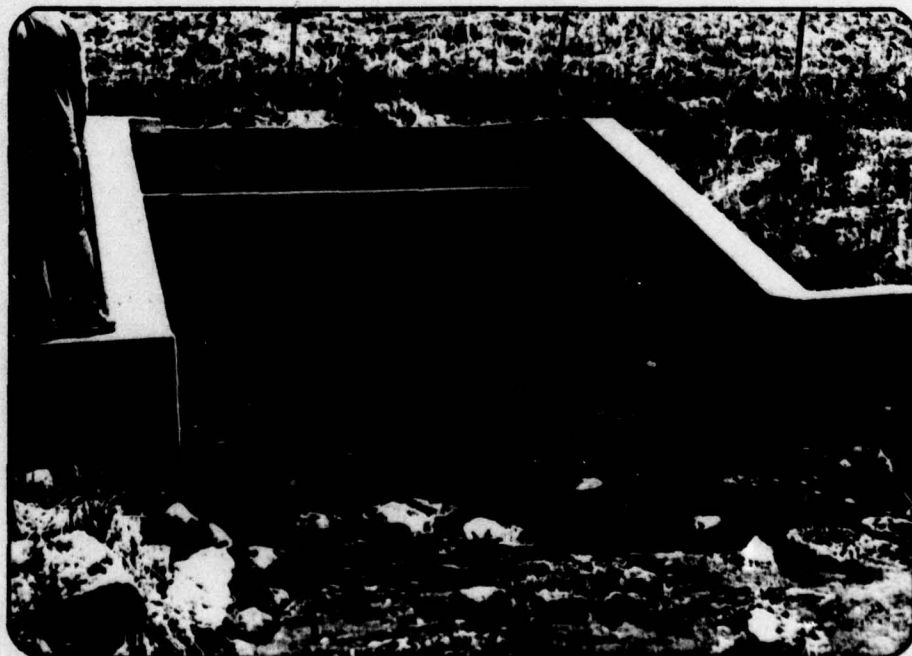
b. Dam - Clear seepage was observed exiting at an estimated rate of 0.5 g.p.m. to the left of the outlet structure. The two filter drain outlets which exit into the impact basin were flowing with clear water. The left outlet was flowing at an estimated rate of 5 g.p.m. The right drain outlet was clogged with material. After removal of the material the drain outlet flowed partially full then tapered to a trickle. This drain was stained orange. This orange staining could possibly be from two sources: 1) iron staining; 2) algae growth.

**PHOTO 4. Close-up View of Outlet Structure**  
(Note flow exiting the drain outlet in right-center of photo.)
