A PHENOMENOLOGICAL MECHANISM FOR THE OCCURRENCE OF THE EXTRUSION CENTRAL  
BURST DEFECT

Westinghouse Electric Corporation  
Advanced Energy Systems Division  
Pittsburgh, Pennsylvania 15236

April 1979

TECHNICAL REPORT AFML-TR-79-4031

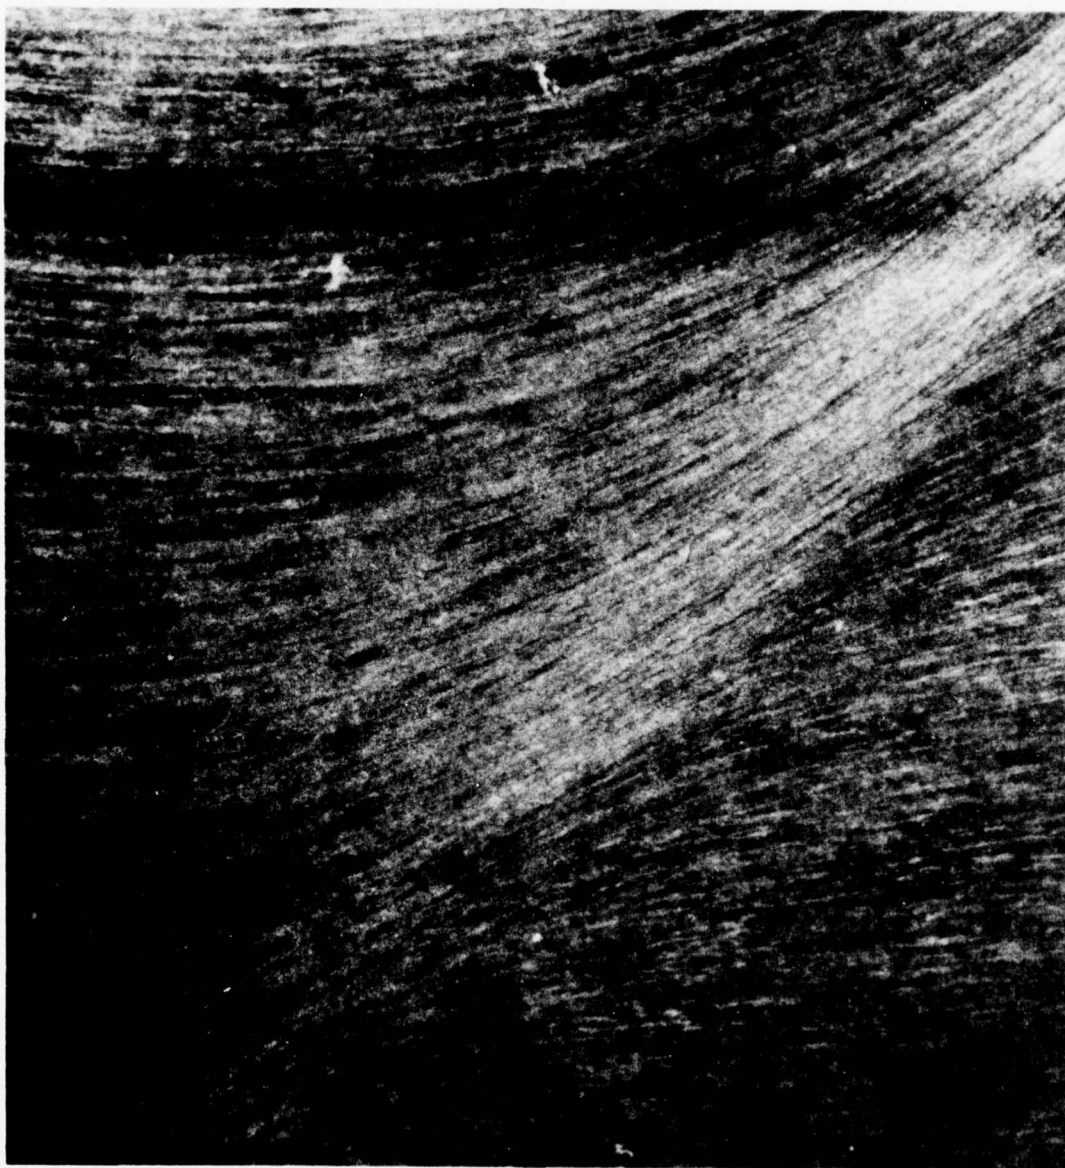
Metallographic examination of the defect at various stages during its development reveals more detail about its origin and propagation. The configuration of the defect and adjacent material shown in Fig. 4 is from an extrusion which was halted just after the defect initiated. A considerable number of voids opening around the inclusion stringers can be seen. Examination of the defect cone shows that the crack propagation occurs in jogged steps where voids develop along the inclusion stringers.

Fig. 4. Micrographs showing the propagation of the defect along the shear discontinuity just after defect initiation. Note that the shear band is more developed ahead of the defect than in the vicinity of the defect.

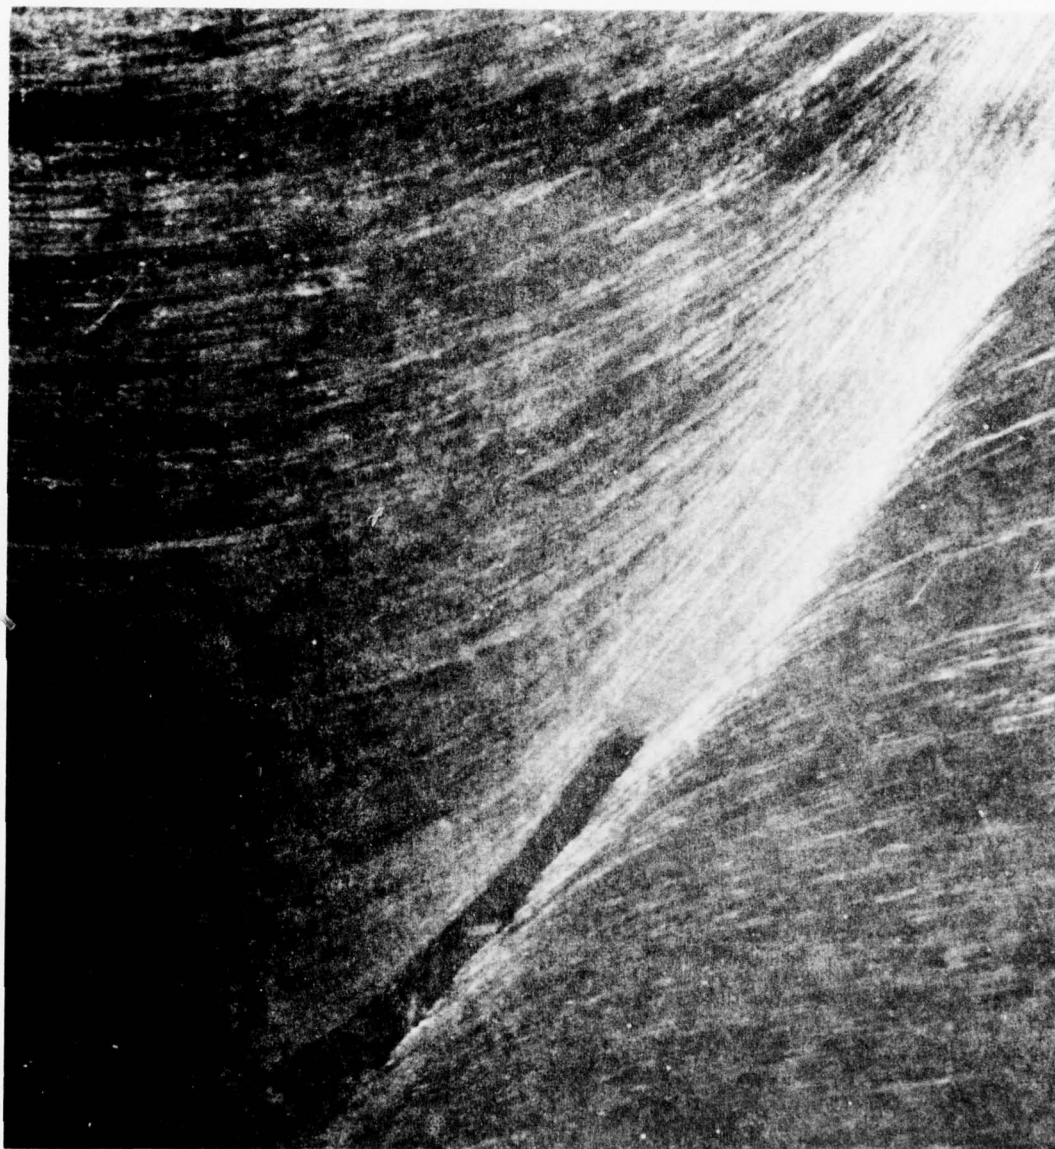
The portion of the defect shown in Fig. 6 is from an extrusion which was halted as the cone was almost two-thirds developed. The striking feature illustrated in this figure is that the crack tip has become blunted. The material ahead of the crack tip, however, shows intense shear indicating a large amount of plastic deformation over a rather large band. A type of turbulent flow occurs forming the toroidal surface noted at the base of the central burst cone in Fig. 2. The terminal stage of the crack propagation is shown in Fig. 7 which is a section of an earlier burst which had passed completely through the process.

Fig. 6. Propagation of the defect at two-thirds development. Note the blunted tip and sharply defined band of localized shear.

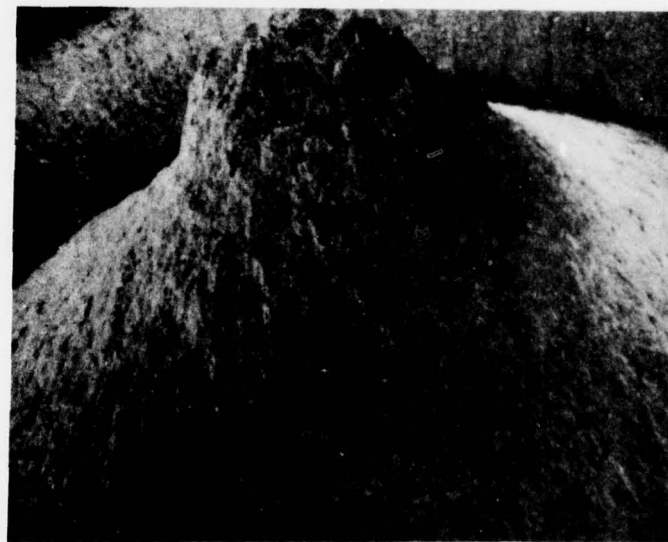
The general shape of the central burst cone examined by scanning electron microscopy is shown in Fig. 8. The included angle of the cone approximates  $90^\circ$  near the tip, but becomes larger at greater distances from the tip. A very small flat region is sometimes found at the cone tip, where fracture initiates.

Fig. 8. SEM macrograph of central burst cone.

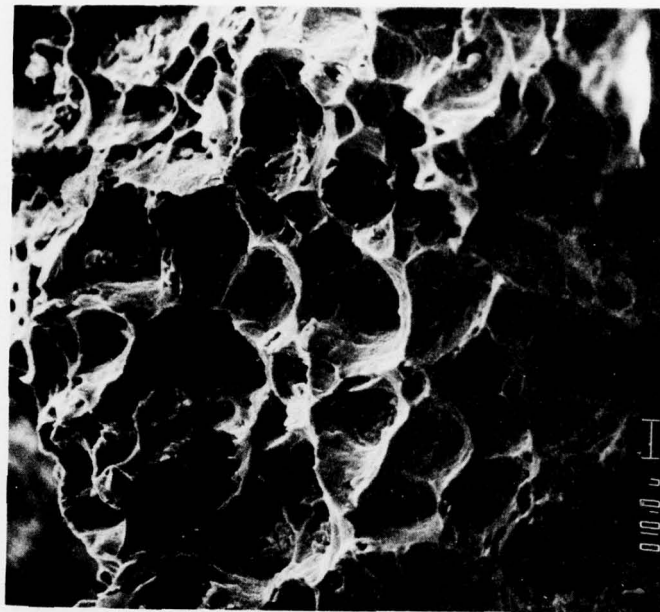
The fracture morphology at the crack tip, Fig. 9, leaves no doubt that a tensile overload failure occurs at the tip of the cone. The fracture morphology at the tip shows deep voids with second-phase particles visible in many of the voids. The voids appear to have grown until the ligaments between them necked to zero area leaving a network of rather sharp ridges indicative of ductile rupture. The walls of the voids are relatively smooth, but show a considerable amount of beach-sand ripples. Some smaller voids are observable along the ripples which connect the voids. The beach-sand ripples along the void walls are more apparent in Fig. 10. The second-phase particles visible in the voids were found to be enriched in iron and copper. The region near the cone tip, shows the sand-beach ripples between rather deep voids.

Fig. 9. SEM micrograph of the tip of the central burst cone showing large voids nucleated by inclusions. Fracture is of the ductile rupture type.

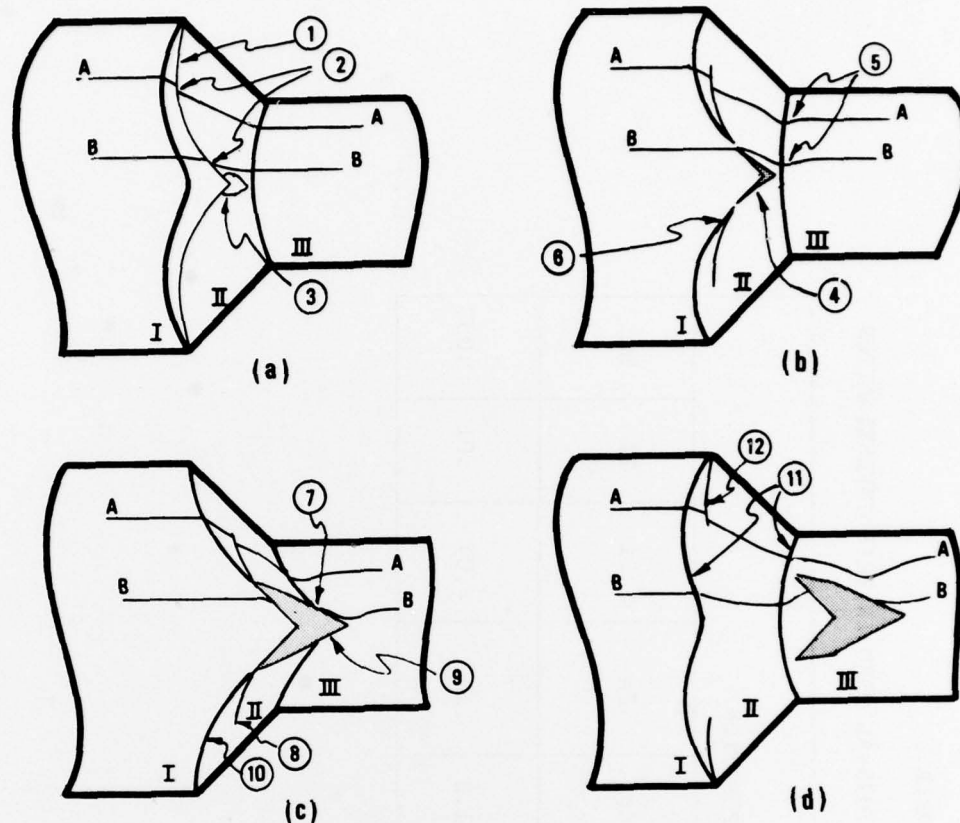
Initially after localized flow occurs, it is energetically favorable for flow to continue at the localized band because of the associated thermal softening. Continued flow along the shear instability band causes the propagation of the defect. In the case of extrusion, the ram motion continues to move the remaining billet through the die so that localized flow in that band is no longer favorable thereby halting the propagation of the defect. The flow field then becomes readjusted and the process begins again.

Fig. 12. Phenomenological mechanism of the development, propagation and repetition of the central burst defect. a) Development of tangential velocity surfaces (1) occurs with bands of localized flow. Tangential flow along the discontinuity (2) is translated to axial flow toward the die exit and results in a region of enhanced tensile stress (3) at the billet axis. b) Initiation of the central burst defect (4) results from tensile overload. Wavy flow lines (5) develop while the deformation zone volume shrinks by movement of the entrance boundary (6) toward the die exit. c) Discontinuous flow lines develop (7) as the defect propagates along the discontinuity surface but propagation becomes less energetically favorable as the geometric position of the flow surface proceeds through the deformation zone (8). The defect opens rapidly (9) as flow concentrates (10) at the outer flow lines. d) As the defect passes through the die the deformation zone (11) becomes re-established and new tangential velocity discontinuity surfaces (12) begin at the outer surfaces of the billet near the entrance to the die cone.
