# **EAST STROUDSBURG DAM**

## **PHASE I INSPECTION REPORT NATIONAL DAM INSPECTION PROGRAM**

**APRIL 1979**

NDS I.D. NO. PA 00637  
DER I.D. NO. 45-155

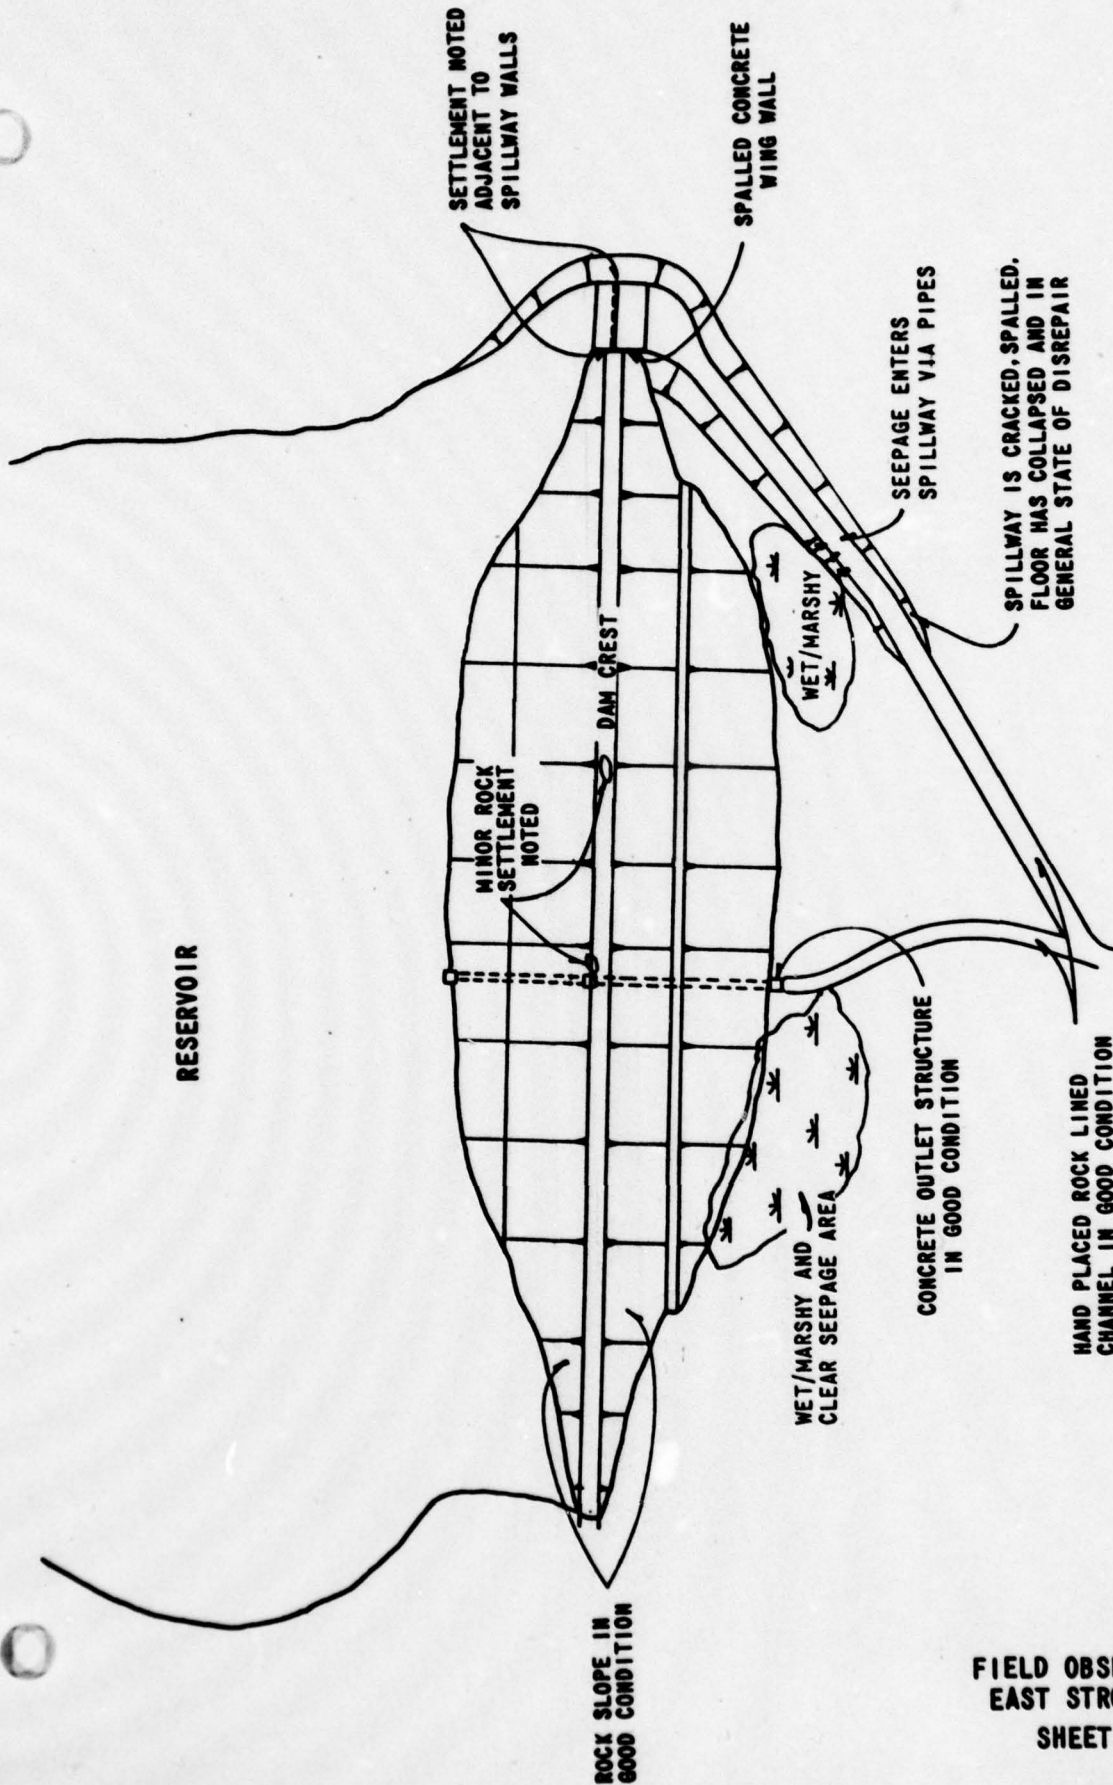
FIELD OBSERVATION PLAN  
EAST STROUDSBURG DAM  
SHEET 5a OF 11

The major item of concern is the quantity of seepage noted through the downstream toe, as well as other areas just above and below the toe. This extensive seepage area is shown on Sheet 5A, Appendix B. The visual inspection also noted several pipes discharging seepage into the wasteway channel. A review of the construction files confirms that seepage noted during construction was collected and transported through pipes that discharge into the wasteway channel. An evaluation of this seepage is discussed in Section 6 and Appendix F, and recommendations to monitor the situation are presented in Section 7.

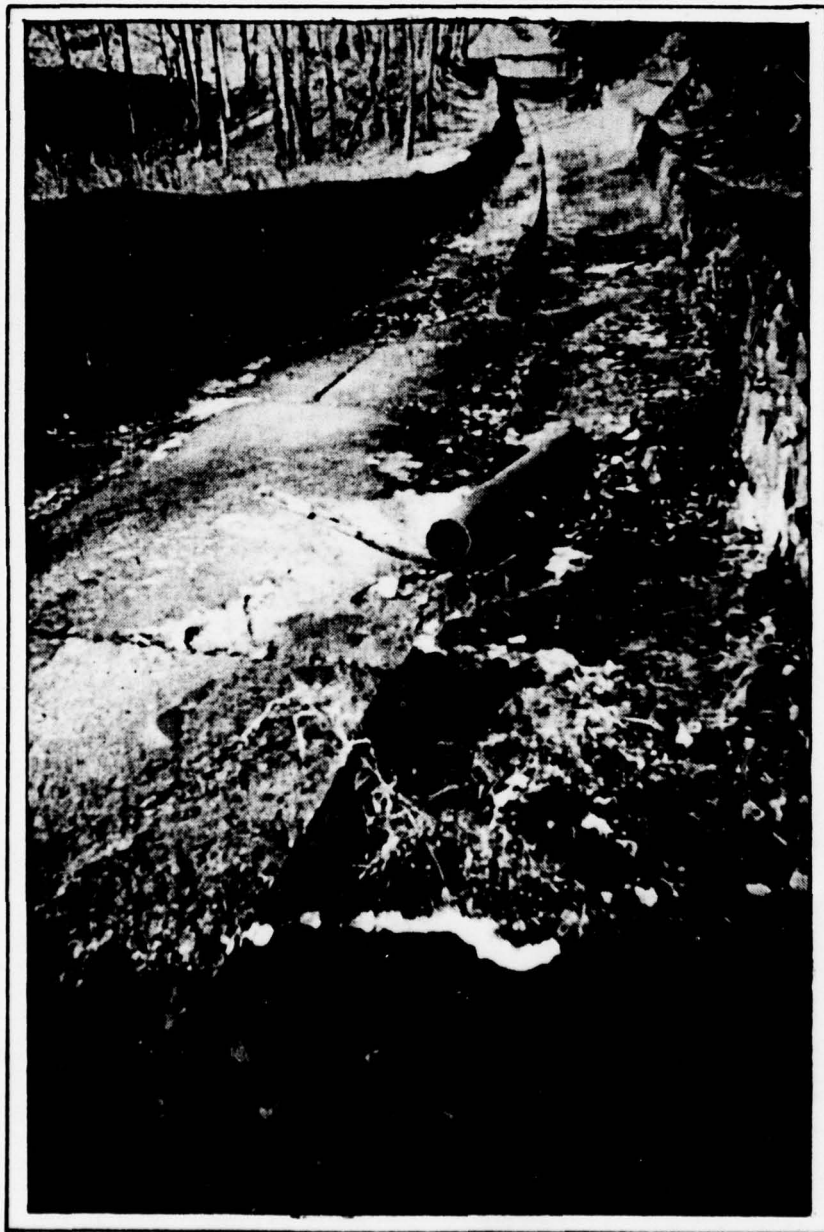
An inspection of the spillway revealed the concrete was in fair condition with spalling. The concrete floor and masonry walls of the wasteway channel are considered to be in fair condition in the upper portion and in very poor condition for the bottom 100 feet of the channel. The portion of the channel considered to be in poor condition has many undermined areas beneath the channel floor, causing the concrete floor to collapse. See Photograph 11. One portion of the left wall has rotated inward and several zones were noted where groundwater seepage is discharging through the wall and beneath the channel floor. A cast iron pipe supported on rock piles is located across the weir of the discharge channel. This pipe is used as a high level water supply intake.

The lower 100 feet of the spillway wasteway channel is in very poor condition. The upper part of the channel and weir are in fair condition. Overall deterioration and poor condition of the structure can be seen in Photograph 11, Appendix D.

DETERIORATED SECTIONS OF  
THE SPILLWAY.

- (1) A thorough investigation of the emergency spillway should be performed by a registered professional engineer experienced in the design of dams. Based on the results of this investigation, the emergency spillway should be rehabilitated.
- (2) Seepage through the embankment should be collected and monitored for changes in flow rates and turbidity.
- (3) Provisions should be made to periodically inspect the gatehouse tower and the intake and discharge pipes.
- (4) The depression noted on the crest of the embankment should be inspected annually and filled, if necessary.

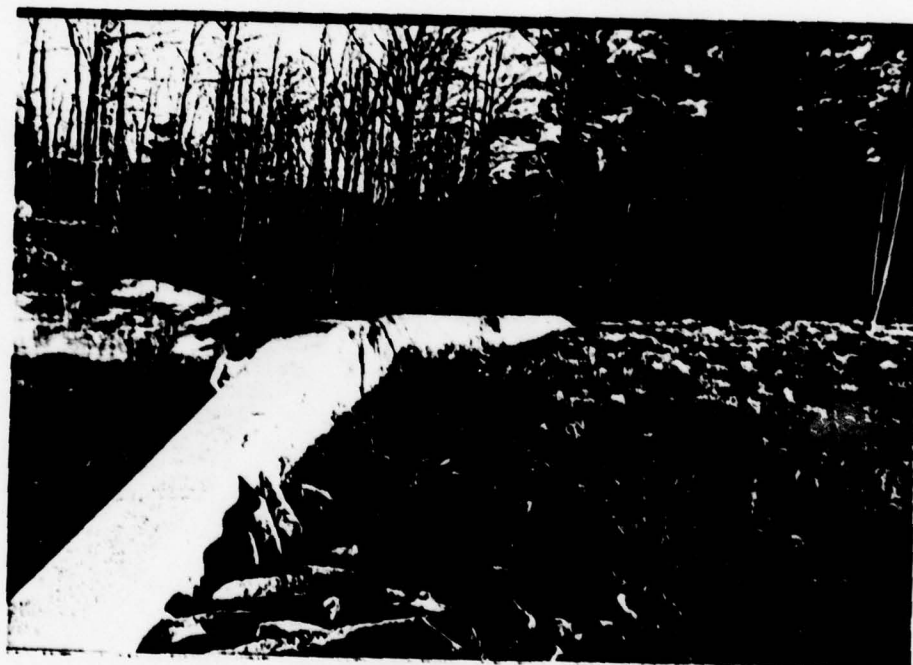
PHOTOGRAPH NO. 16

The junctions between the abutments and the embankment were inspected and evaluated to be in good condition. The junction between the abutment and the spillway was inspected and settlement of 12 to 14 inches was noted, as shown on Photograph 16. This reduces the storage capacity of the reservoir.

Photograph No. 16 shows the relatively large amount of settlement adjacent to the spillway wall. This settlement reduces the maximum reservoir level and, therefore, the spillway capacity. Other observations regarding the condition of the downstream channel, spillway and reservoir are located in Appendix B.

DEPRESSION IN EMBANKMENT  
ADJACENT TO LEFT SPILLWAY  
WALL.

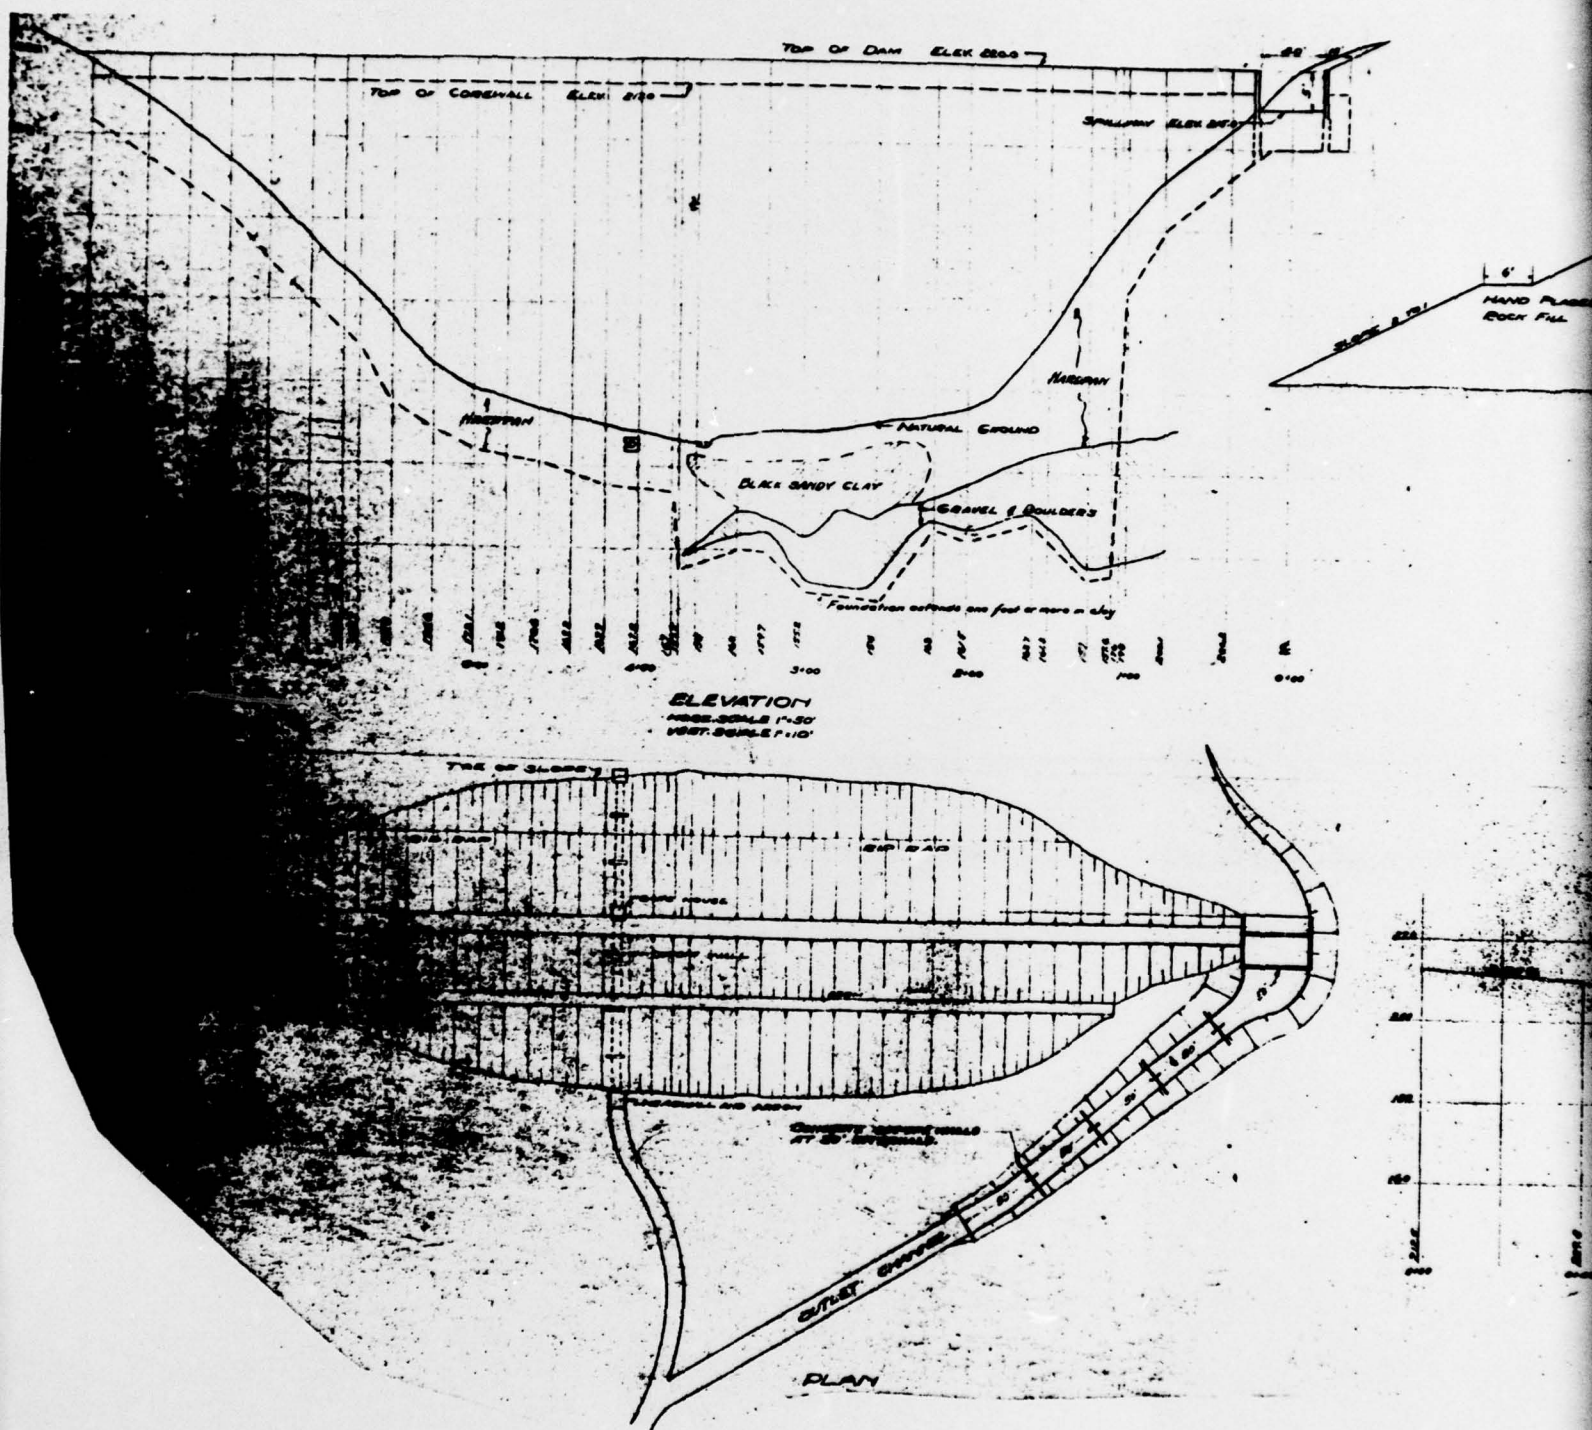
PLATE 3

zones. Additional excavations in the area revealed a large gravel layer, shown on the typical section enclosed herein as Plate 3. This gravelly and boulder ridden zone was a constant source of seepage and foundation construction problems. Seepage was controlled by a series of sumps and terra cotta drainage pipes. As the fill work proceeded, these terra cotta pipes were filled with concrete and sealed.
