DELAWARE RIVER BASIN
MARSHALL FALLS CREEK, MONROE COUNTY
PENNSYLVANIA
NDS ID PA. 00636
DER ID 45-116

WHITE HERON DAM (MINISINK LAKE)

PHASE I INSPECTION REPORT NATIONAL DAM INSPECTION PROGRAM

NDS I.D. NO. PA 00636
DER I.D. NO. 45-116

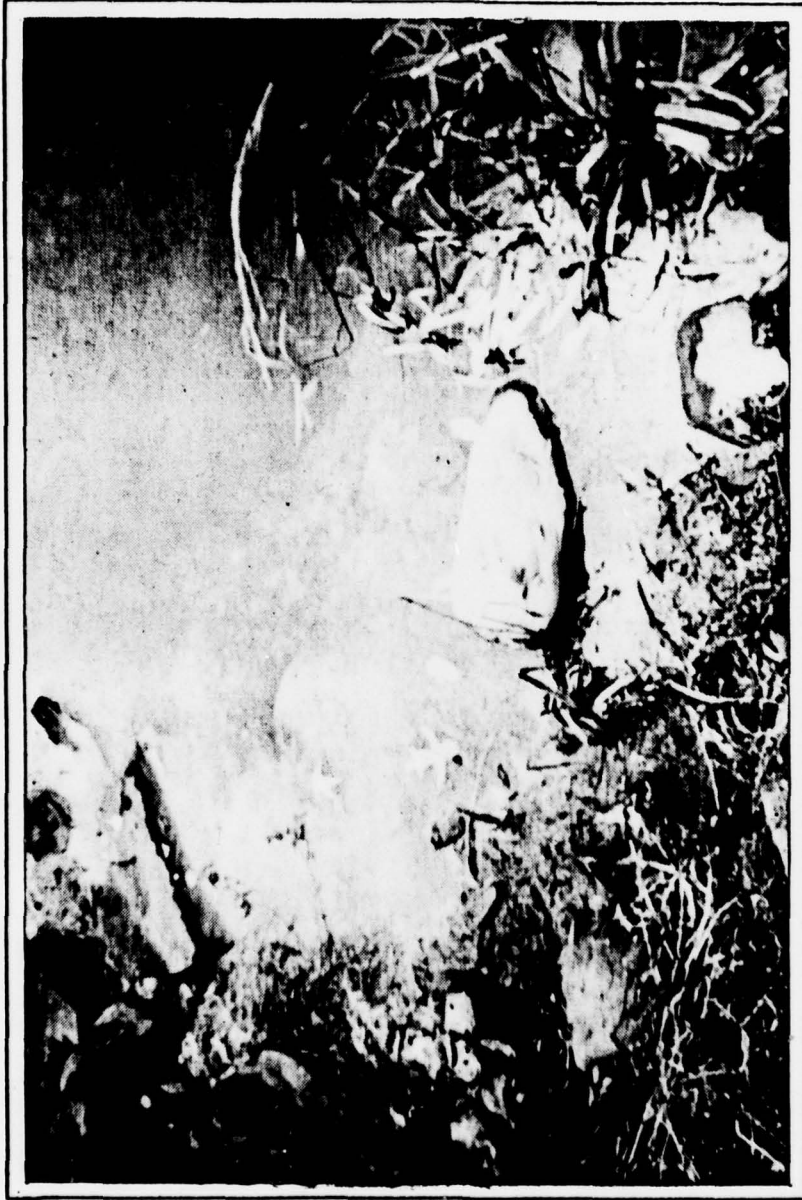
DISCHARGE PIPES AT EDGE OF POND
JUST BELOW WATER LEVEL. SEE
PHOTOGRAPH 1.

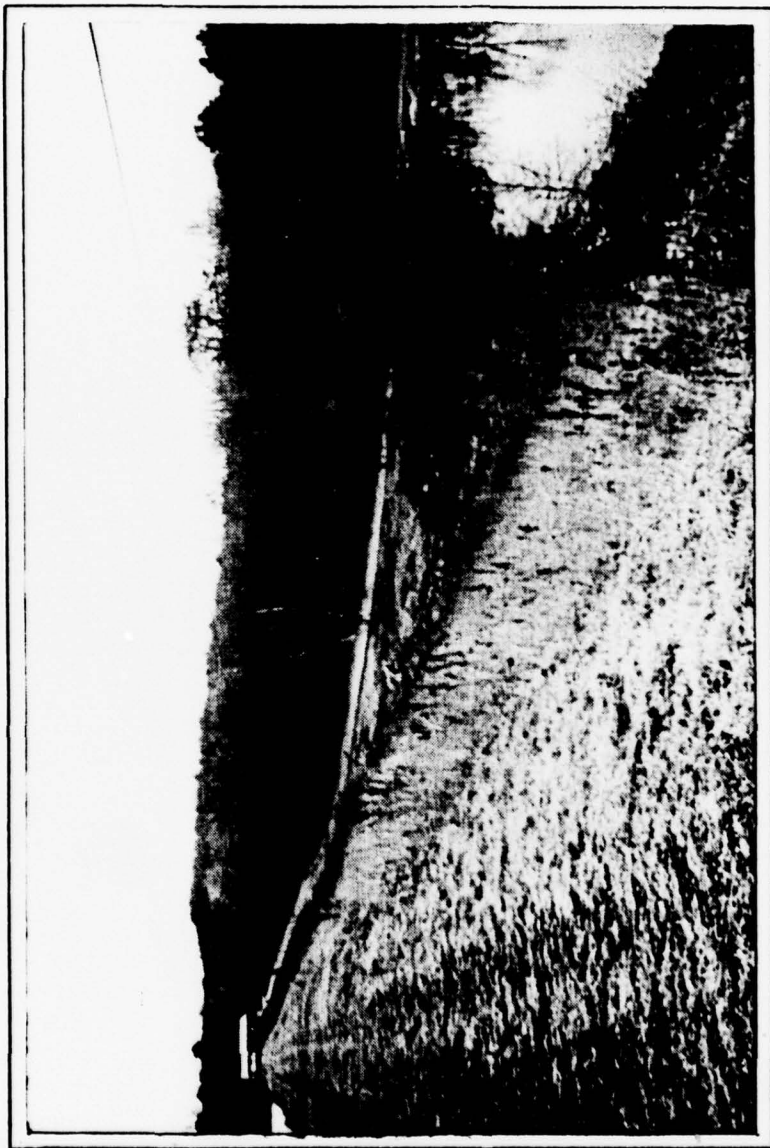
PHOTOGRAPH NO. 8

VIEW OF DOWNSTREAM SLOPE LOOKING
FROM RIGHT ABUTMENT.

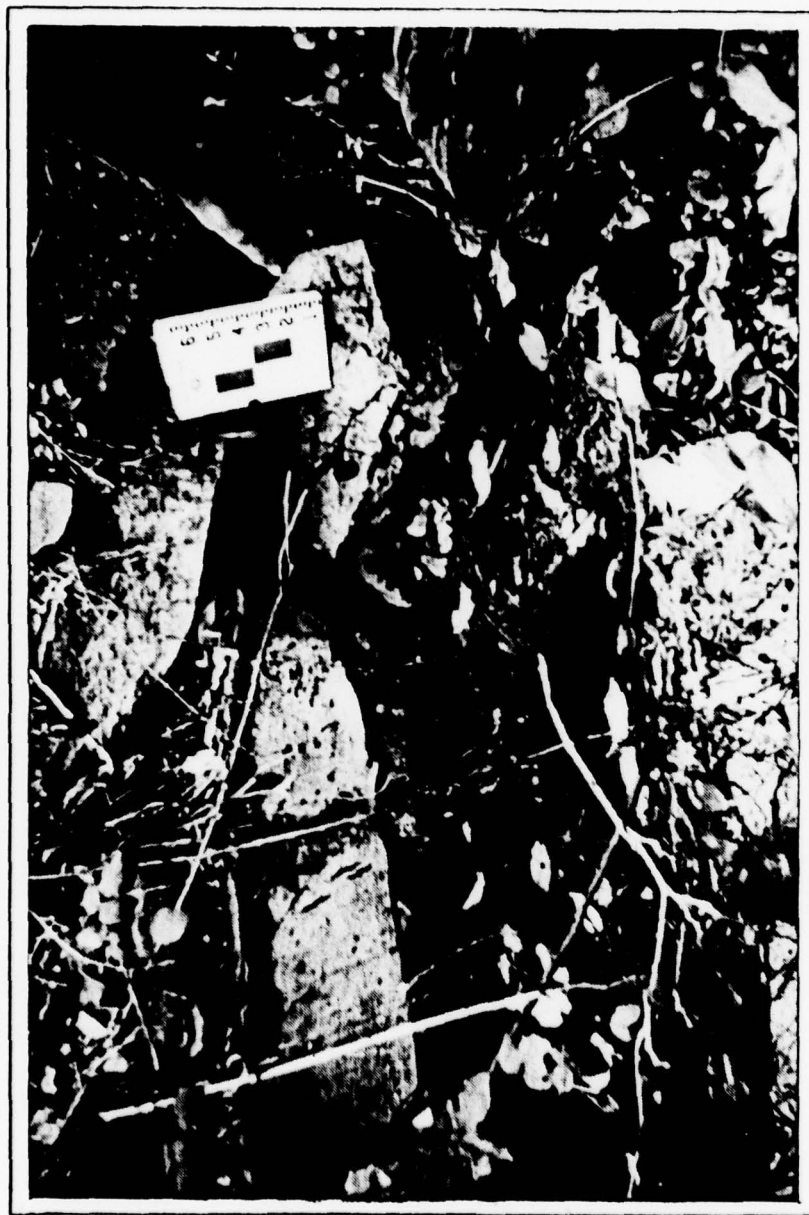
PHOTOGRAPH NO. 10

CLOSE-UP VIEW OF EMBANKMENT SEEPAGE.

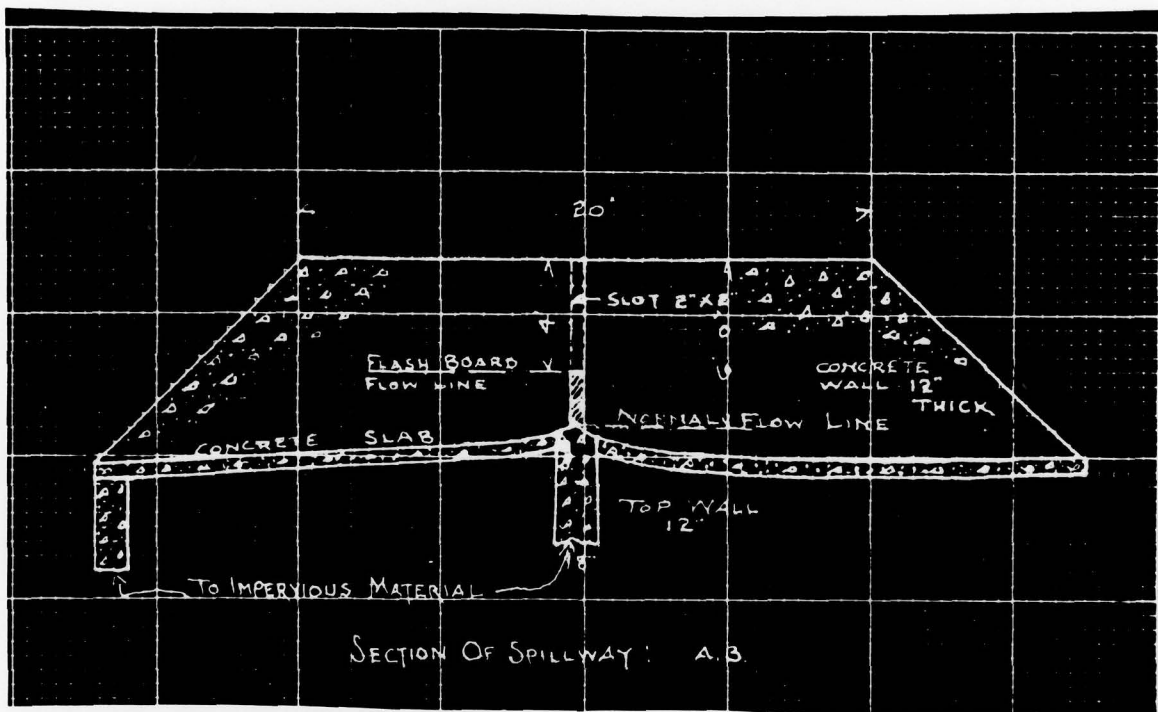
PLATE 5

NOTE: FLASH BOARDS HAVE BEEN REPLACED
WITH A PERMANENT TRAPEZODIAL WEIR
TO ABOUT THE SAME ELEVATION
