MIDDLE BRANCH OF CROTON RIVER, PUTNAM COUNTY

# MIDDLE BRANCH DAM

## PHASE I INSPECTION REPORT

NY 00034

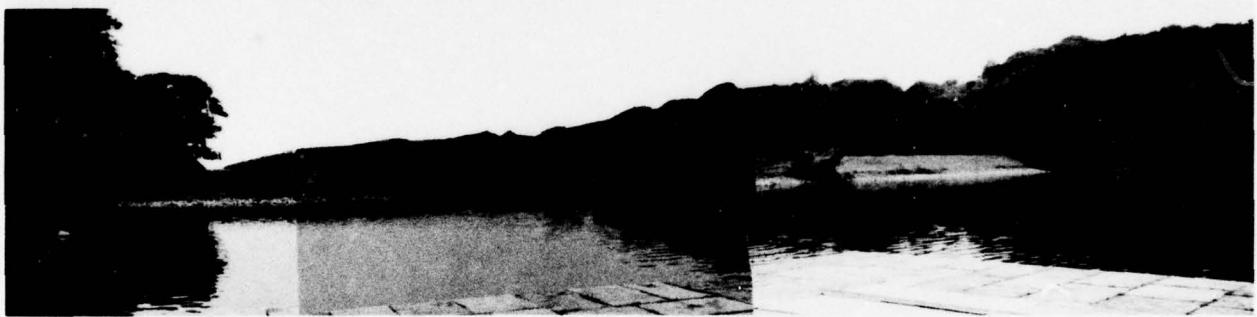
OVERALL VIEW OF UPSTREAM SLOPE

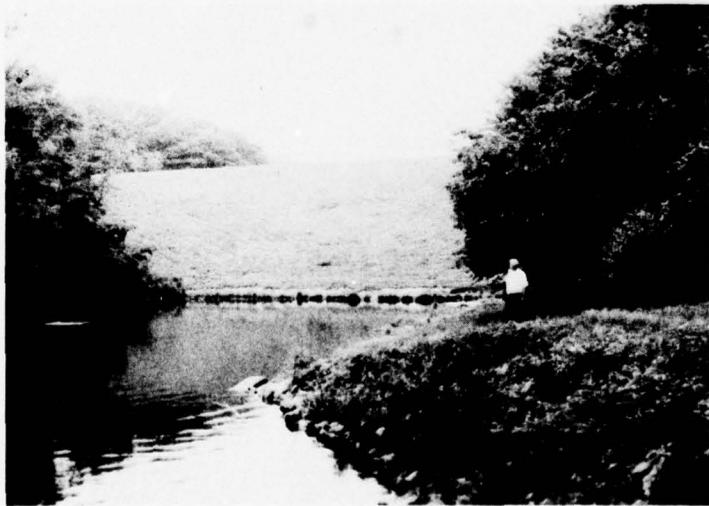
OVERALL VIEW OF DOWNSTREAM SLOPE

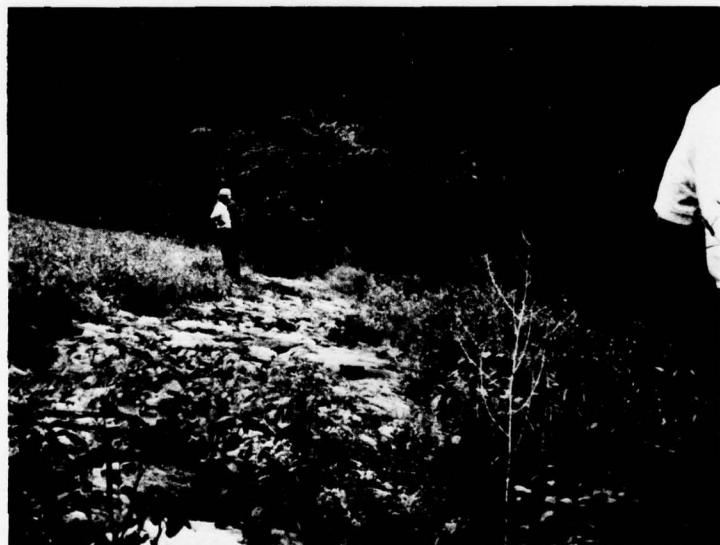
TOE OF DOWNSTREAM SLOPE
