# DIVERTING RESERVOIR DAM

## PHASE I INSPECTION REPORT

Name of Dam: Diverting Reservoir Dam  
County and State: Putnam County, New York  
Inventory Number: NY 00056

Date of Inspection: July 17, 1978

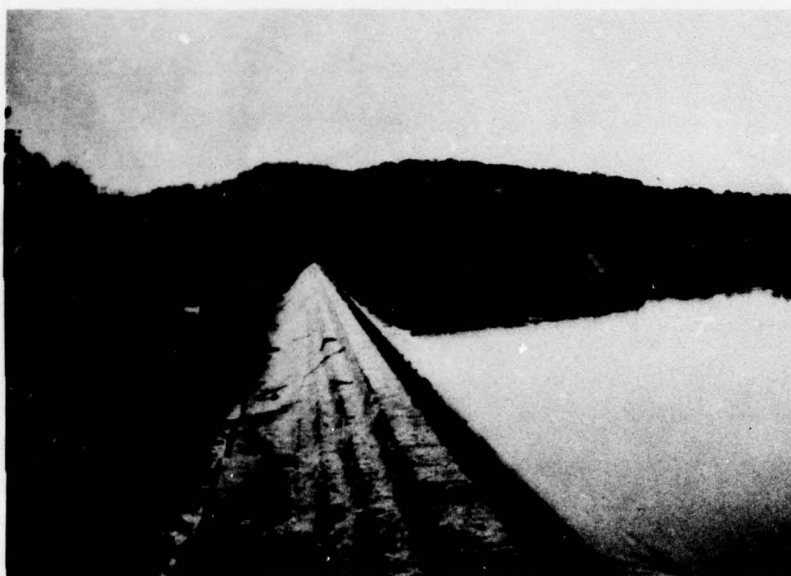
**VIEW OF SPILLWAY LOOKING SOUTHWEST**

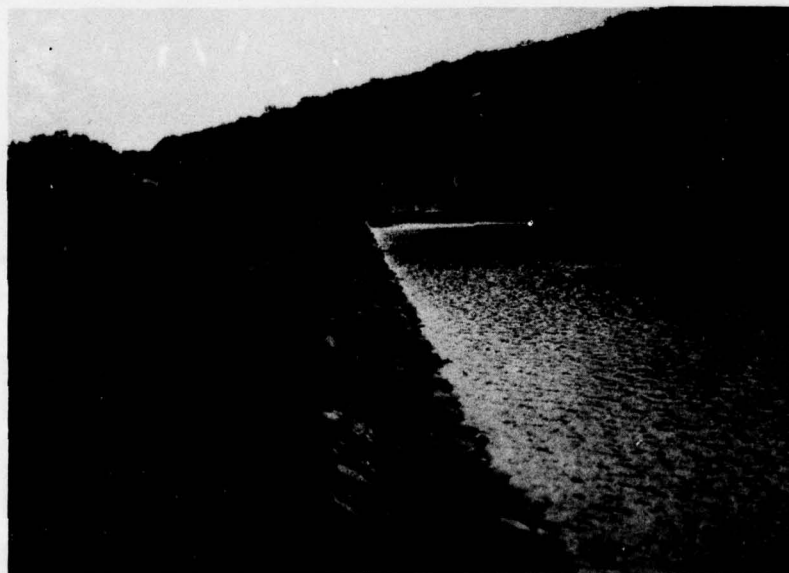
UPSTREAM SLOPE OF EARTH EMBANKMENT

Riprap is in excellent condition.

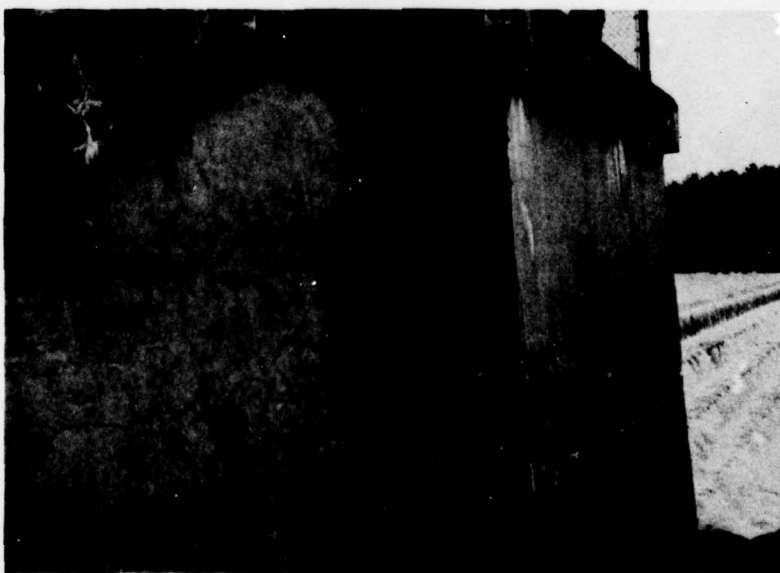
SOUTHWEST ABUTMENT AT JUNCTION OF  
SPILLWAY AND EMBANKMENT

| VISUAL EXAMINATION OF | OBSERVATIONS | REMARKS OR RECOMMENDATIONS |
|---|---|---|
| SURFACE CRACKS<br>CONCRETE SURFACES | A horizontal crack was noted in the spillway's southwest abutment. | The crack does not appear to affect the stability of the structure. |
