**BROOKSIDE RESERVOIR
MONTGOMERY COUNTY
INVENTORY NO 168**

**PHASE I INSPECTION REPORT
NATIONAL DAM SAFETY PROGRAM**

Name of Dam Brookside, City of Amsterdam NY163

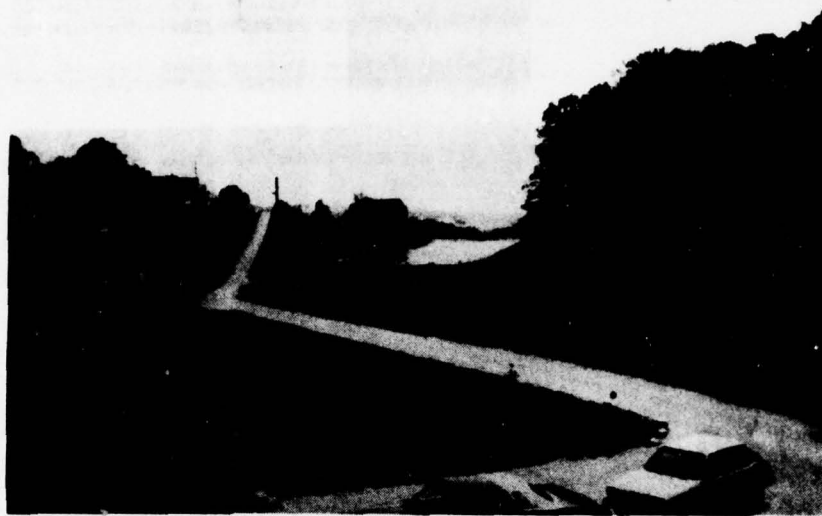
7. View of reservoir and access road from filtration plant.

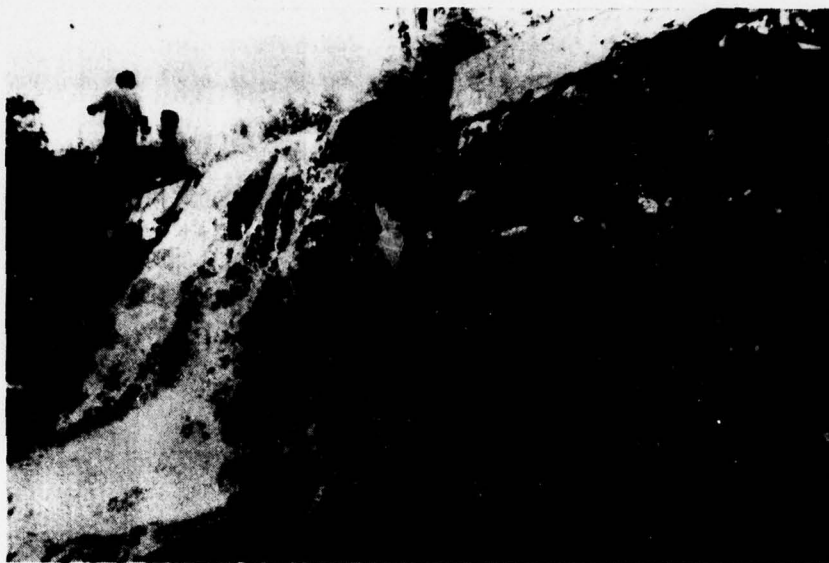
13. Drop area below spillway. Notice drain pipes through masonry wall.
