WARNER GAP HOLLOW DAM

(EDGEMONT RESERVOIR)

PHASE I INSPECTION REPORT NATIONAL DAM INSPECTION PROGRAM

WARNER GAP HOLLOW DAM
(EDGEMONT RESERVOIR)
WASHINGTON COUNTY, MARYLAND
NDI NO. MD 00006

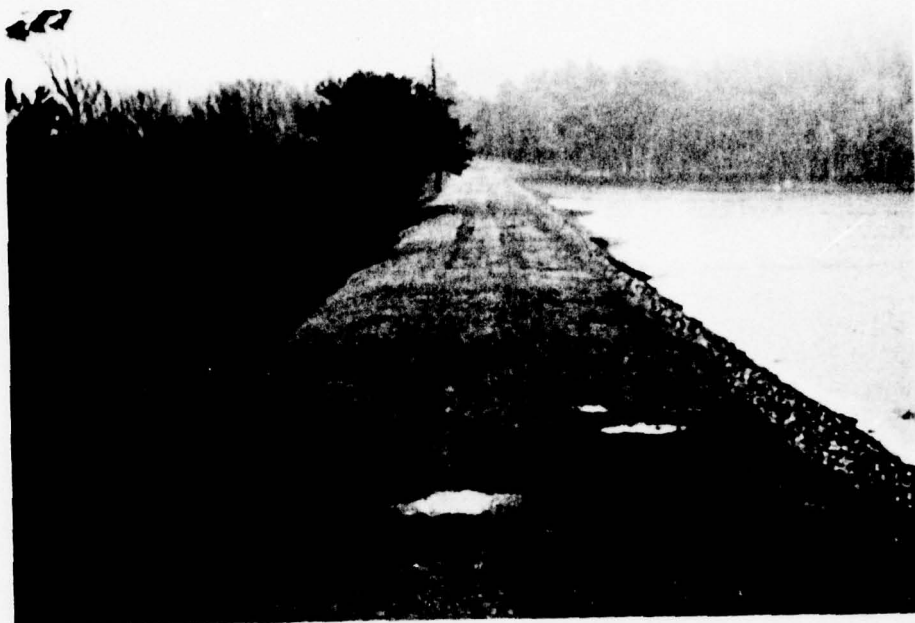
CREST

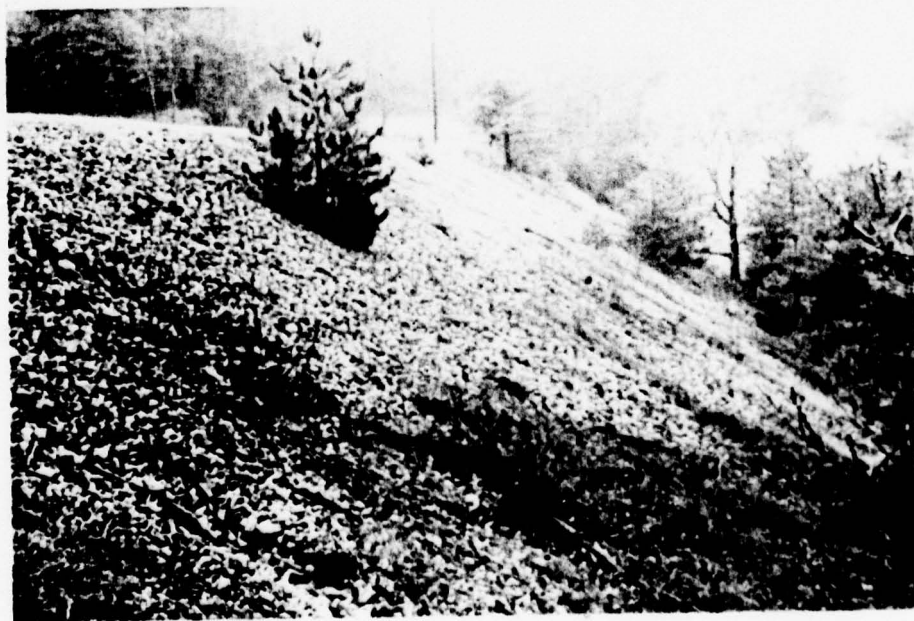
2. The recent dumping of replacement rip-rap over the downstream slope may account for the non-uniform slope surface noted during the inspection. Tension cracks, toe heave, and/or alignment irregularities which might indicate deep seated movement of the dam slopes were not observed.

DOWNSTREAM FACE-VIEWED FROM
RIGHT ABUTMENT

1. Document operating procedures in writing.
2. Remove woody vegetation from downstream embankment slope.
3. Develop a warning system to warn downstream residents of large spillway discharges during periods of heavy rainfall and runoff or failure of the dam.

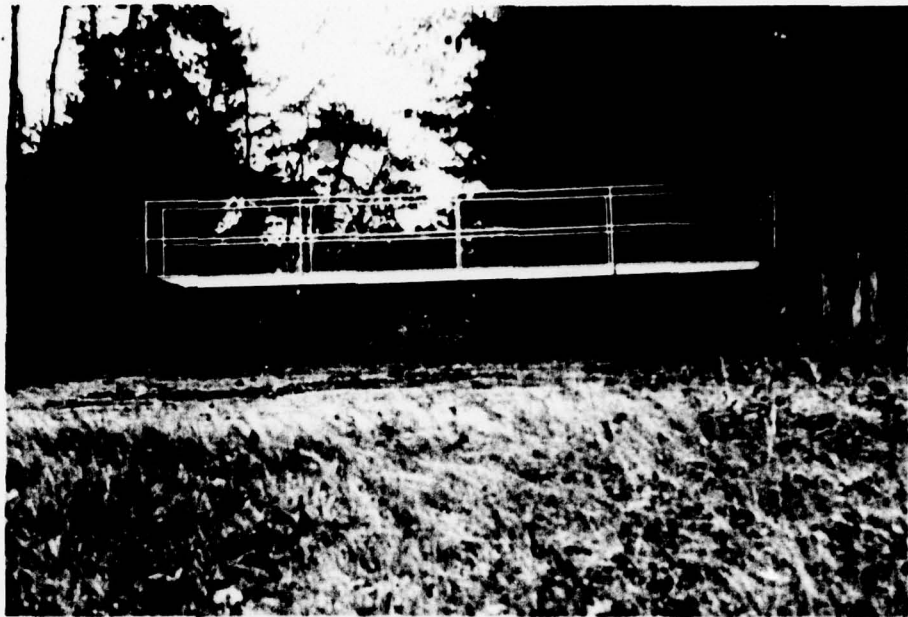
OVERFLOW SPILLWAY-ENTRANCE

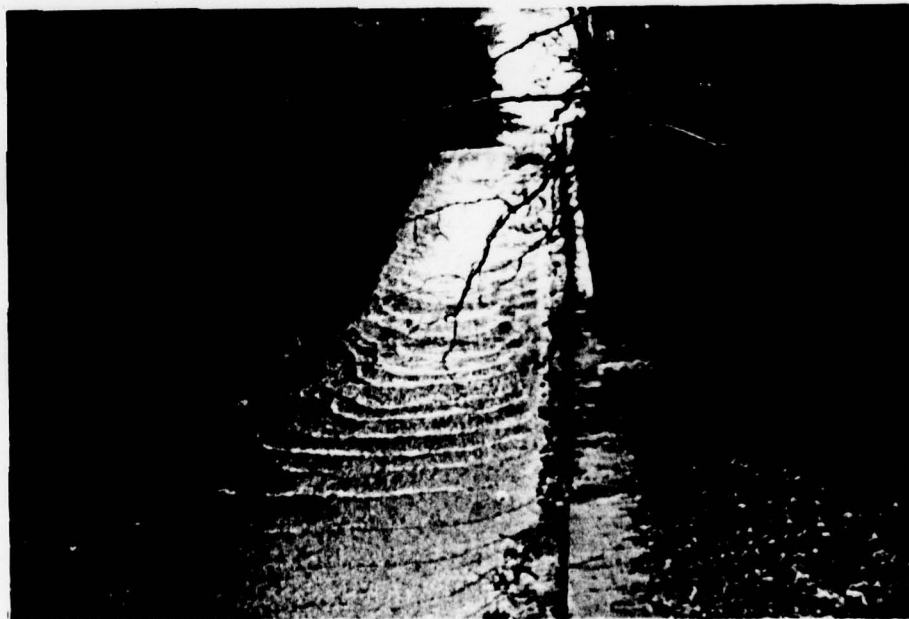
2. Appurtenant Structures. The concrete overflow spillway appears to be in good condition with only minor cracking, spalling, and slight deterioration. Although flow in the spillway prevented direct observation of construction joints on the floor, some joints are suspected to be open. It could not be determined whether flow was occurring beneath the slabs, but the floor and walls appeared stable and settlement from undermining was not indicated.

OVERFLOW SPILLWAY

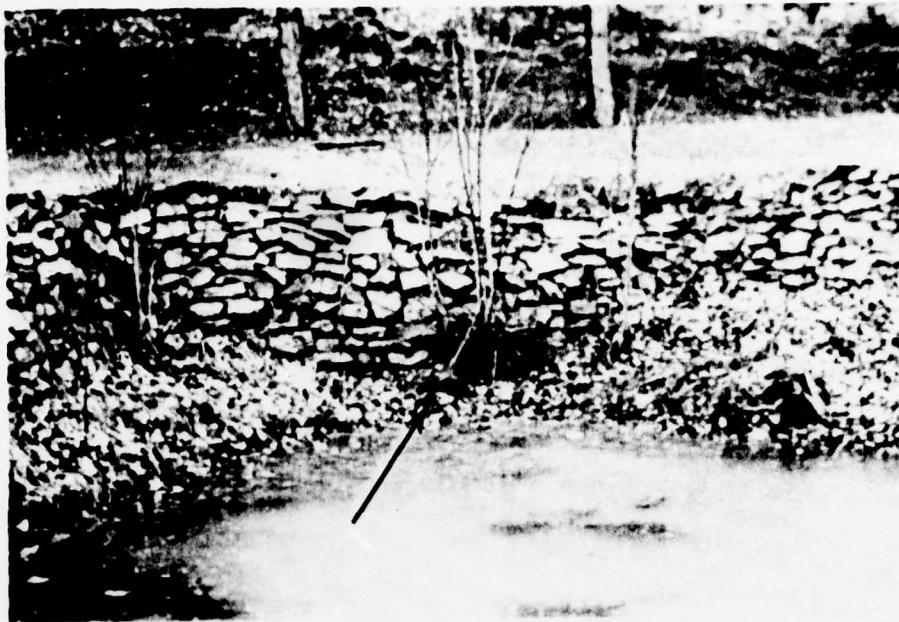
1. The concrete associated with the rectangular overflow spillway was in good condition.
2. Debris and sediment partially choke the outlet channel for the 30" blow-off pipe. The valve was inoperative at the time of the inspection.
3. The control and by-pass valves for the discharge mains are regularly operated.

30" BLOW-OFF (DRAIN)

1. Initiate an engineering study to evaluate spillway capacity and determine remedial measures to reduce the overtopping potential at the dam.
2. The 30-inch drain valve should be restored to an operable condition and should be provided with a positive seal on the upstream side of the dam.
3. The seepage at the left abutment should be monitored on a routine basis to detect any changed conditions in quantity or turbidity. Flow measurements should be made with the use of a weir.

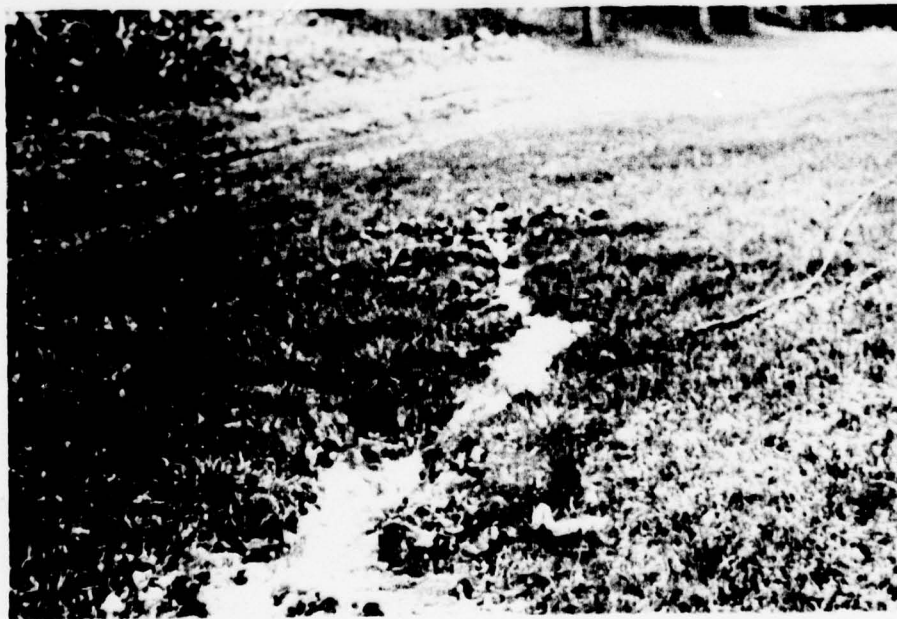
3. The 1968 investigation judged the seepage activity beyond the left abutment not as serious as the leakage at the right abutment and further evaluation was deferred until the spring of 1969. No record of the deferred evaluation was found during the data review. Based upon the relative clarity and apparent seasonal fluctuation of seepage, the source of discharge at the left abutment appears to be primarily spring activity not directly affecting the stability of the dam. However, the quantity and turbidity of seepage should be monitored on a routine basis.

SEEPAGE, LEFT SIDE BEYOND TOE

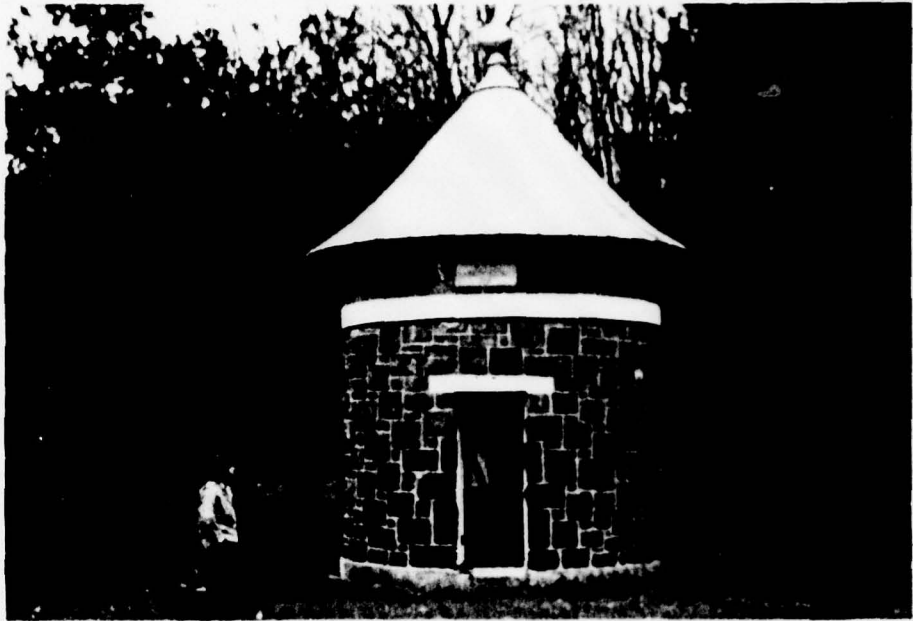
GATE HOUSE

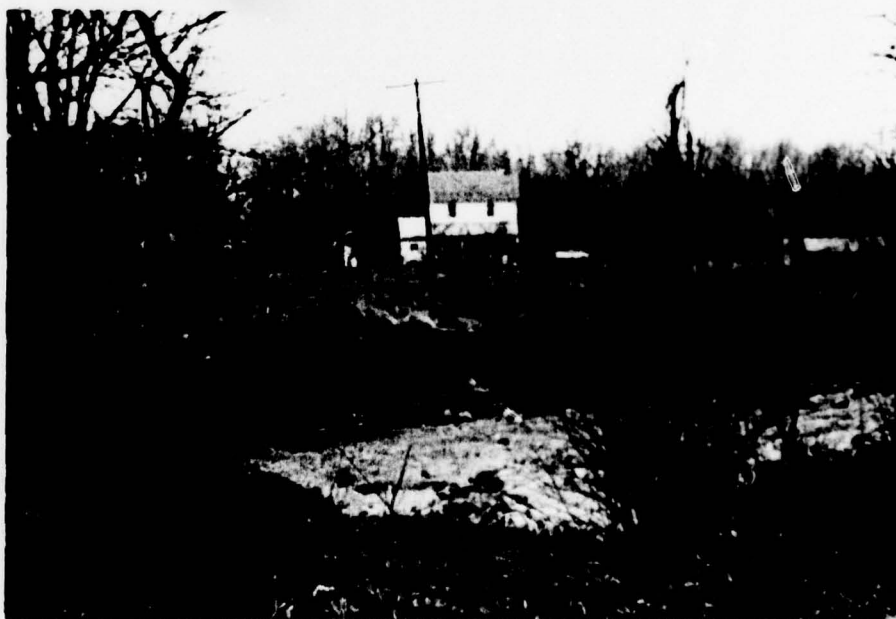
DOWNSTREAM DWELLING
(STATION #4 OF
HYDRAULIC ROUTINGS)
