LAKE PARSIPPANY DYKE

NO 1

NJ 00356

PHASE 1 INSPECTION REPORT
NATIONAL DAM SAFETY PROGRAM

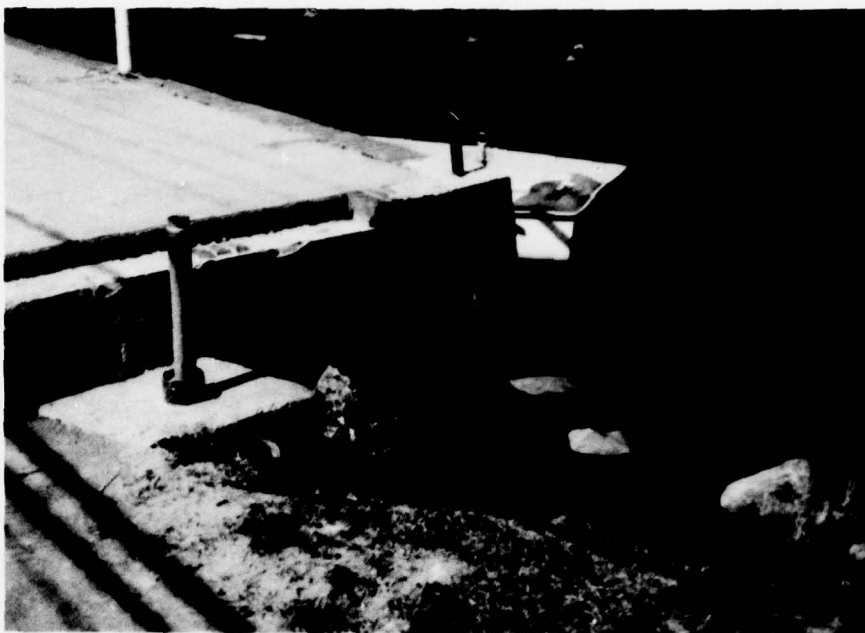
PHOTO 5

DETERIORATION OF SOUTH END OF CONCRETE DOCK

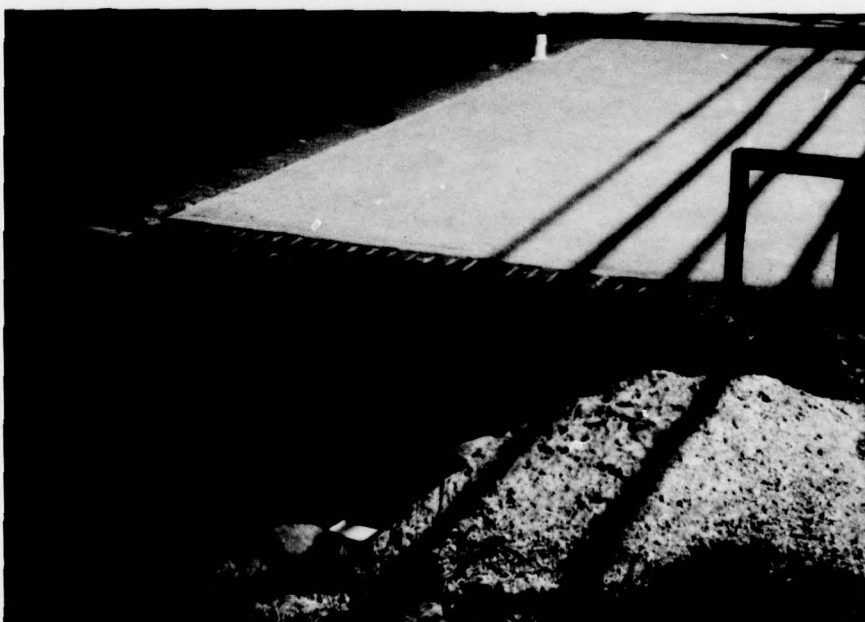
PHOTO 6

DETERIORATION OF NORTH END OF CONCRETE DOCK
