LEVEL II  
**SPEEDWELL DAM**

**NJ 00359**

**PHASE 1 INSPECTION REPORT  
NATIONAL DAM SAFETY PROGRAM**

May, 1979

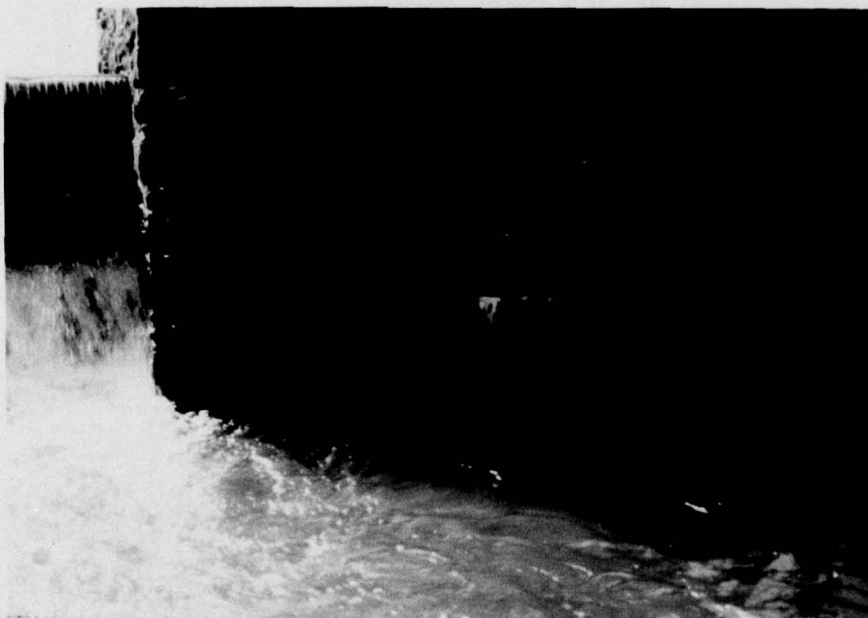
The gate lift stems are severely rusted at the water line causing significant reductions in cross section. The gates could not be observed completely but appeared to be in good condition.

PHOTO 8  
DOWNSTREAM VIEW OF GATES
