**LAKE GILMAN DAM**  
**NJ 00431**

**PHASE 1 INSPECTION REPORT**  
**NATIONAL DAM SAFETY PROGRAM**

PHASE I REPORT  
NATIONAL DAM INSPECTION PROGRAM

Name of Dam: Gilman Lake Dam Fed ID# NJ 00431  
and NJ ID# 362

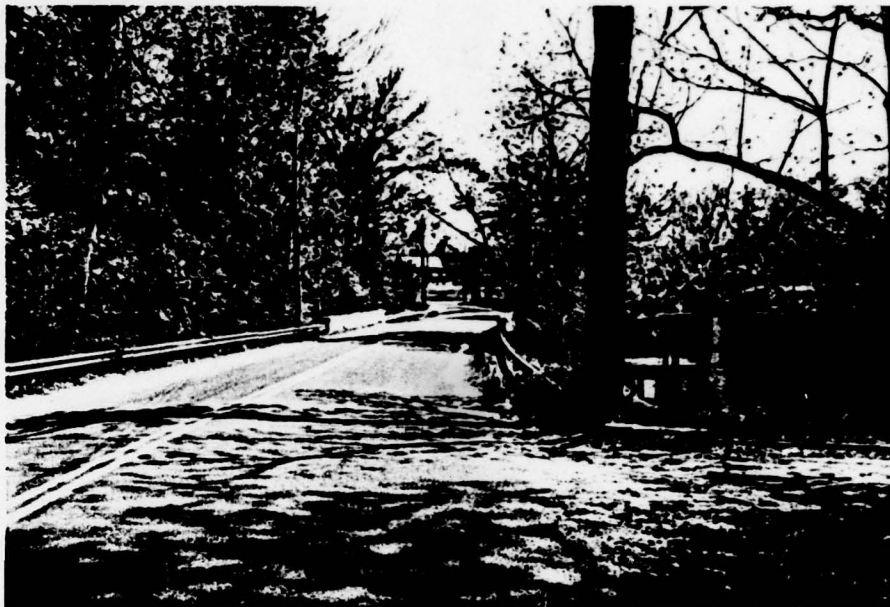
View of Crest Looking Northeast

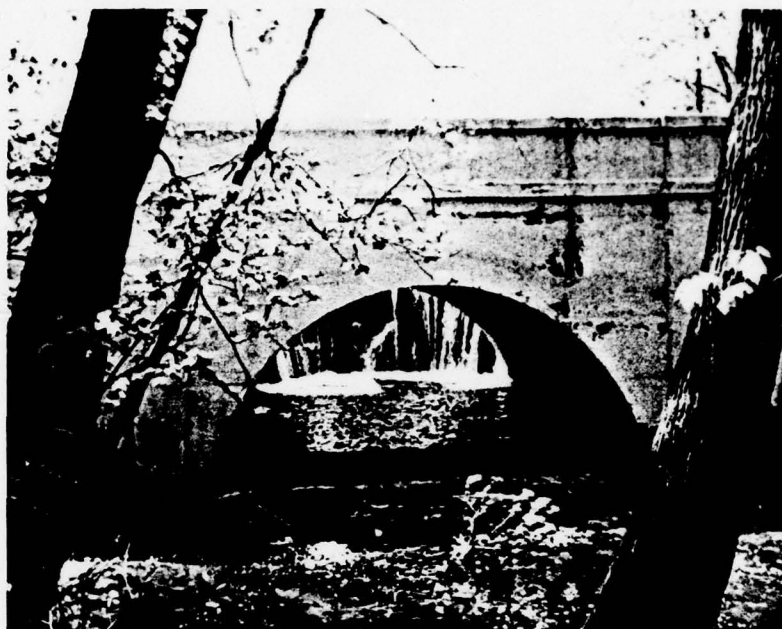
View of Spillway Outlet

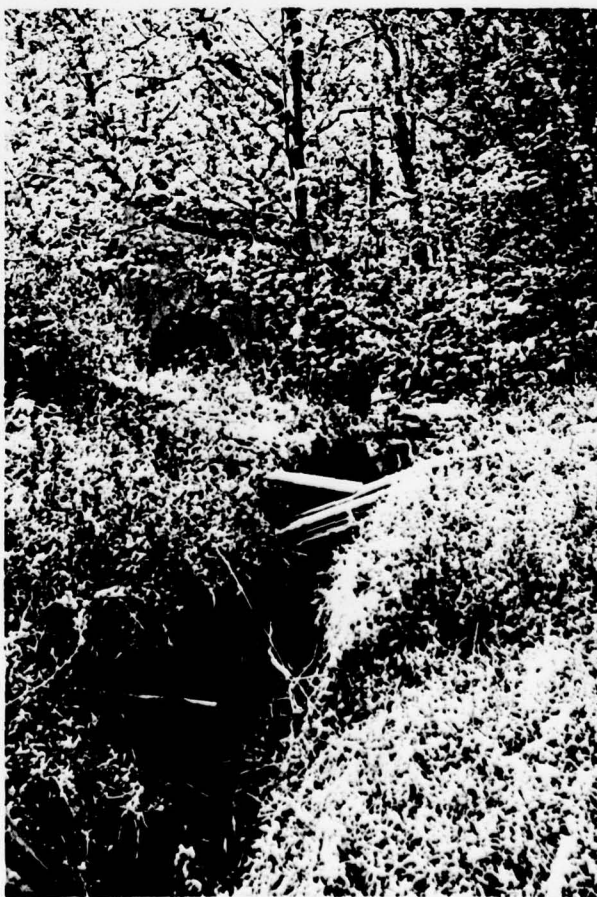
| VISUAL EXAMINATION OF | OBSERVATIONS | REMARKS OR RECOMMENDATIONS |
|---|---|---|
| UNUSUAL MOVEMENT OR<br>CRACKING AT OR BEYOND<br>THE TOE | None observed. | Deeply incised ditch just below bridge (on right side). Caused by discharge from roadway curb inlet. (Undercutting toe of embankment). |

View of Ditch at Right Downstream Toe of Dam

(3). Construct curbs and catch basins along the roadway gutters to better channelize the roadway runoff.
