Name Of Dam: LAKE COHOON DAM
Location: CITY OF SUFFOLK
Inventory Number: VA. 12301

PHASE I INSPECTION REPORT NATIONAL DAM SAFETY PROGRAM

DEWARD M. MARTIN & ASSOCIATES
WILLIAMSBURG, VIRGINIA

AUGUST 1979

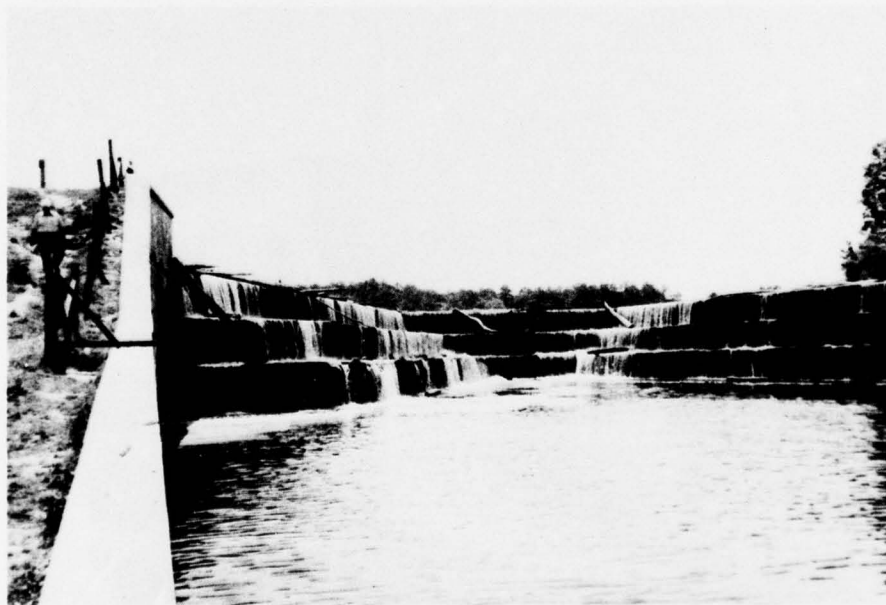
Spillway - Front View

3.1.5 Spillway: The spillway, which had water flowing over the crest at the time of inspection, had some spalling of the concrete at the leading edge of the spillway steps and at the joints.

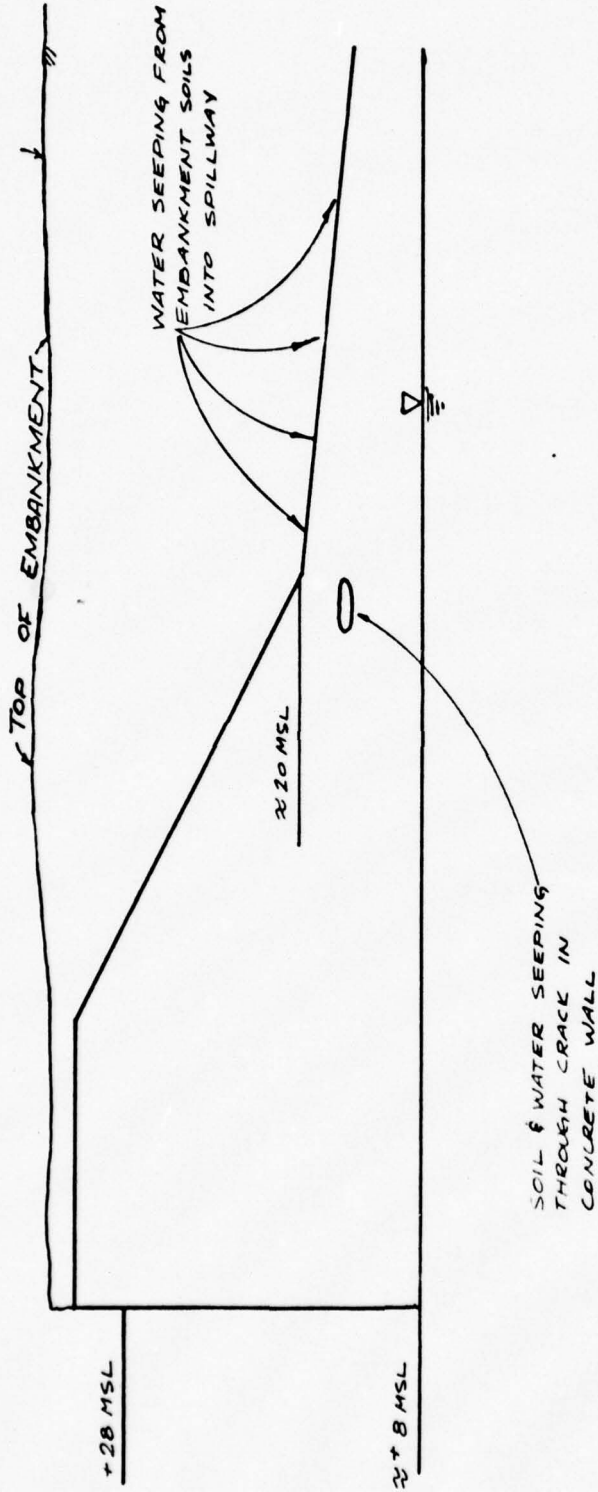
SCHEMATIC OF NORTH SIDE OF SPILLWAY

OBSERVED SEEPAGE	LAW ENGINEERING TESTING COMPANY GEOTECHNICAL & ENVIRONMENTAL CONSULTANTS 7913 WESTPARK DRIVE, MCLEAN, VIRGINIA 22101		Job No. W-9-2279
	SCALE	Drawn: DLB Checked: MJC	Date: 6-12-79
LAKE COHOON DAM	NONE		PLATE NO. 6
NANSEMOND COUNTY, VIRGINIA

VISUAL EXAMINATION OF	OBSERVATIONS	REMARKS OR RECOMMENDATIONS
SEE PAGE ON LEAKAGE	Left side of spillway wall, water seeping over top of wall and through joint at this point. The joint shows brown mud accumulation on face and small roots.	Trees were cut down at left side just back of this wall. This loss of trees may contribute to the seepage.
STRUCTURE TO ABUTMENT/EMBANKMENT JUNCTIONS	No indication of cracks.	
DRAINS	None visible.	
WATER PASSAGES	30" C.I. pipe through dam.	
FOUNDATION	Not visible.

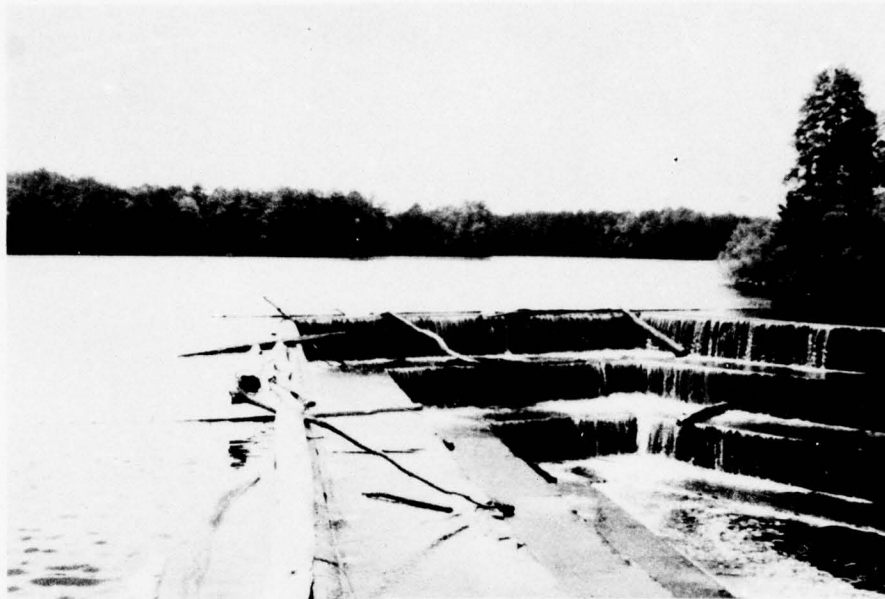
PHOTOGRAPH NO. 3
Spillway

VISUAL EXAMINATION OF	OBSERVATIONS	REMARKS OR RECOMMENDATIONS
CONCRETE WEIR	Spalling of spillway steps and abutment walls	Needs referberishing to avoid more deterioration.
APPROACH CHANNEL	Water flows over 120-foot V-shaped spillway.	
DISCHARGE CHANNEL	Discharge into tailwater pool.	
BRIDGE AND PIERS	None.

The visual inspection indicated the need for an upgraded maintenance program. The deterioration of the concrete and reinforcing steel in the spillway and abutments should be corrected to prevent further damage and the vegetation on the embankment should be cut regularly to prevent the growth of large trees and bushes which can cause damage to the dam. The extent of the damage caused by the trees on the lower side of the embankment to the left of the spillway is difficult to evaluate now and therefore should be monitored regularly to detect any changes or increased seepage. In addition, the water levels observed in the test wells on either side of the core wall seriously question its stability.

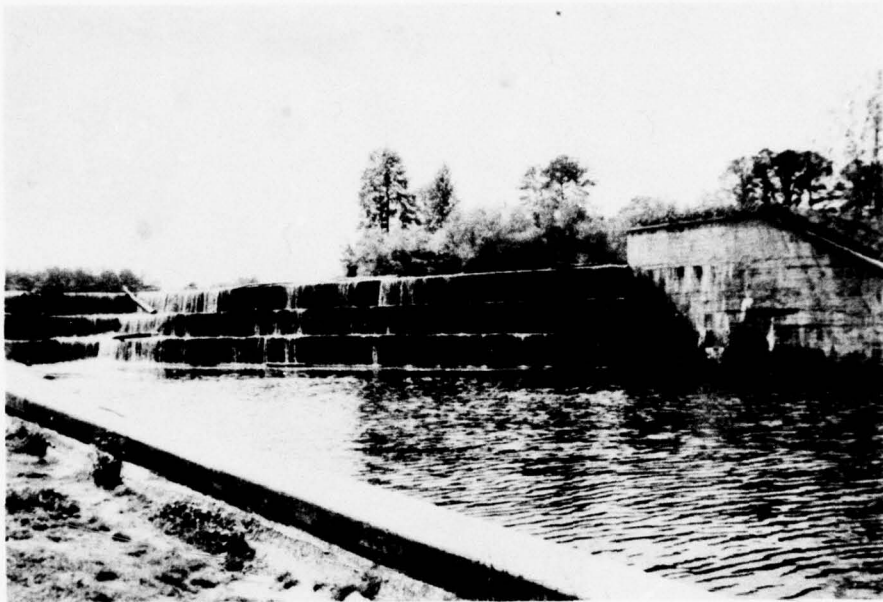
PHOTOGRAPH NO. 5
Spillway Abutment

3.1.4 Abutments: The abutment walls show white stains, spalling, and actual seepage. At the left abutment wall, about 4 feet downstream from the end of the slope wall, there is a joint showing seepage of less than 1 GPM accumulation of mud and small roots. The abutment walls showed signs of spalling and reinforcing bars were visible in some locations.
