PHASE I INSPECTION REPORT  
NATIONAL DAM SAFETY PROGRAM

PHASE 1 INSPECTION REPORT  
NATIONAL DAM SAFETY PROGRAM  
WANAKSINK LAKE DAM I.D. No. NY 330  
DEC #195 DELAWARE RIVER BASIN  
SULLIVAN COUNTY  
(FORMERLY LORDS RESERVOIR DAM)

Name of Dam: Wanaksink Lake Dam (I.D. No. NY 330)  
(formerly Lords Reservoir Dam)

Date of Inspection: November 15, 1978

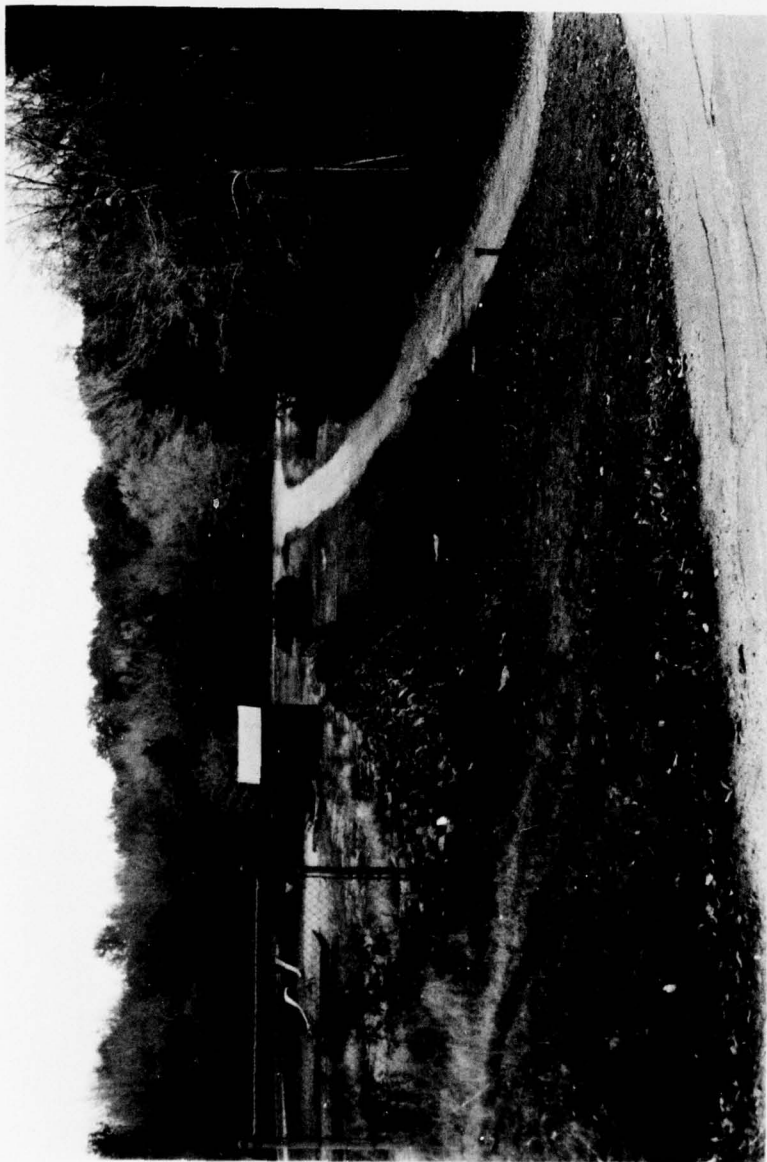
Overview of Wanaksink Lake Dam  
Downstream Face

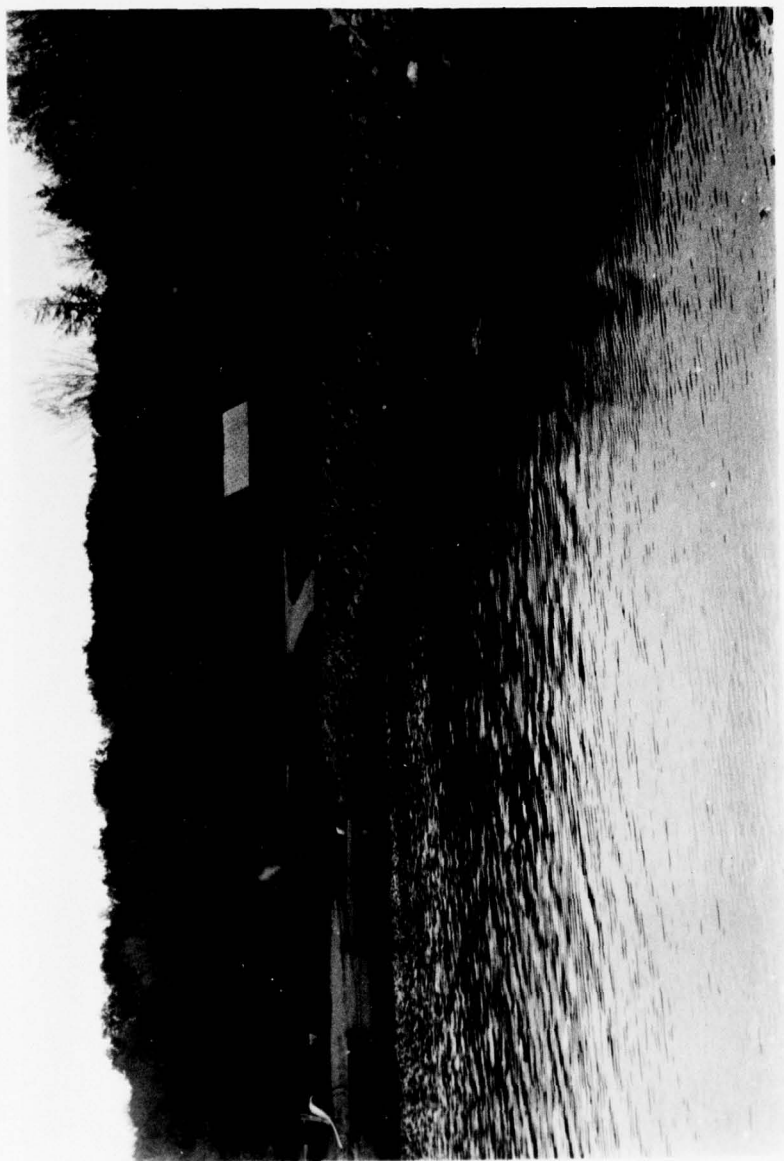
Overview of Wanaksink Lake Dam  
Upstream Face

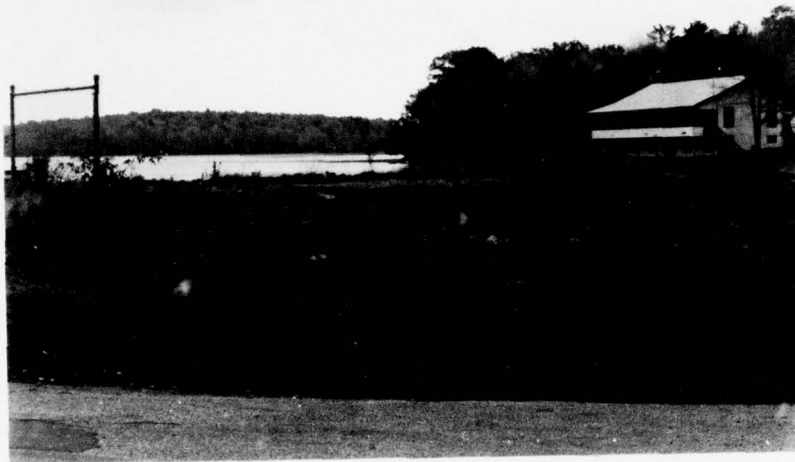
PHOTO #1

North Abutment, Downstream Face

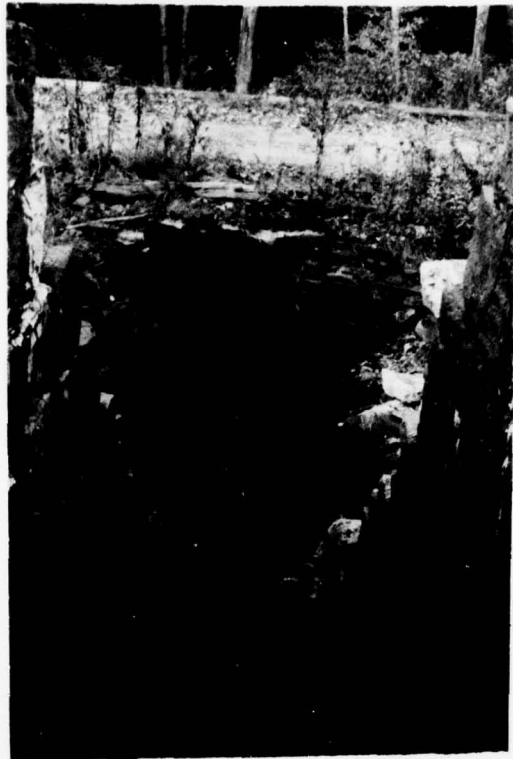
PHOTOS #3 & 4

The riprapped tailrace channel is in good condition, but the flow is constricted by the presence of a masonry culvert beneath the access road near the toe of the dam. No problems have been reported due to this culvert.

Spillway Channel and Access Road Culvert  
Looking West

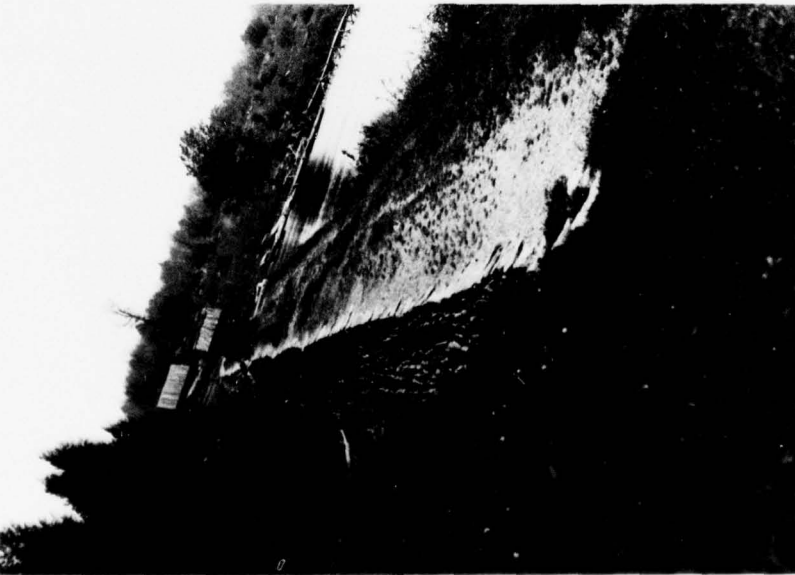
PHOTO #6

Old Photograph of Dam (5-31-13)  
Looking North

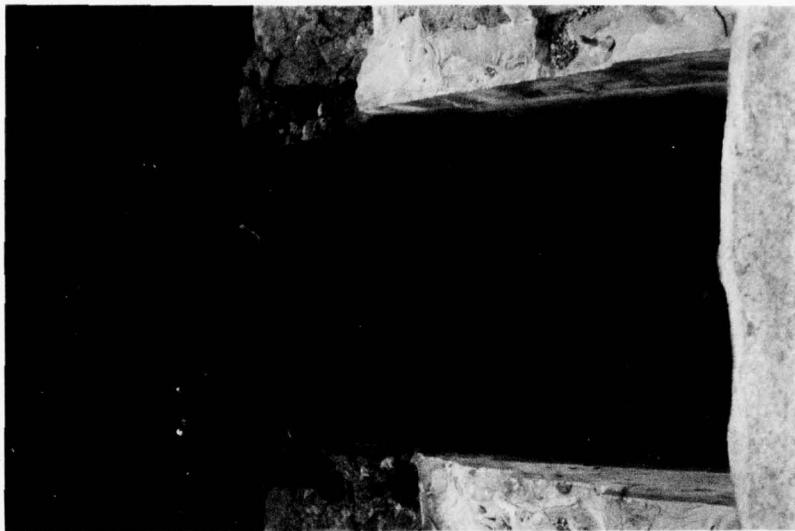
PHOTO #5

Spillway Channel  
Looking Upstream from Crest

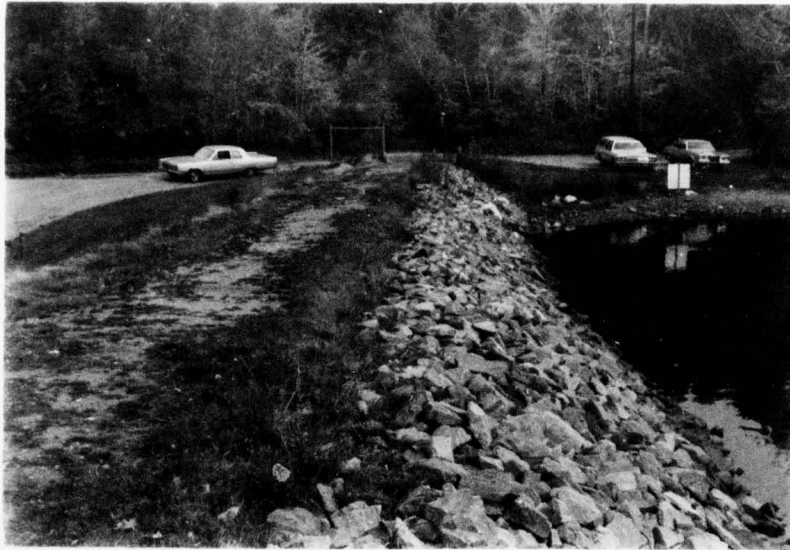
PHOTO #7

The embankment crest exhibits some minor settlement; the largest depression, approximately 6 inches. Slight distortion of the riprap on the upstream face was observed, which could be related to uneven placement. A bulge (approximately 10 feet long) located south of the spillway on the downstream face was observed. This bulge could be a result of the seepage and subsequent grouting program conducted by the owner. The structure, as viewed from the downstream area, exhibits signs of previous settlement. The embankment appears to have settled differentially from the spillway. The masonry blocks are tipped substantially near the spillway walls (see photograph #2), then diminish with distance from these walls. This may indicate heave of the spillway section or general settlement of the embankment portions due to loading conditions. These problem areas do not, at present, constitute hazardous conditions, but they should be periodically monitored and observed. No problems were observed in the abutment areas, other than the presence of small trees and brush. Recently placed fill between the toe of the dam and the access road (see photograph #9) obscured any observation below the dam. This fill was placed (source: Mr. Ernest Greenwell) to cover the small depressions resulting from the removal of brush and small trees from the area. The area was being seeded at the time of visual inspection. No drainage system was incorporated in the construction of the dam. No seepage was observed during visual inspection of the dam.

Crest and Upstream Face  
Looking North from Spillway

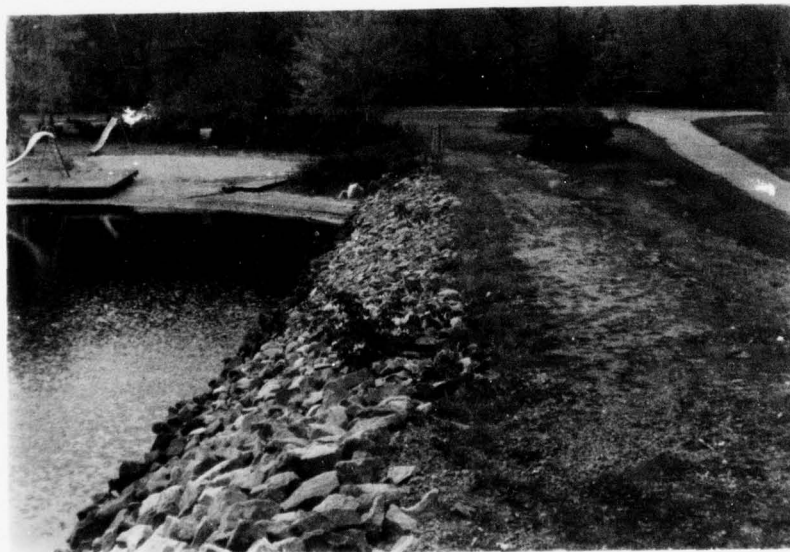
PHOTO #8

Crest and Upstream Face  
Looking South from Spillway

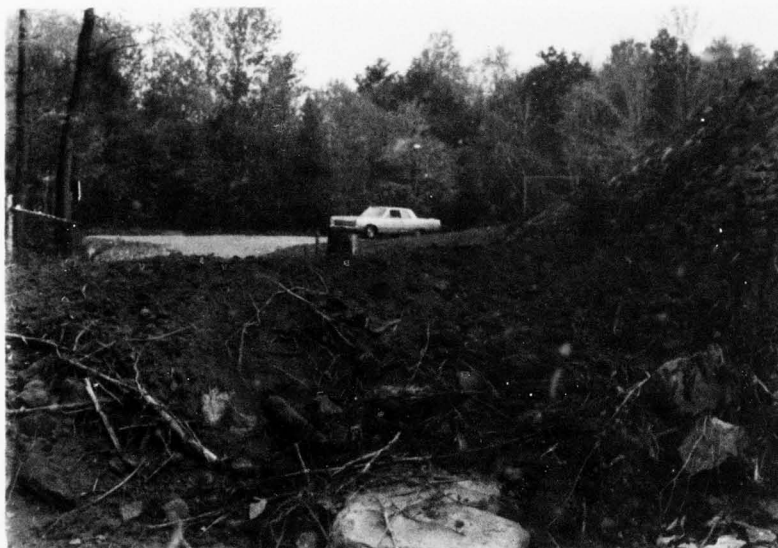
PHOTO #9

New Fill Placed at Toe  
Looking North from Spillway Channel
