Finch Hollow Watershed Project, Site 1. Inventory Number NY-697
Susquehanna River Basin. Broome County,
New York. Phase 1 Inspection Report,

1. REPORT NUMBER	2. GOVT ACCESSION NO.	3. RECIPIENT'S CATALOG NUMBER
4. TITLE (and Subtitle) Phase I Inspection Report Finch Hollow Watershed Project - Site 1 Susquehanna River Basin, Broome County, New York Inventory No. NY 697		5. TYPE OF REPORT & PERIOD COVERED Phase I Inspection Report National Dam Safety Program

PHASE I INSPECTION REPORT
NATIONAL DAM SAFETY PROGRAM
FINCH HOLLOW WATERSHED PROJECT - SITE I
I.D. No. NY 697
DEC #96A-3852
SUSQUEHANNA RIVER BASIN
BROOME COUNTY, NEW YORK

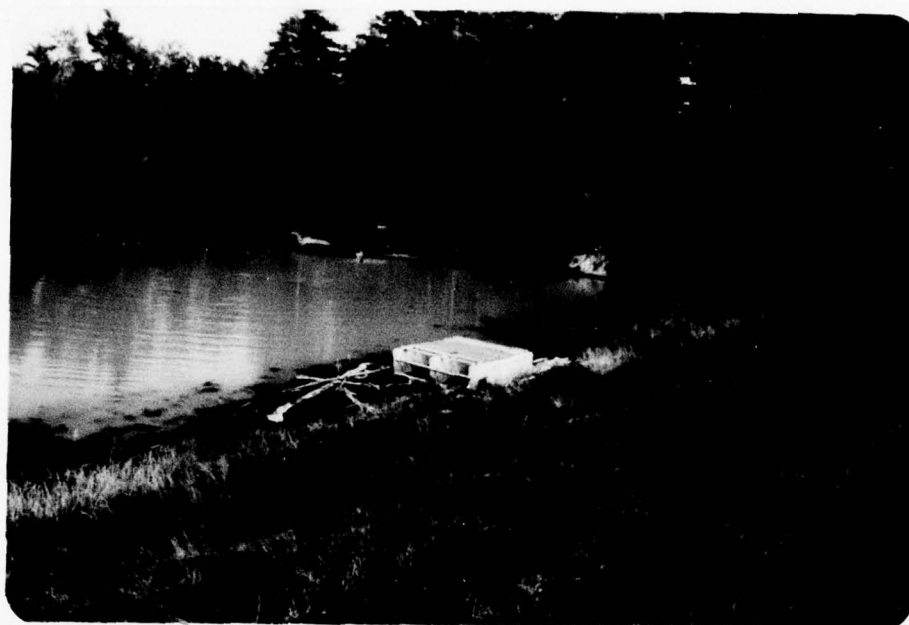
No signs of distress were observed in the earth embankment and no evidence of seepage, misalignment, sloughing, subsidence, depressions, surface cracking, or undesirable growth were noted in connection with the embankment. Riprap was in place on the upstream slope in the vicinity of the normal pool level for wave protection. (See photos #1, 2, & 12)

Upstream Face of Dam
Photo #2

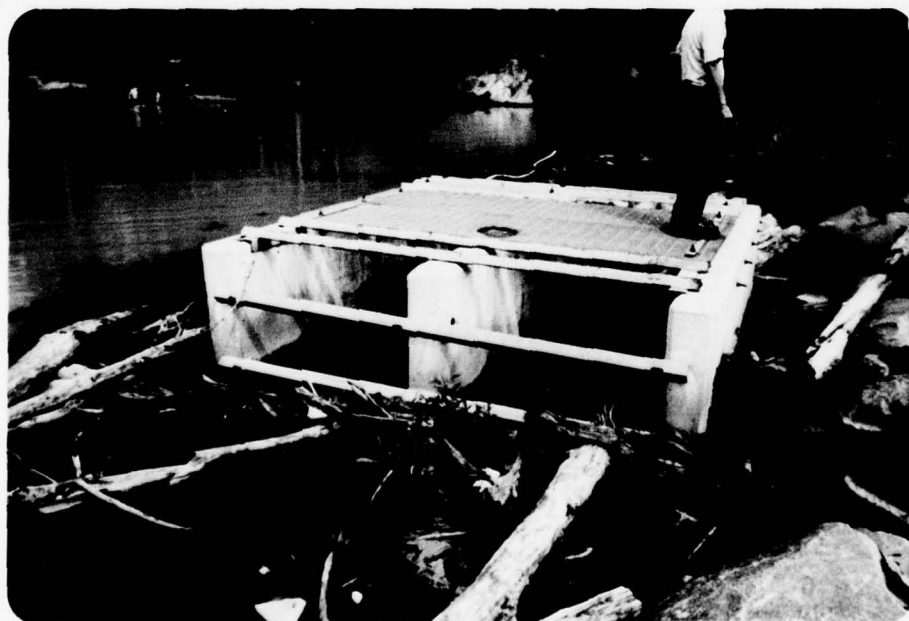
1. The riser top grating is loose and the bolting units require repair. (See photo #5);
2. Considerable debris is surrounding the intake of the principal spillway. This debris should be removed with periodic removals conducted in the future. (See photos #3 & 4).

Right Side of Principal Spillway Riser
Photo #3

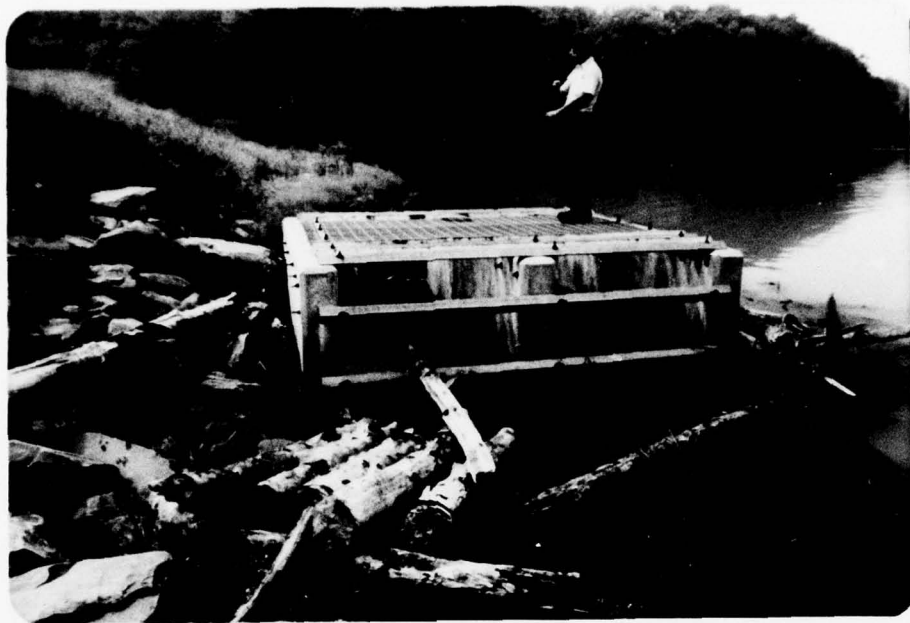
Left Side of Principal Spillway Riser
Photo #4

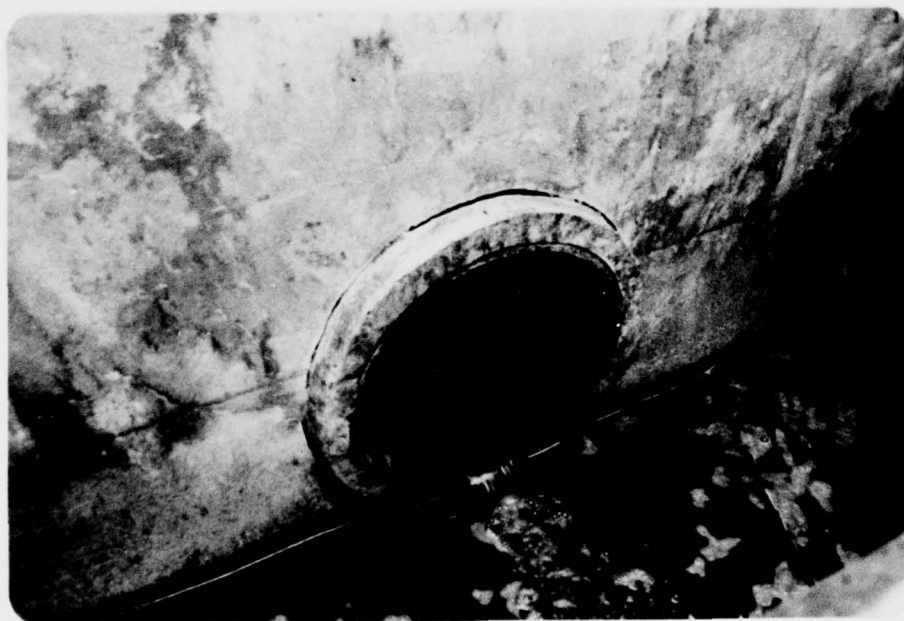
The principal spillway consists of a vertical drop inlet structure, a reinforced concrete pipe through the embankment; an impact basin at the toe of the embankment, and an outlet channel. (See photos #3, 4, 6, 7, & 11). These components appear to be in satisfactory condition with the following exceptions:

Outlet of 36" Concrete Pipe in Impact Basin
Photo #7

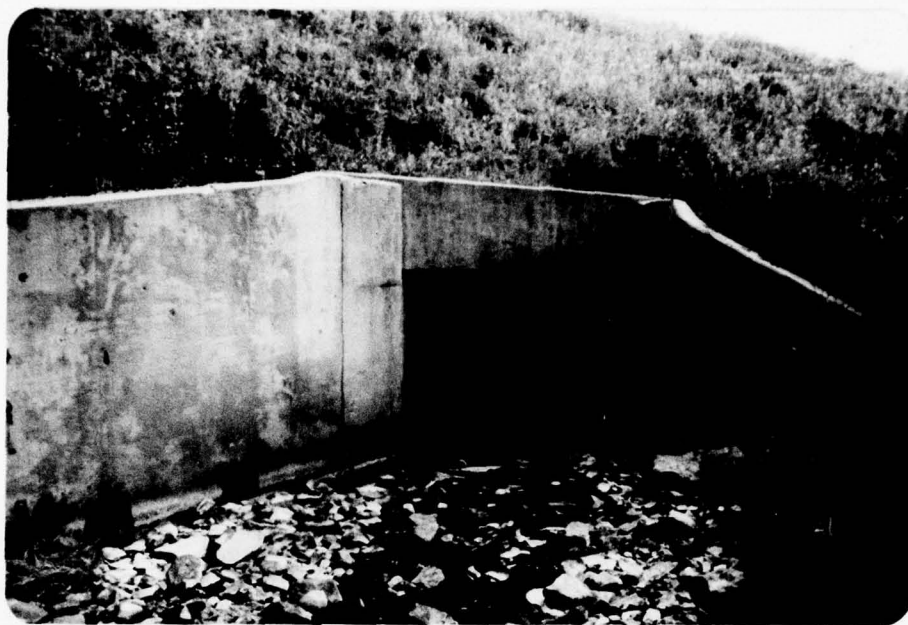
Box Culvert Beneath Highway Embankment
Photo #14

below homes with small box culvert to carry flow from dam
if dam failure occurred flow would back up behind this
