USARTL-TN-35

HLH ROTOR BOX BEAM FATIGUE TEST

M. Hanson

September 1979

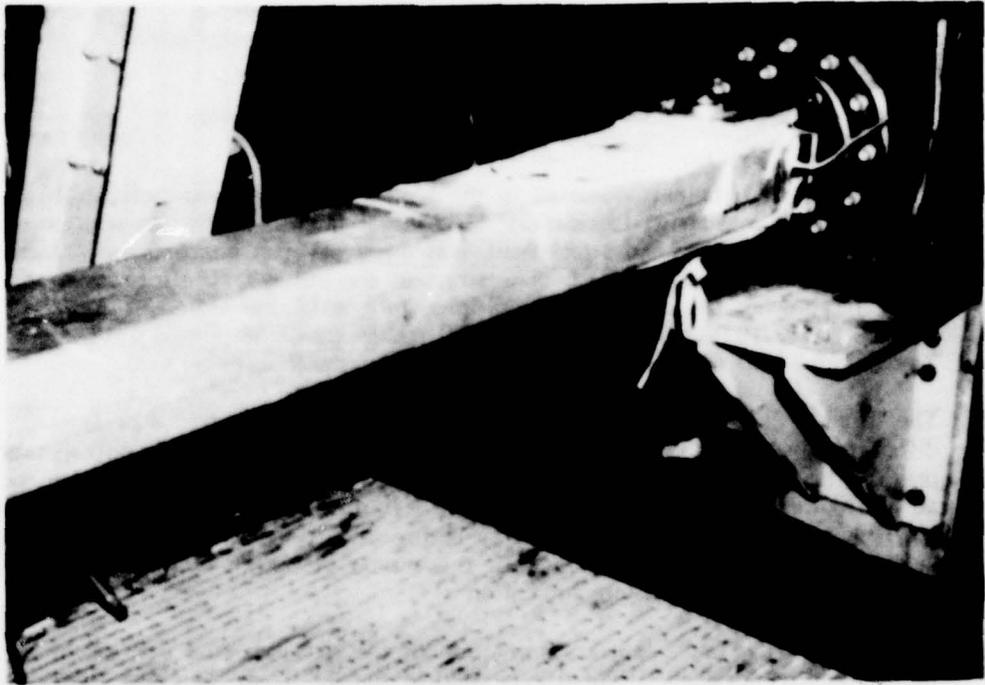
After replacement of the failed bolt, testing resumed. A strain of 3500 microinches per inch peak to peak was achieved in the test section when an axial deflection limit detector again shut down the machine. The maximum strain had shifted away from midspan (see Figure 14). After several more shutdowns and inspections, the limit detector was removed and testing resumed. The frequency was increased gradually to find the peak of the resonance curve. The amplitude of the strains increased as frequency increased. At 20 Hertz and 22,000 cycles the beam failed catastrophically in the grip area at the reaction end where smoke had been previously observed. The fiberglass beam failed in shear at the adapter pin connections of each flange (see Figure 15). The doublers on one flange debonded and, in turn, sheared the bolts that were used to secure the doublers to the beam (see Figure 16). The doubler assembly on the other flange failed in tension (see Figure 15).

Figure 16. Shear failure of doubler assembly.

4. Fatigue testing was terminated after 22,000 cycles when a shear failure occurred in the grip area. Smoke was emanating from the root end just prior to failure. Interlaminar charring was evident between the plies of the unidirectional material in the bearing failure area. The beam had been designed to react to bearing loads without the use of doublers. It was decided to install aluminum doublers to reduce the possibility of grip failure. Even with the use of doublers the combined strength of the unidirectional material and doubler was inadequate to react the loads.
