| SECURITY CLASSIFICATION OF THIS PAGE (When Data Entered) | | |
|--|--|--|
| 4. TITLE (and Subtitle) Phase I Inspection Report Lake Moraine Dam Chenago River Basin, Madison County, New York Inventory No. 354 | 5. TYPE OF REPORT & PERIOD COVERED Phase I Inspection Report National Dam Safety Program | 6. PERFORMING ORG. REPORT NUMBER |
| 7. AUTHOR(s) John B. Stetson, P.E. | 8. CONTRACT OR GRANT NUMBER(s) DACP-51-79-C-0001 | 9. PROGRAM ELEMENT, PROJECT, TASK AREA & WORK UNIT NUMBERS |
| 10. CONTROLLING OFFICE NAME AND ADDRESS New York State Department of Environmental Conservation/ 50 Wolf Road Albany, New York 12233 | 11. REPORT DATE 28 September 1979 | 12. NUMBER OF PAGES |

PHASE I INSPECTION REPORT
NATIONAL DAM SAFETY PROGRAM
NAME OF DAM - LAKE MORaine DAM ID# - NY 354

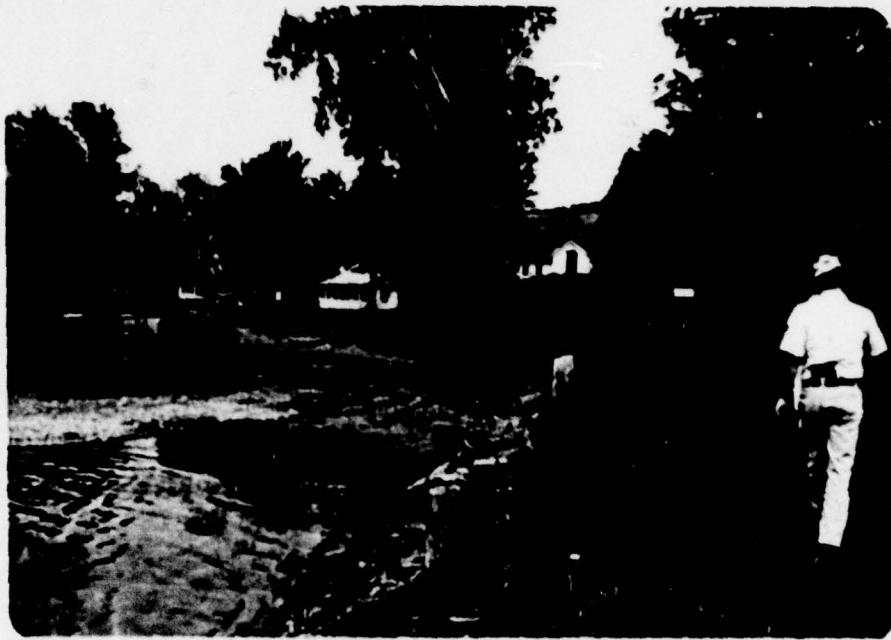
1. Summer and winter residences . . . at the east end of the reservoir. These structures are located at an elevation below the top of the dam. Some flow could divert around the dam between the structures located in the left portion of this photograph.

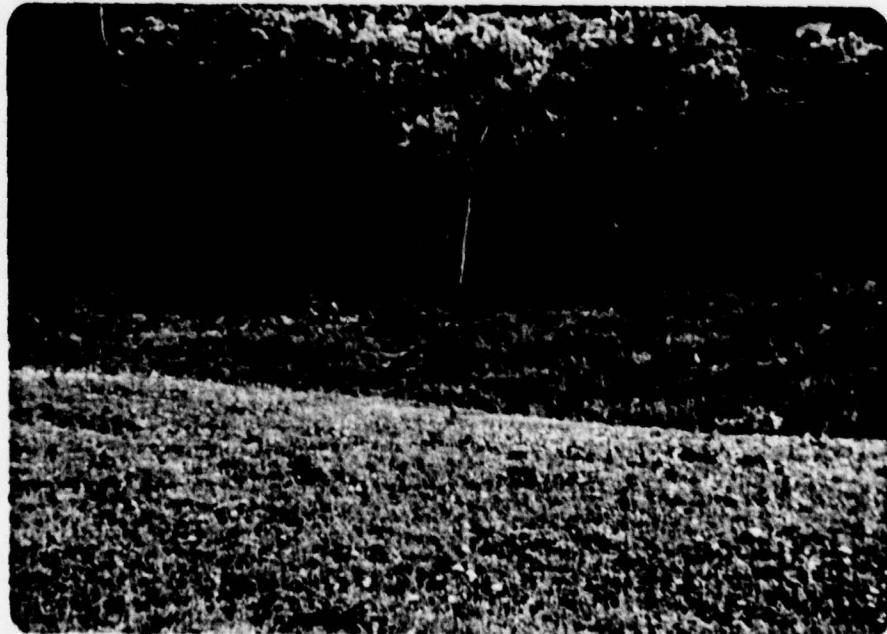
2. View of the area below toe of the east section of dam. Small discharge channel in center of picture is no longer used.

A poorly defined stone lined ditch runs parallel to the toe of the westerly portion of the dam. Some flowing water was observed in this ditch, although no specific source for this water was found. The inspection took place after a long spell of dry weather, so that it is unlikely that surface run-off would have caused this amount of flow. An abandoned outlet structure is located near the center of the easterly portion of the dam. There is no information regarding this structure. Water in the abandoned discharge channel near the outlet from this structure shows evidence of iron oxide precipitation.

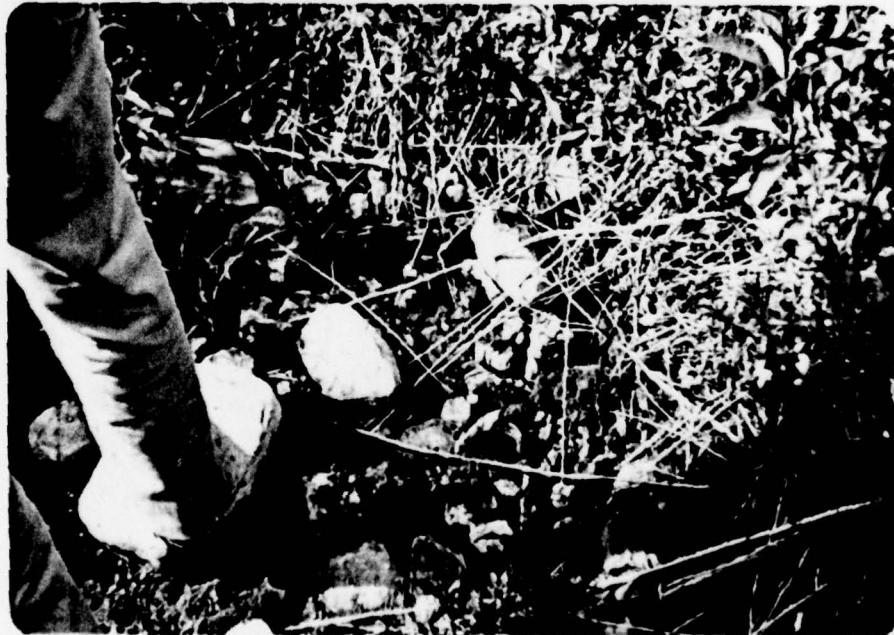
4. Close-up of wet area with slight amounts of seepage coming through toe of the east section abutment. This area is located near the center of the east embankment section.

Water flow believed to be through-the-dam seepage occurs at the downstream toe of the easterly dam section. Some damp and spongy areas also were noted at higher elevations on the downstream slope of this easterly segment. Two capped observation well pipes, recently installed by the State Department of Transportation, are in place and extend through the top of the embankment, presumably to obtain information on water levels in the embankment to relate to the noted seepage conditions.

| VISUAL EXAMINATION OF | OBSERVATIONS | REMARKS OR RECOMMENDATIONS |
|---|--|---|
| JUNCTION OF EMBANKMENT AND ABUTMENT, SPILLWAY AND DAM | Softness at toe along drainageway on eastern section. Seepage found at one location midway along toe. The western abutment of eastern section has softness 1/3 way down from top of dam. | |

2. Monitor the quantity and further investigate the source of under/through-the-dam seepage in the easterly embankment section.
3. Investigate the condition of the abandoned outlet structure in the easterly embankment and undertake remedial measures necessary to mitigate the effect of dangerous conditions which may exist.

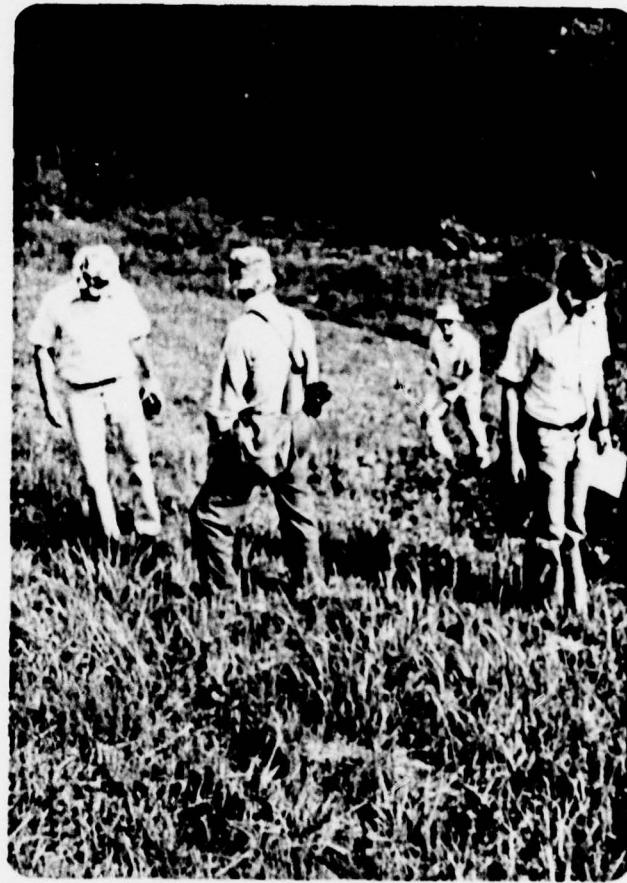
5. Inspection of another wet area on east section of dam at its west abutment at a distance one-third the way down from the top of the dam. The soft/wet area is between 200-500 square feet in area.

Two areas of suspected seepage were discovered near the west abutment of the easterly section of the dam. These areas were on the face of the dam at approximately 1/2 of the height of the dam. No flowing water was noted in these areas, however, definite evidence of moisture and spongy ground conditions were discovered.

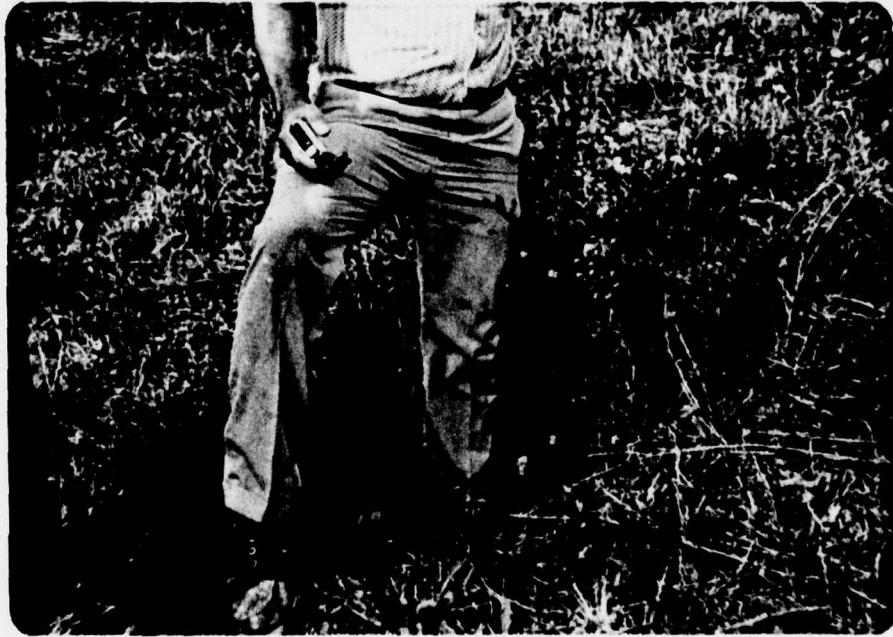
7. Hole location west dam section, less the 1/2 cubic yard in size. A number of animal holes have been located in the area. The origin of this hole is unknown.

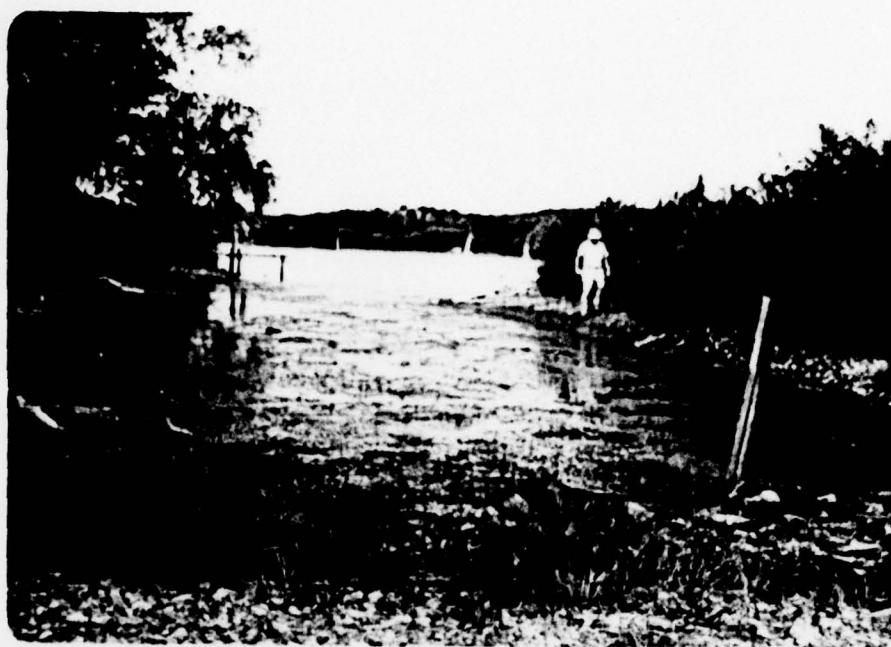
8. Note spillway entrance channel at west end of dam. The channel is not lined.

| VISUAL EXAMINATION OF | OBSERVATIONS | REMARKS OR RECOMMENDATIONS |
|---|--|---|
| APPROACH CHANNEL | Not lined. Silted somewhat. Side slopes in poor condition due to sloughing and it appears as though some areas were never built up to height of dam crest which would detrimentally affect the spillway's operation. | Should be riprapped. |

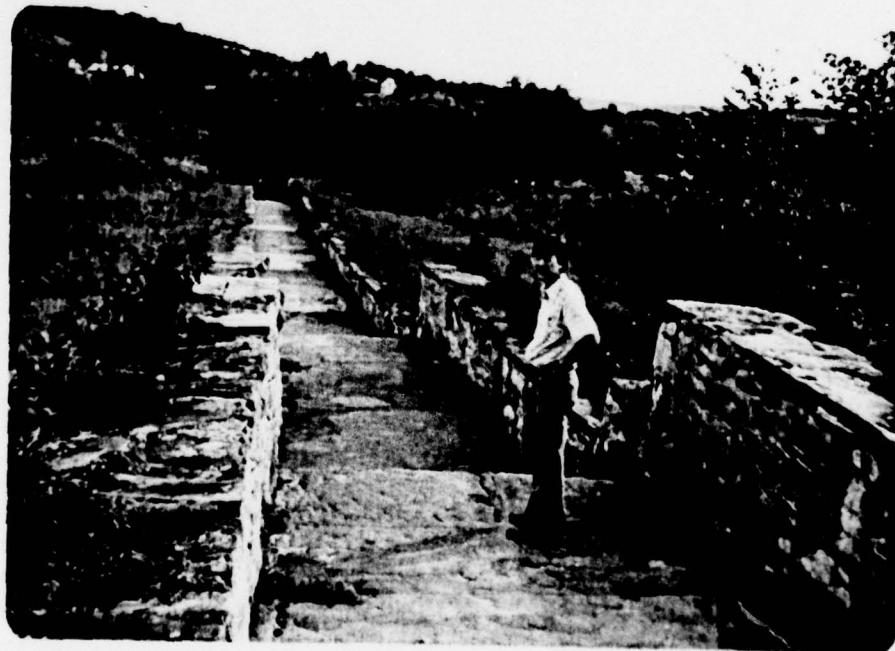
9. Spillway necks down from 35 feet to this 10 foot section.

The emergency spillway, located at the west abutment of the westerly embankment, is in generally good condition. The structure is constructed of masonry and shows no signs of severe deterioration. A short approach channel extends from the spillway crest to the impoundment. At the time of this inspection, water was standing in the approached channel. Observation wells have recently been installed in the center of both the easterly and westerly embankments. These piezometers are shown on the survey map (See Figure No. 2.).
