⑥ National Dam Inspection Program. *Number*
Musser Forests Dam (NDIVPA-287,
DER IDV 32-65), Ohio River Basin, McKee
Run, Indiana County, Pennsylvania.

PHASE I ~~REPORT~~ Inspection Report,
NATIONAL DAM INSPECTION PROGRAM

NAME OF DAM: Musser Forests Dam
STATE LOCATED: Pennsylvania
COUNTY LOCATED: Indiana
STREAM: McKee Run
SIZE CLASSIFICATION: Small
HAZARD CLASSIFICATION: High
DATE OF INSPECTION: May 23 and 25, 1979

MUSSER FORESTS DAM
NDI I.D. NO. PA-287
MAY 23, 1979

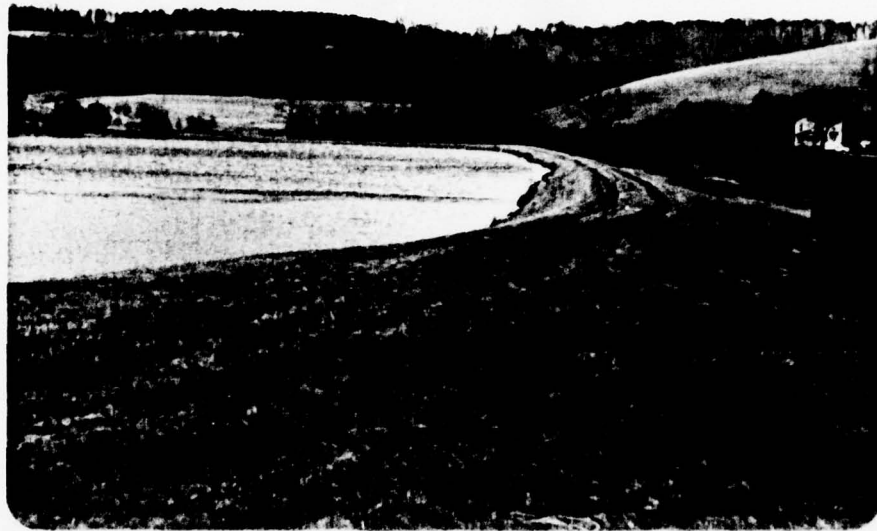
Photograph No. 1
Crest (looking east).

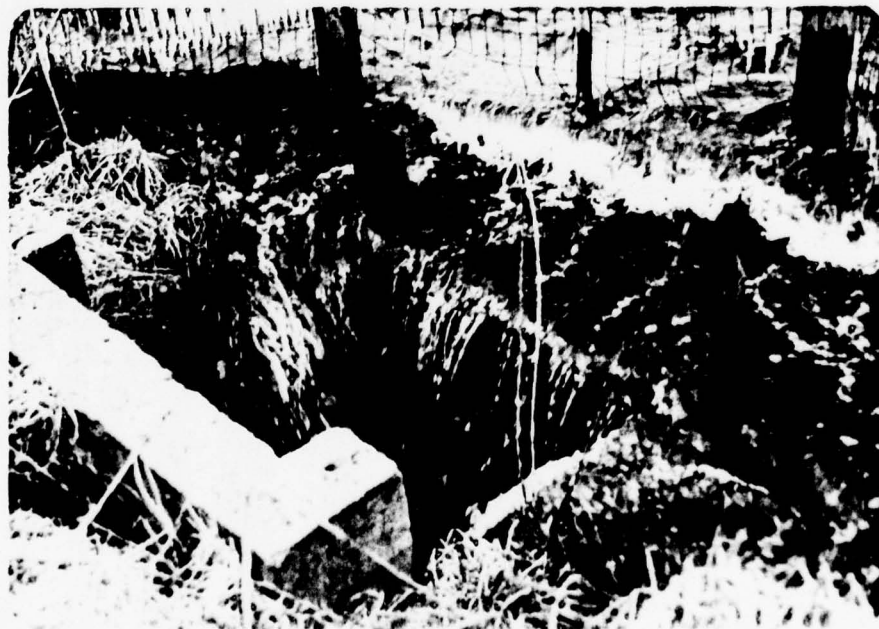
Photograph No. 2
Primary spillway intake structure.

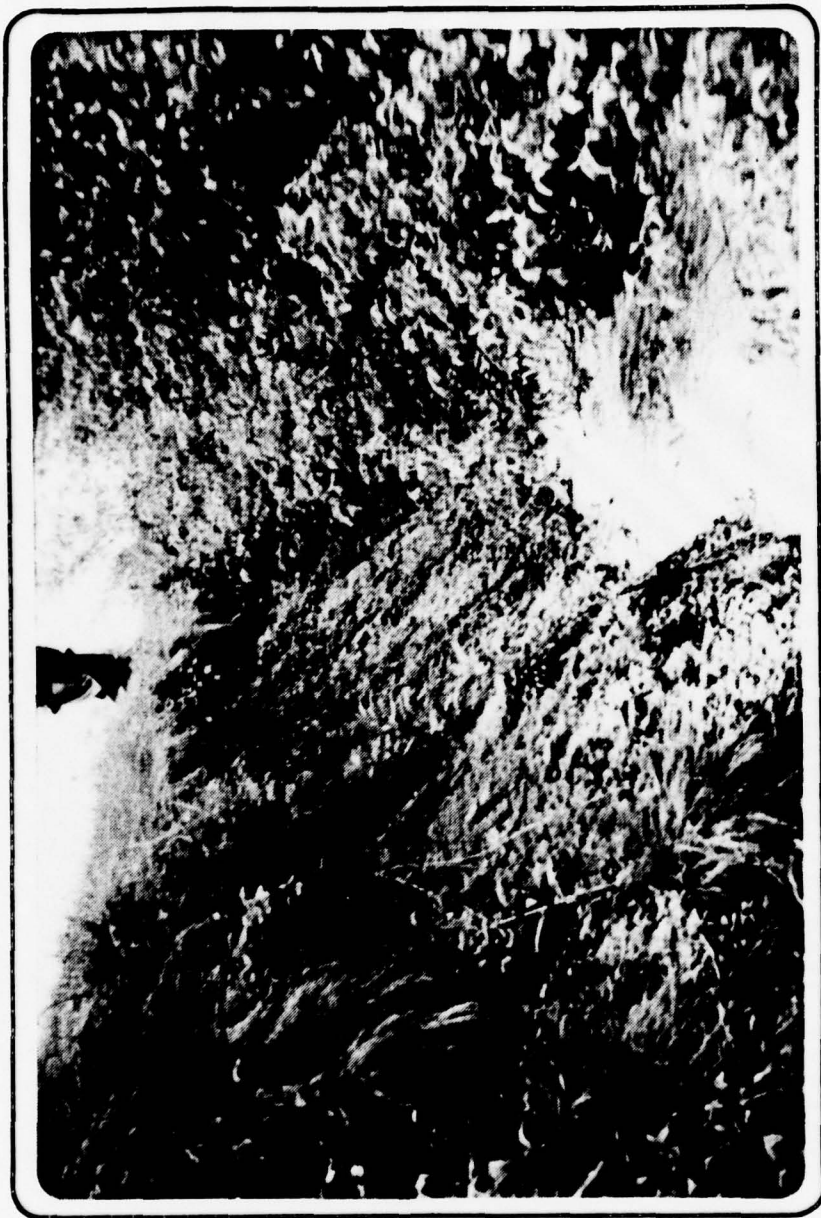
Photograph No. 6

Discharge through the primary spillway discharge channel which follows the toe of the embankment near the left abutment was found to be eroding the embankment toe. At some sections, the toe of the embankment appears to be cut 4 to 5 feet deep by this erosion. This condition is considered to constitute a threat to the integrity of the embankment if allowed to continue. The condition of the remaining portion of the embankment is considered to be fair. The crest of the dam was found to be irregular. However, the irregularities do not appear to be from recent movements. The upstream slope of the dam has no erosion protection and has eroded due to wave action. A wet area was observed at the toe level of the dam at the center of the main embankment. No measurable seepage appears to be associated with this wet area.

(2) Appurtenant Structures. Severe erosion in the spillway discharge channel along the toe of the dam near the left abutment is considered to pose a stability problem to the embankment if this condition is not corrected.

Primary spillway discharge channel. Note erosion along the toe of the dam.

1. The owner should immediately retain a professional engineer to evaluate the erosion in the primary and emergency spillway discharge channel and to prepare and execute plans for providing adequate erosion protection. This study should also consider means of providing emergency drawdown facilities or restoring and improving the existing facilities with upstream closure or control.
