AD-A078 912 GAI CONSULTANTS INC MONROEVILLE PA
NATIONAL DAM INSPECTION PROGRAM UPPER BRIDGEPORT DAM NDI I.D. N--ETC(U)
JUN 79 DACW31-79-C-0013

PHASE I REPORT
NATIONAL DAM INSPECTION PROGRAM

Upper Bridgeport Dam: NDI I.D. No. PA-00465

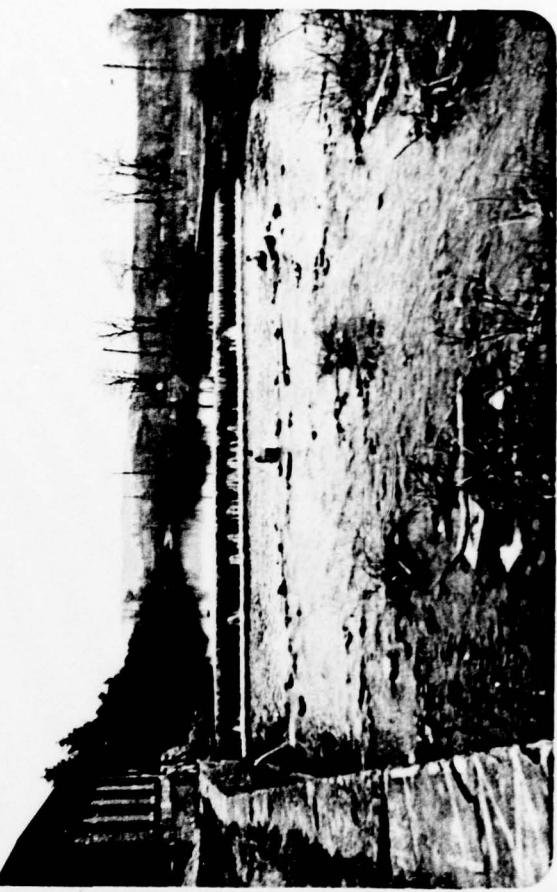
PHOTOGRAPH 12 View of Lower Bridgeport Dam situated approximately 2,400 feet downstream from Upper Bridgeport Dam.

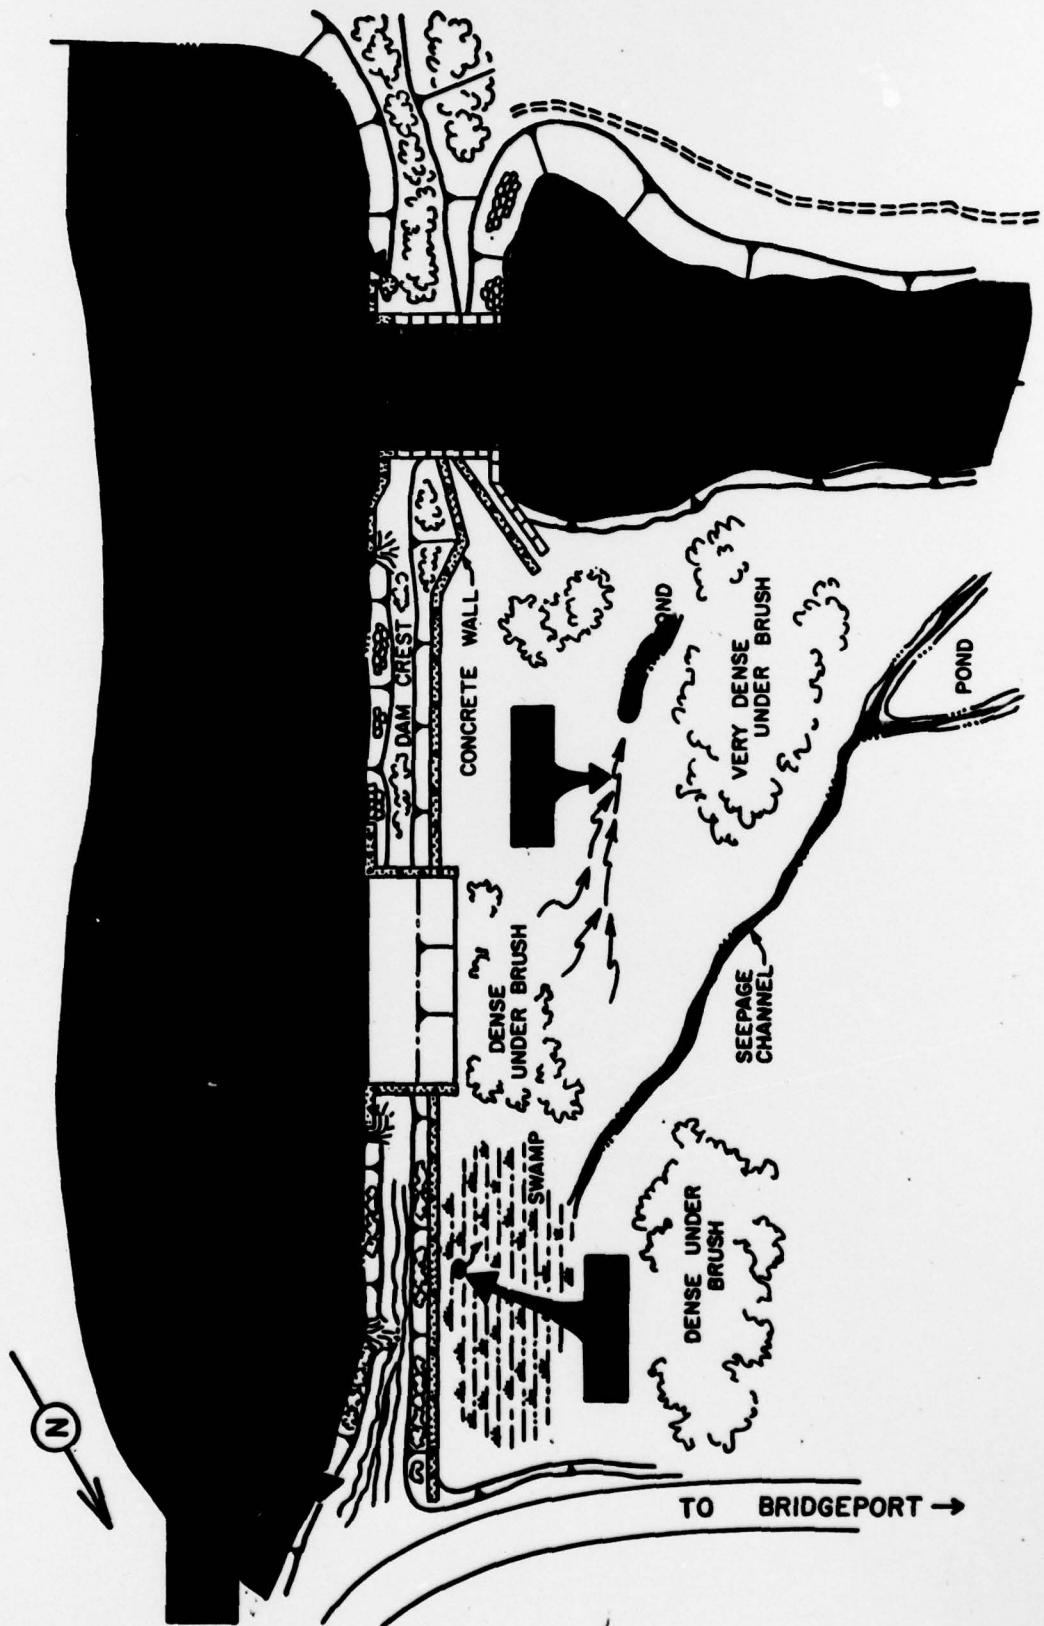
FIGURE 1 - UPPER BRIDGEPORT DAM
GENERAL PLAN
FIELD INSPECTION NOTES

1. Embankment. The embankment, as shown on Figure 1, was constructed of earth atop a clay foundation. No records of compaction procedures or construction techniques are available. A concrete corewall was installed in 1894 which reportedly extends from the right abutment to the left wingwall of the service spillway, a length of about 800 feet. No outer corewall details are available. Cross-sectional dimensions, specifically, heights, crest widths, and slope angles vary significantly along the embankment.
