PENNSYLVANIA
VALLEY-HI EAGLE LAKE DAM

NDS I.D. No. PA - 00186
PENNADER I.D. No. 29 - 33

PHASE I INSPECTION REPORT
NATIONAL DAM INSPECTION PROGRAM

PREPARED BY
GAI CONSULTANTS, INC.
570 BEATTY ROAD
MONROEVILLE, PENNSYLVANIA 15146
SEPTEMBER 1979

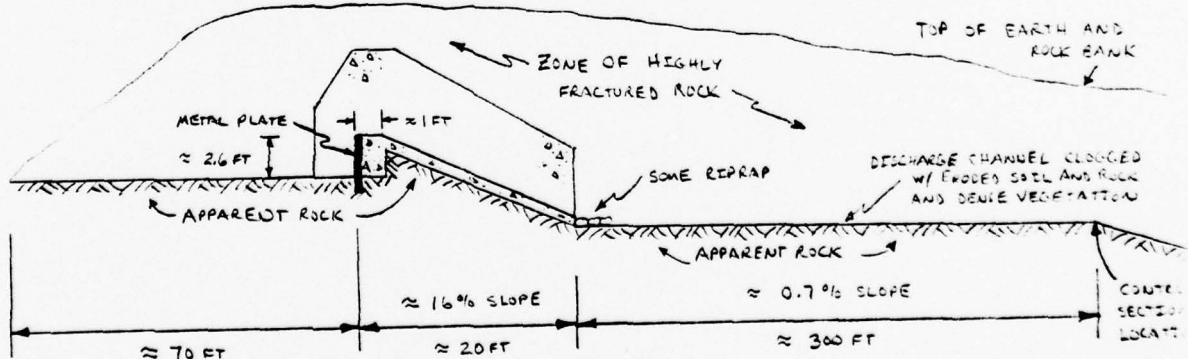
- PROFILE OF SPILLWAY : (NOT TO SCALE)
(PRIMARILY BASED ON FIELD MEASUREMENTS AND OBSERVATIONS)

- SPILLWAY IS A FREE OVERFALL, CONCRETE, TRAPEZOIDAL-SHAPED WEIR STRUCTURE WHICH DISCHARGES INTO A RELATIVELY FLAT OPEN CHANNEL. THE DISCHARGE CHANNEL IS PRESENTLY CLOGGED WITH FALLEN ROCK AND SOIL FROM THE UNPROTECTED SIDEWALLS, AND BY DENSE VEGETATION GROWING WITHIN THE CHANNEL. THUS, THE CHANNEL HAS LESS OF A CONVEYANCE CAPACITY, WHICH WHEN COUPLED WITH THE RELATIVELY FLAT CHANNEL SLOPE CAN LEAD TO ADVERSE TAILWATER CONDITIONS ON THE WEIR OUTFLOWS. WEIR DISCHARGES CAN BE DEFINED BY THE RELATIONSHIP:
