MEADOW GROUNDS DAM,

(NDS I.D. PA - 00185,
PENNDER I.D. 29 - 32)

PHASE I INSPECTION REPORT
NATIONAL DAM INSPECTION PROGRAM

PHASE I INSPECTION REPORT
NATIONAL DAM INSPECTION PROGRAM
MEADOW GROUNDS DAM
NDI# PA-185, PENNDER# 29-32

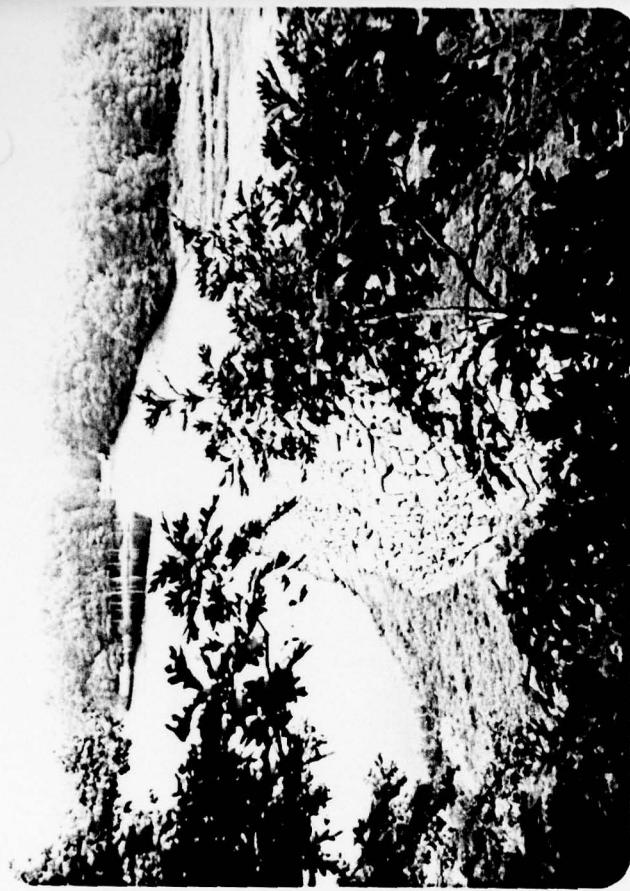
PHOTOGRAPH 3 View of left abutment-embankment contact and downstream slope.

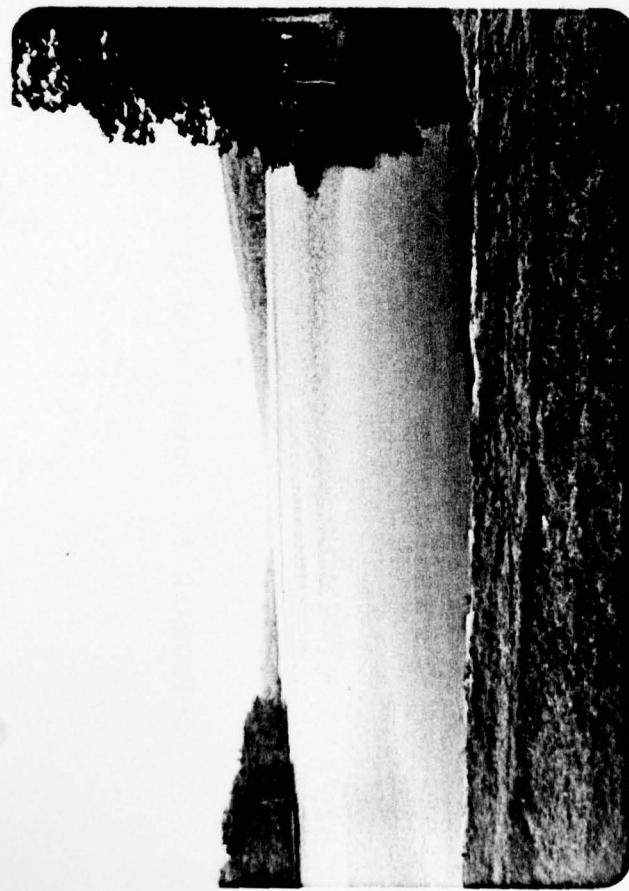
PHOTOGRAPH 5 View showing upstream slope (left of center) and spillway (extreme right).

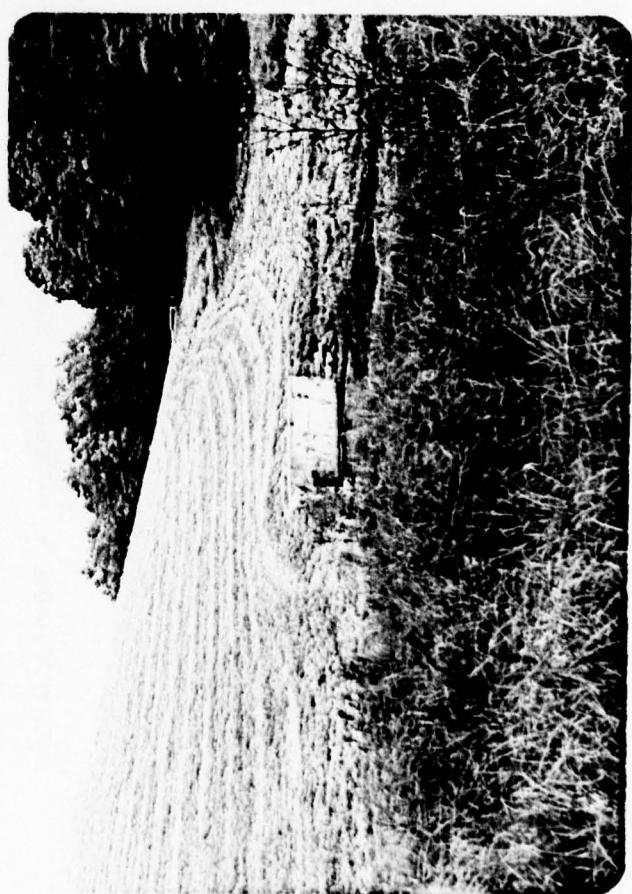
1. Spillway. Visual inspection revealed the spillway to be in good condition (see Photographs 6 and 7). No obstructions or concrete deterioration were observed. The channel immediately downstream of the stilling basin is adequately protected by hand-placed and/or dumped rock riprap (see Photograph 8).

PHOTOGRAPH 6 View of spillway from right sidewall.

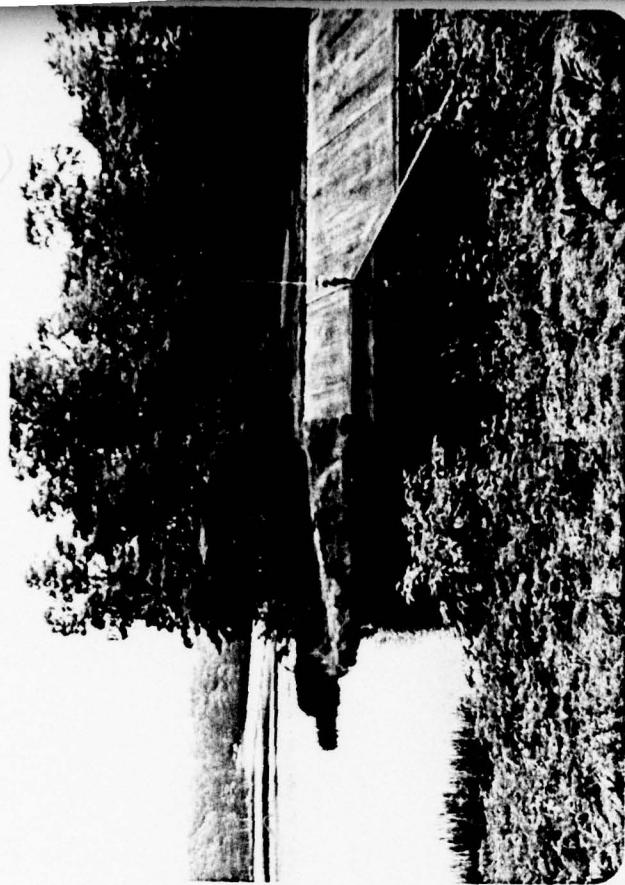
PHOTOGRAPH 7 View of spillway from downstream, left channel wall.

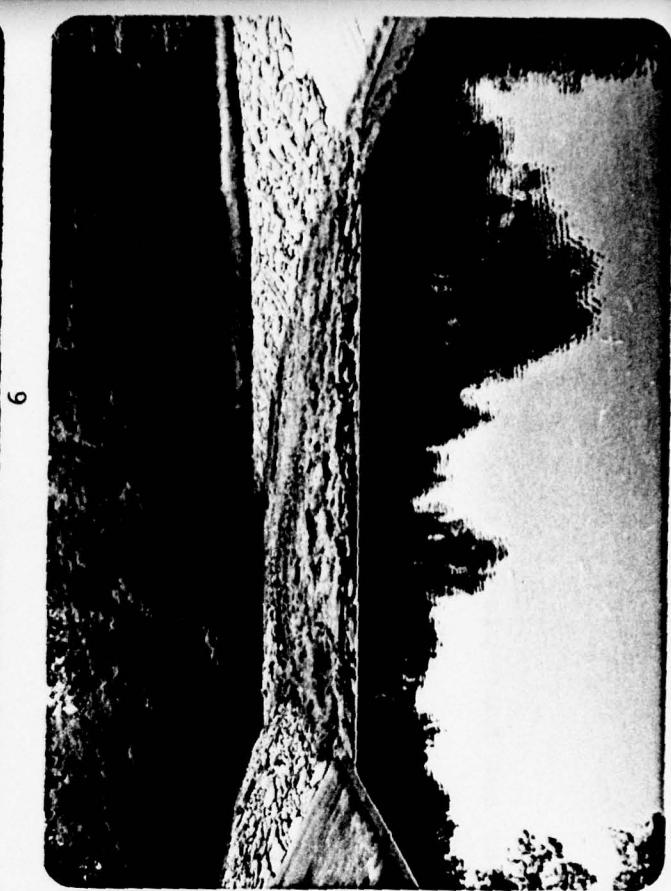
PHOTOGRAPH 8 Downstream view of spillway channel from weir crest.

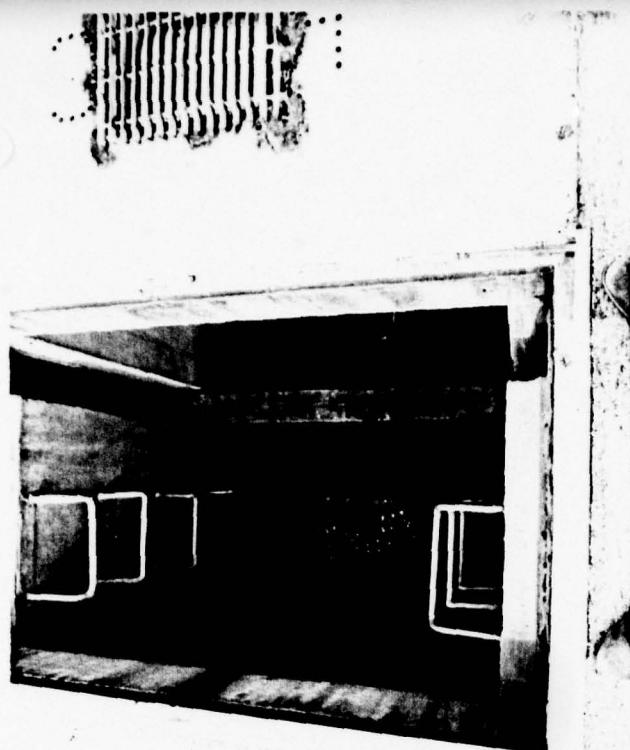
PHOTOGRAPH 10 View of interior of control riser.

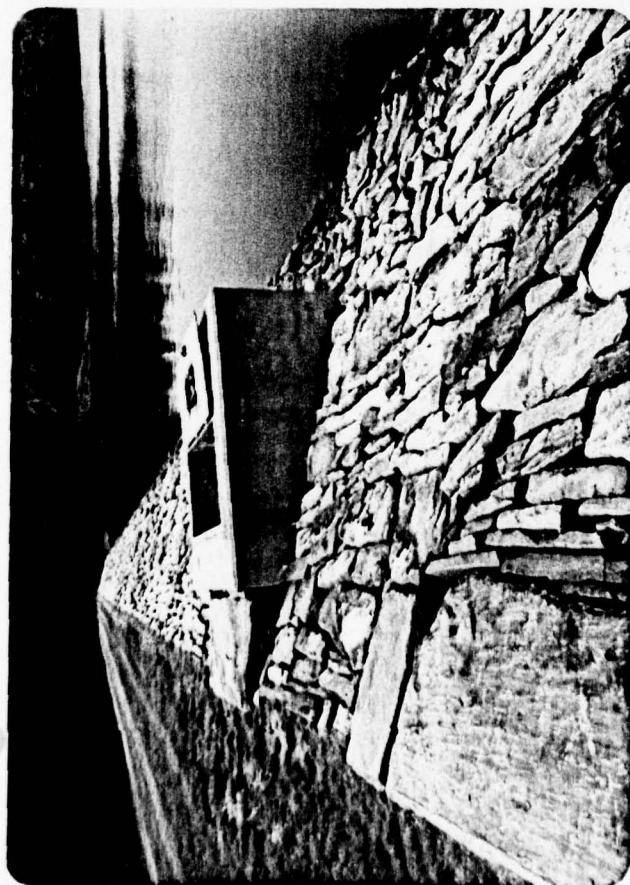
PHOTOGRAPH 9 View showing top of control riser and hand-placed riprap.

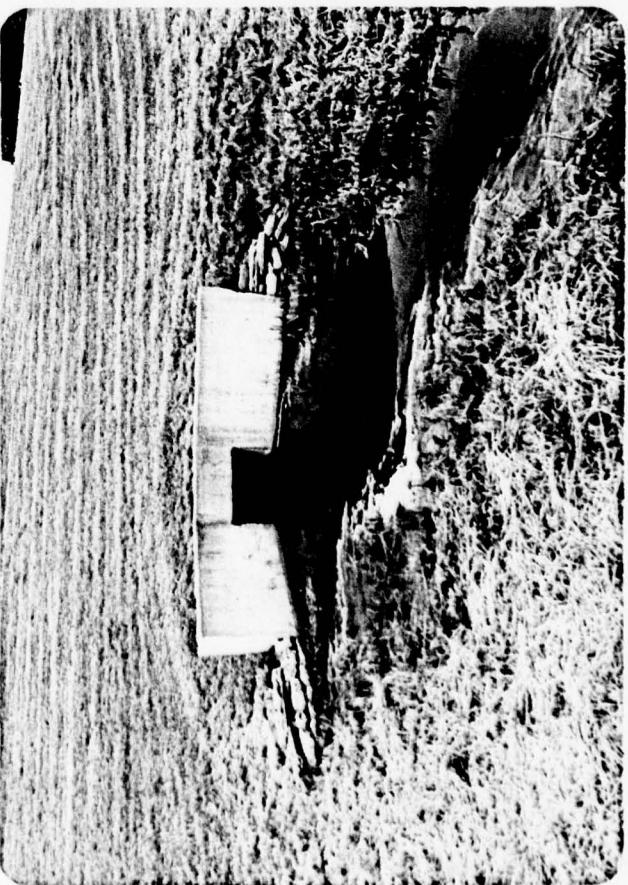
2. Outlet Works. Visible portions of the outlet works were found to be in good condition (see Photographs 9, 10, and 11). No concrete deterioration was noted on the control riser or outlet endwall. The interior of the outlet conduit was not inspected because of partial inundation and noxious conditions attributed to the stagnant pool at the outlet (see Photograph 11). The stoplogs were in place and functioning as designed.

PHOTOGRAPH 11 View of outlet endwall and stagnant pool.

a. Evaluate the outlet works channel and take necessary remedial measures to provide unimpeded discharge through the channel.
