MIDDLE DAM

NDI ID NO. PA-00256  
DER ID NO. 45-3

PHASE I INSPECTION REPORT  
NATIONAL DAM INSPECTION PROGRAM

JANUARY 1980

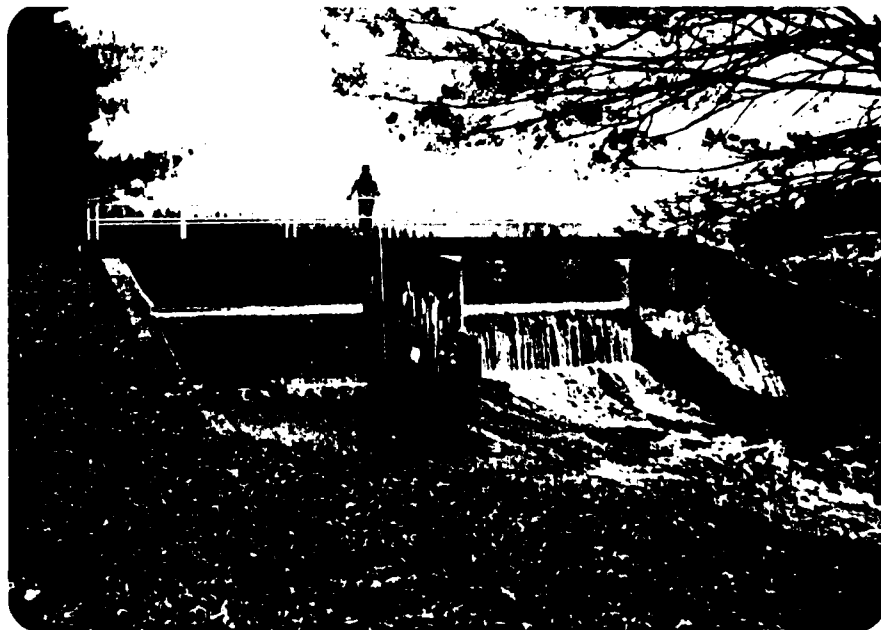
c. Appurtenant Structures. The concrete spillway weir is in good condition (Photograph F). Minor cracking and leaching are present on the spillway sidewalls and on the bridge pier. The right wall also had some spalling at the weir. The concrete apron at the toe of the weir on the left side of the spillway is damaged. Pieces of concrete about 3 inches thick are broken and displaced over about a 30-square foot area. It did not appear that the toe of the weir was undermined. Beyond the end of the concrete apron, the spillway outlet channel is in good condition (Photograph G). No erosion is present in the stone-lined channel. The underside of the spillway bridge is at Elevation 781.2, which is 0.1 foot above the design elevation of the top of the dam.

(3) Appurtenant Structures. The cracking, leaching, and spalling of the concrete spillway sidewalls are maintenance items and do not significantly affect the stability of the structures. The broken and displaced concrete in the apron was minor in terms of effect on stability at the time of the inspection. However, additional deterioration of concrete might lead to significant erosion of underlying material that would affect stability.

| VISUAL EXAMINATION OF | OBSERVATIONS | REMARKS OR RECOMMENDATIONS |
|---|---|---|
| DISCHARGE CHANNEL | Walls: minor cracking and leaching, spalling on right wall at weir.<br>Apron: concrete broken and displaced - approx. 30 S.F. | Apron concrete that is displaced approx. 2 1/2" thick. No apparent undermining at toe of weir. |

F. Spillway.

(2) Make repairs to the spillway apron. Perform additional investigations and studies to more accurately assess the stability of the spillway weir as well as the nature and extent of measures required to provide adequate factors of safety for all expected loading conditions. Take appropriate action as required.

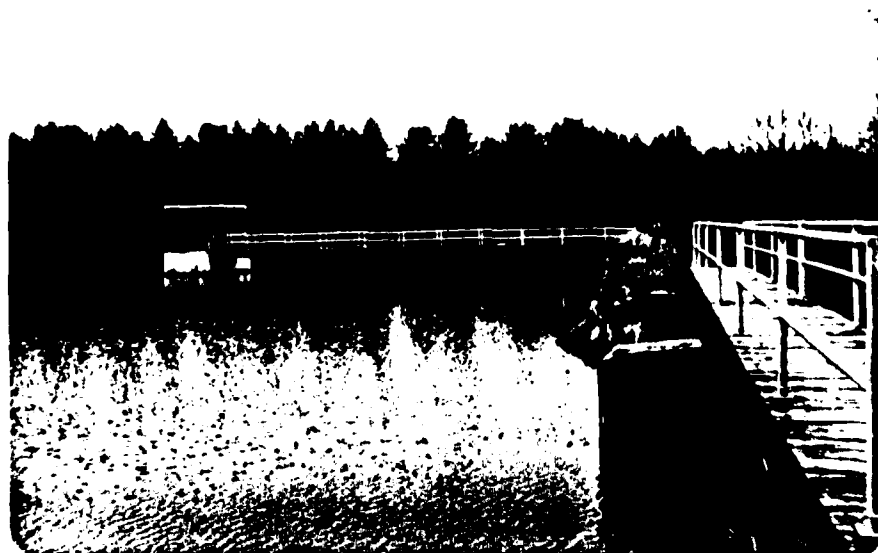
The intake structure located in the reservoir is in good condition (Photograph H). The Superintendent of Public Utilities stated that the three slide gates in the intake structure are all in good working order. Since there are no outlets at the dam, it was not requested that the gates be operated for this inspection. An examination was made of the valve chamber located along the downstream side of the corewall. Standing water about 12 inches deep and mud were present in the tunnel (Photograph I) and valve chamber. The two gate valves were nearly submerged. The source of the water could not be determined. The exposed portion of the corewall in the valve chamber is in good condition. It was damp at several locations, but there were no leaks.

| VISUAL EXAMINATION OF | OBSERVATIONS | REMARKS OR RECOMMENDATIONS |
|---|---|---|
| INTAKE STRUCTURE | Good condition - no deficiencies. | |

H. Intake Structure.
