**POHATCONG LAKE**

**DAM LEVEL II**  
**NJ 00504**

**PHASE 1 INSPECTION REPORT  
NATIONAL DAM SAFETY PROGRAM**

**MARCH 1980**

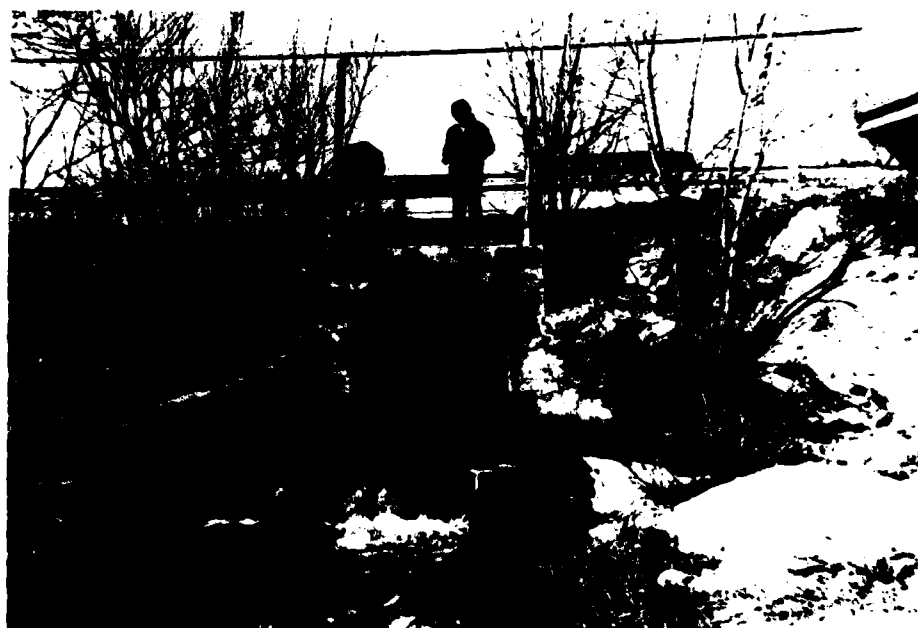
November, 1979  
View of Main Spillway Outlet

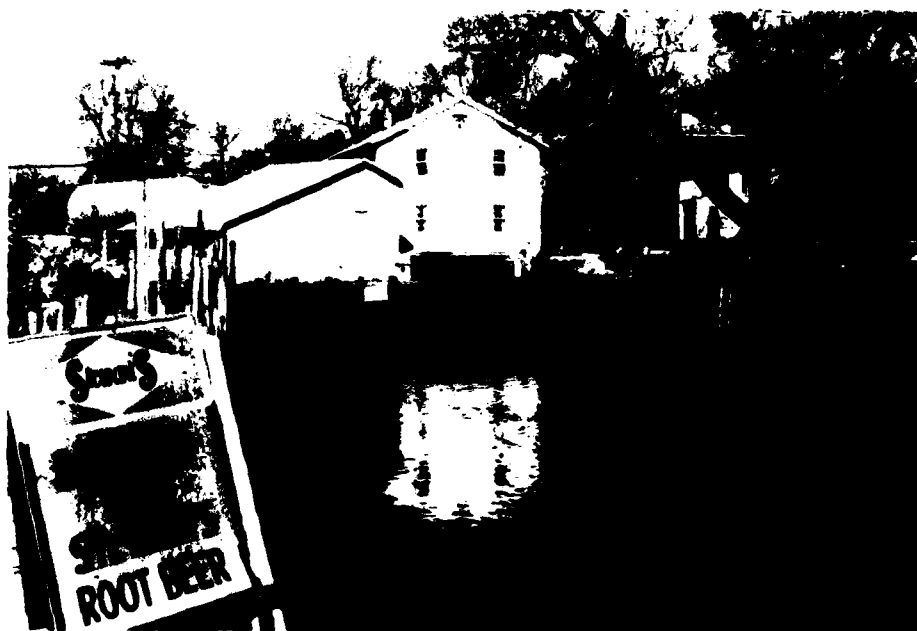
View of Auxiliary Spillway Outlet (Penstock Through Utility Building)

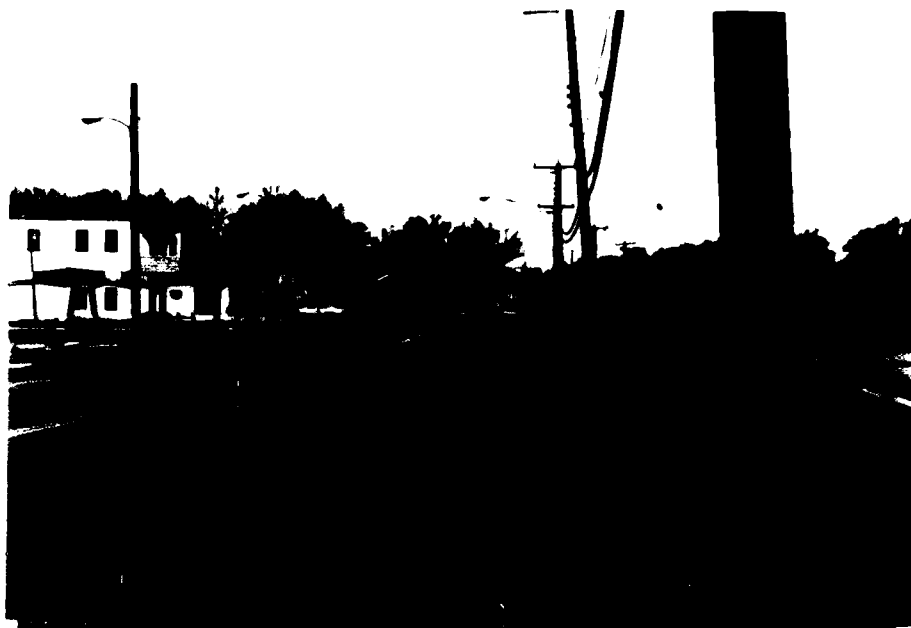
View of Cresf Looking Southwest January, 1980

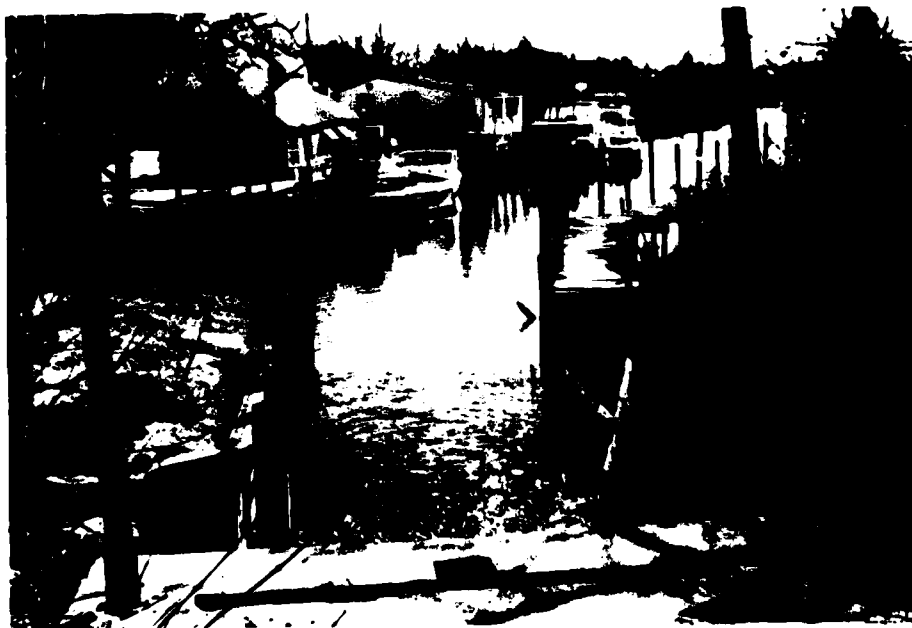
View Downstream November, 1979
