Phase I Inspection Report

Rainbow Lake Dam

Upper Hudson River Basin, Hamilton County, NY

Inventory No. NY 18

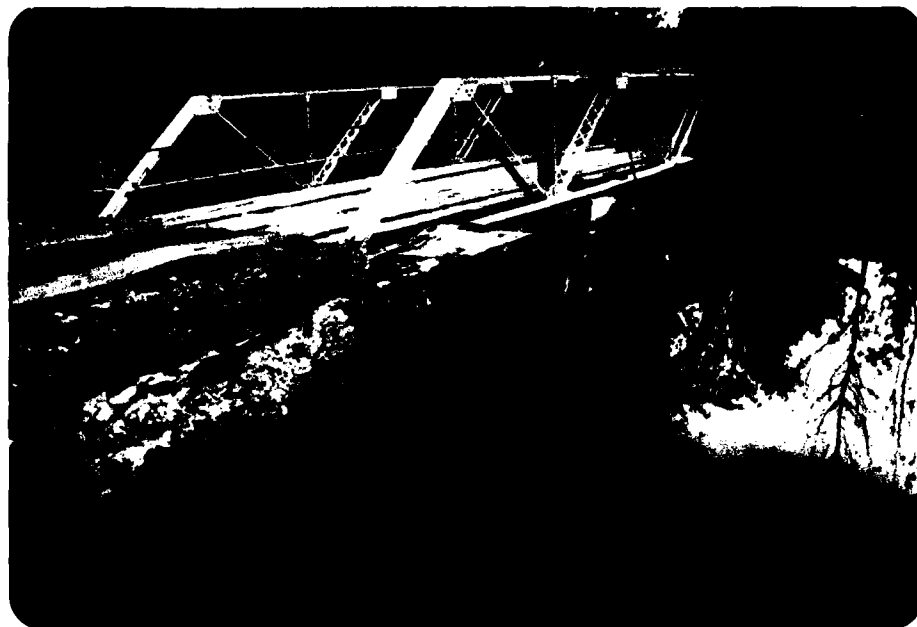
Upstream Face - Note Void to Left of Spillway
