PHASE I INSPECTION REPORT

PA 483  
WASHINGTON COUNTY, COMMONWEALTH OF PENNSYLVANIA  
NDI No. PA 01124  
PennDER No. 63-75  
SCS No. PA 483

PA 483 is a 74 foot high, zoned earthfill floodwater retarding dam designed by the U.S. Department of Agriculture, Soil Conservation Service (SCS). The dam is owned and operated by the Washington County Commissioners. The dam consists of a 360 foot long embankment, a vegetated earth side channel emergency spillway, and an intake riser and outlet conduit (principal spillway). The dam and appurtenant structures were found to be in good overall condition at the time of the inspection.

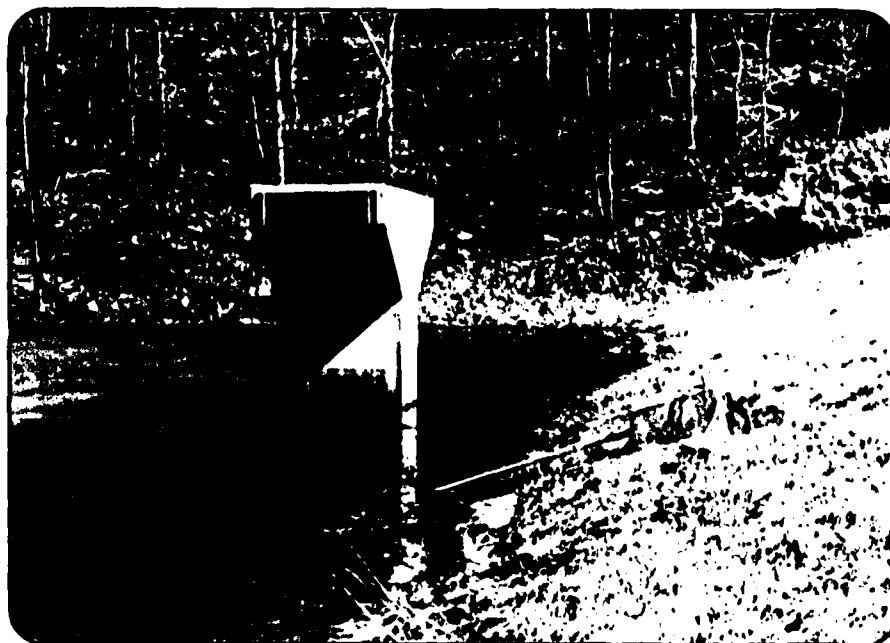
| VISUAL EXAMINATION OF | OBSERVATIONS | REMARKS OR RECOMMENDATIONS |
|---|---|---|
| EMERGENCY GATE | The emergency gate is a 24 in. square slide gate. The gate is at the upstream end of a 73 ft. long, 24 in. diameter, reinforced concrete pipe which connects to the riser. Controls for the emergency gate are located on the upstream embankment to the right of the riser. | According to the owner's representatives, the emergency gate is never operated. It should be checked and maintained in an operable condition. |

PHOTO 2. View of the Riser Unit and Reservoir Drain Control

- 1) Periodically monitor the areas of the slide on the left abutment and the slumps on the right hillside to ensure that these conditions do not become serious.
- 2) Check the emergency gate and maintain it in an operable condition.

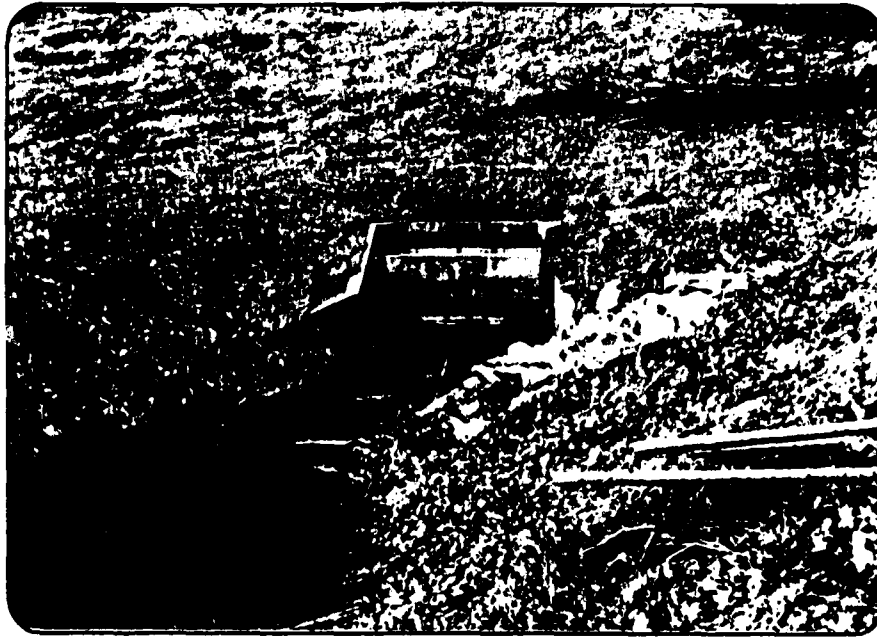
| VISUAL EXAMINATION OF | OBSERVATIONS | REMARKS OR RECOMMENDATIONS |
|---|---|---|
| OUTLET STRUCTURE | The outlet structure is a reinforced concrete impact basin with a baffle wall and end sill. The concrete appears to be in good condition with no cracking or spalling. | |

**PHOTO 5. View of the Impact Basin**
