MISCELLANEOUS PAPER SL-80-13

INVESTIGATION OF DISTRESSED
COMPOSITE WALLS, U. S. ARMY RESERVE
ARMORY, GREENWOOD, MISSISSIPPI

September 1980

Final Report

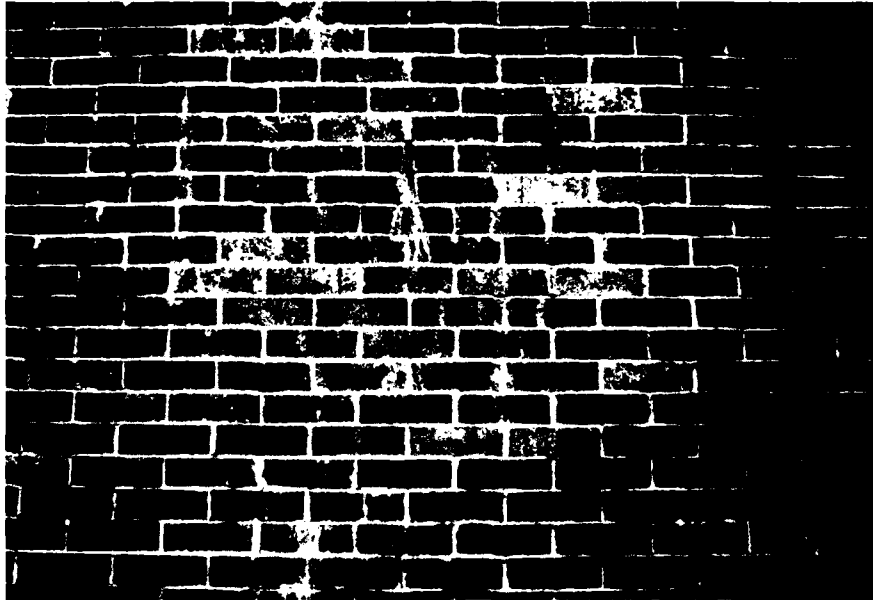
2. Examination of the exterior of the building revealed evidence of efflorescence (Figure 2), open mortar joints, and epoxy grout mortar joint repair at certain locations. The exterior examination was interrupted by an afternoon rain shower. When the investigation was resumed the following day, it was discovered that certain CMU surfaces of the roof parapet displayed evidence of a moisture content gradient as shown by surface discoloration and shading (Figure 3).

Figure 2. Typical efflorescence on exterior wall

(3) Efflorescence was apparent at several locations around building.
