LAKE LINGANORE

NDI ID NO. MD-21

PHASE I INSPECTION REPORT
NATIONAL DAM INSPECTION PROGRAM

JULY 1980

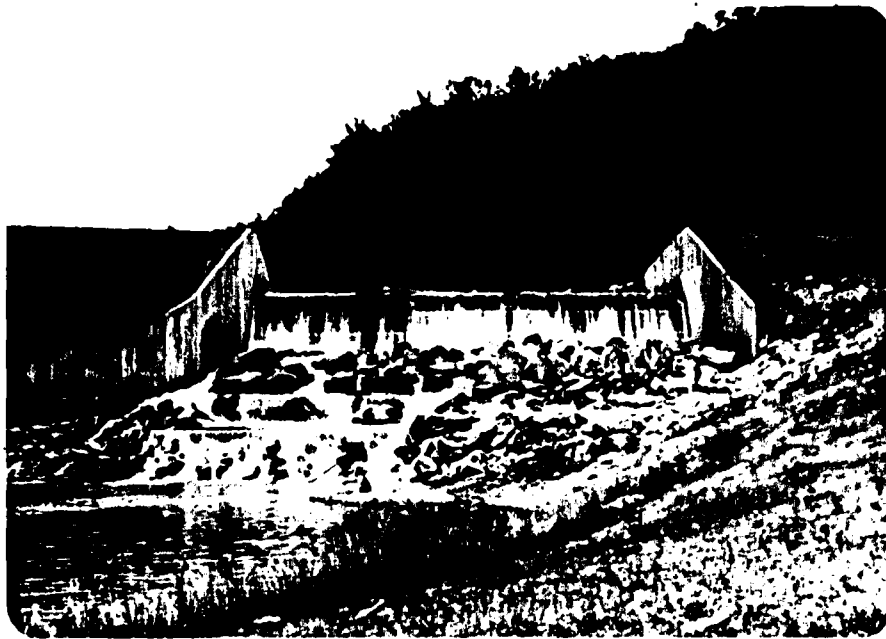
Spillway and stilling pond

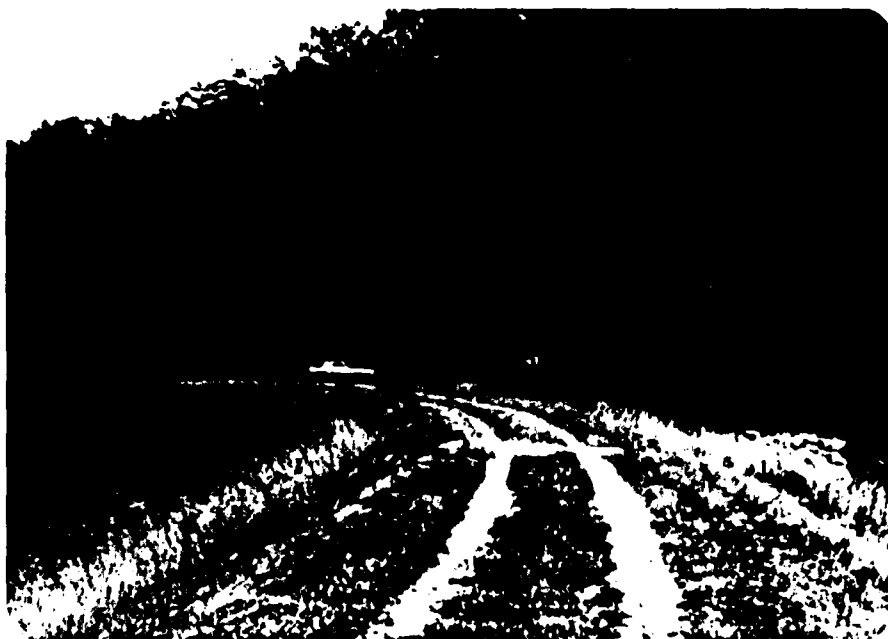
- a. Assessment. The Lake Linganore Dam is an intermediate storage, high hazard impoundment. If the dam failed, the City of Frederick Water Purification Plant and two residences located downstream along Linganore Creek within 1.8 miles of the dam could sustain damage. The hydrologic and hydraulic analyses of the dam indicate that the spillway is seriously inadequate, resulting in an unsafe, non-emergency classification for the dam. The dam would be overtopped during a flood equalling 50% of the Probable Maximum Flood (PMF), but would not be overtopped by a flood equaling 48% of the PMF. The dam embankment is rated only fair because of the presence of limited surface erosion and an erosion gully, the presence of a seepage area at the right end of the dam and a wet area downstream of the left spillway retaining wall, and the low point on the crest which is 6 inches below the dam crest design elevation.

A. Crest of Dam

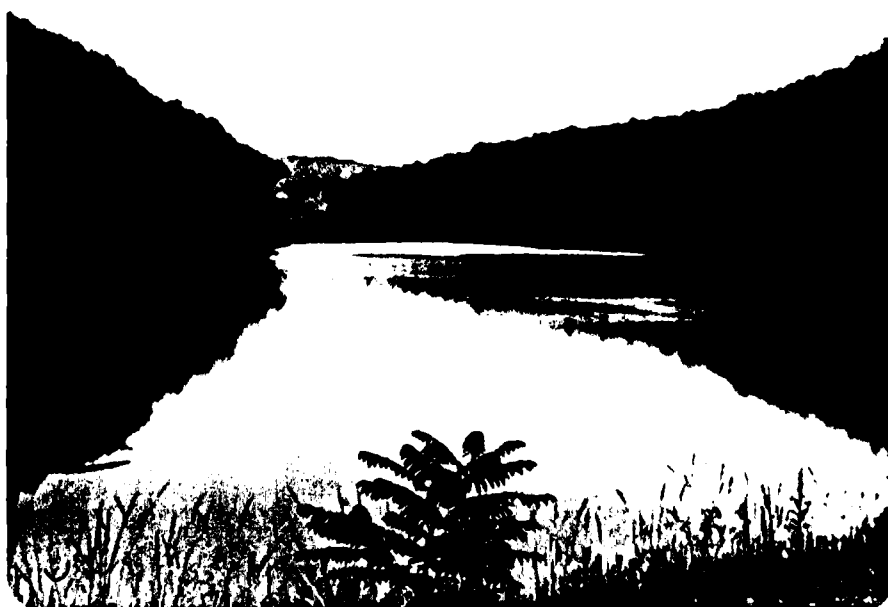
B. Lake Linganore immediately upstream of dam

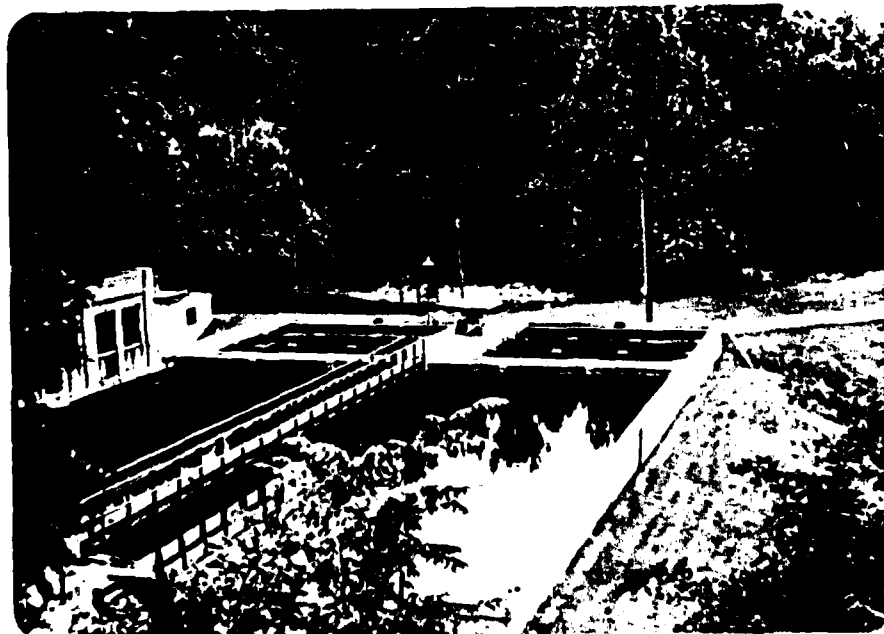
H. Frederick Filtration Plant along Linganore Creek
