NDI No. PA 01137  
PENN DER No. 63-90

RAW WATER POND.

UNITED STATES STEEL CORPORATION  
RAW MATERIALS DIVISION

PHASE I INSPECTION REPORT  
NATIONAL DAM INSPECTION PROGRAM

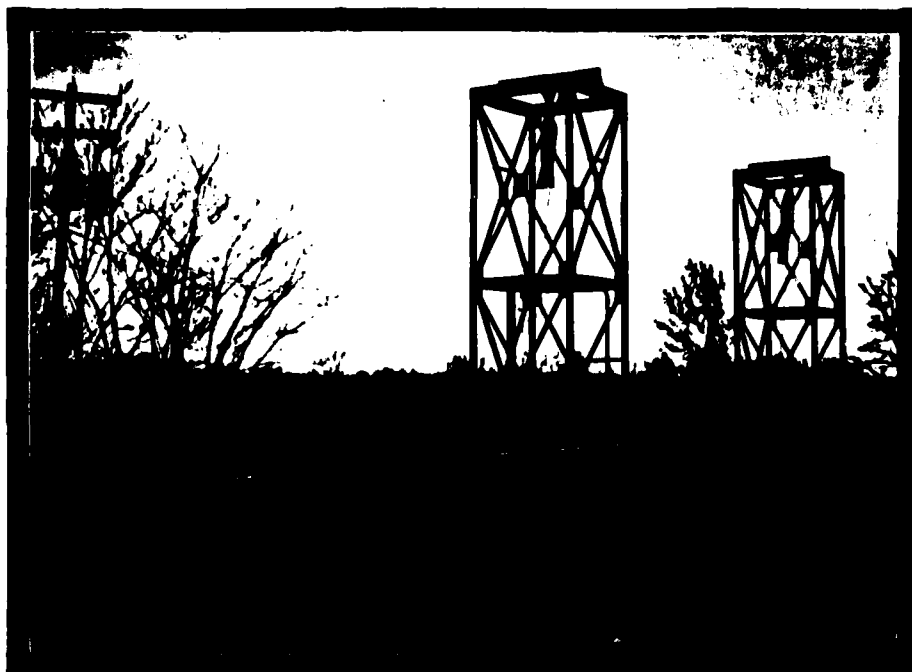
Photo 7 Mine Drainage Pumps.

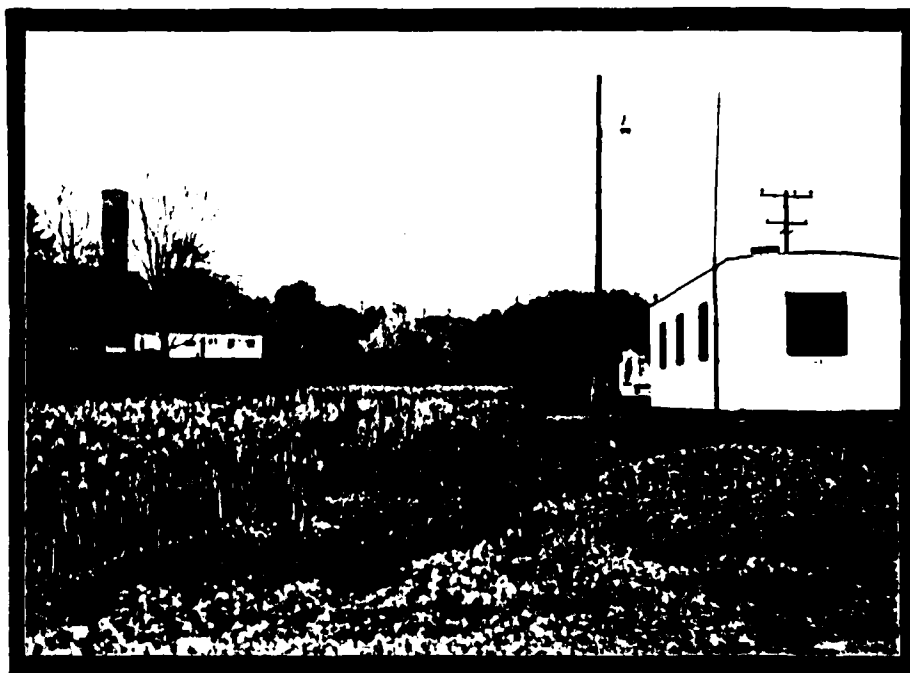
(2) Natural drainage below the Treated Water Pond is via an unnamed tributary to Sawmill Creek. In the 1.5 mile reach between the Treated Water Pond and the confluence with Sawmill Creek, 8 inhabited dwellings were observed on the floodplain at elevations low enough to be imperiled by high flows. Also, a mine portal and loadout facility and State Route 917 lie near the bottom of the valley.

Photo 12 Downstream Hazards below Treated Water Pond.
