Name Of Dam: CRAB ORCHARD CREEK

Location: BLAND COUNTY

Inventory Number: VA. 02102

## PHASE I INSPECTION REPORT NATIONAL DAM SAFETY PROGRAM

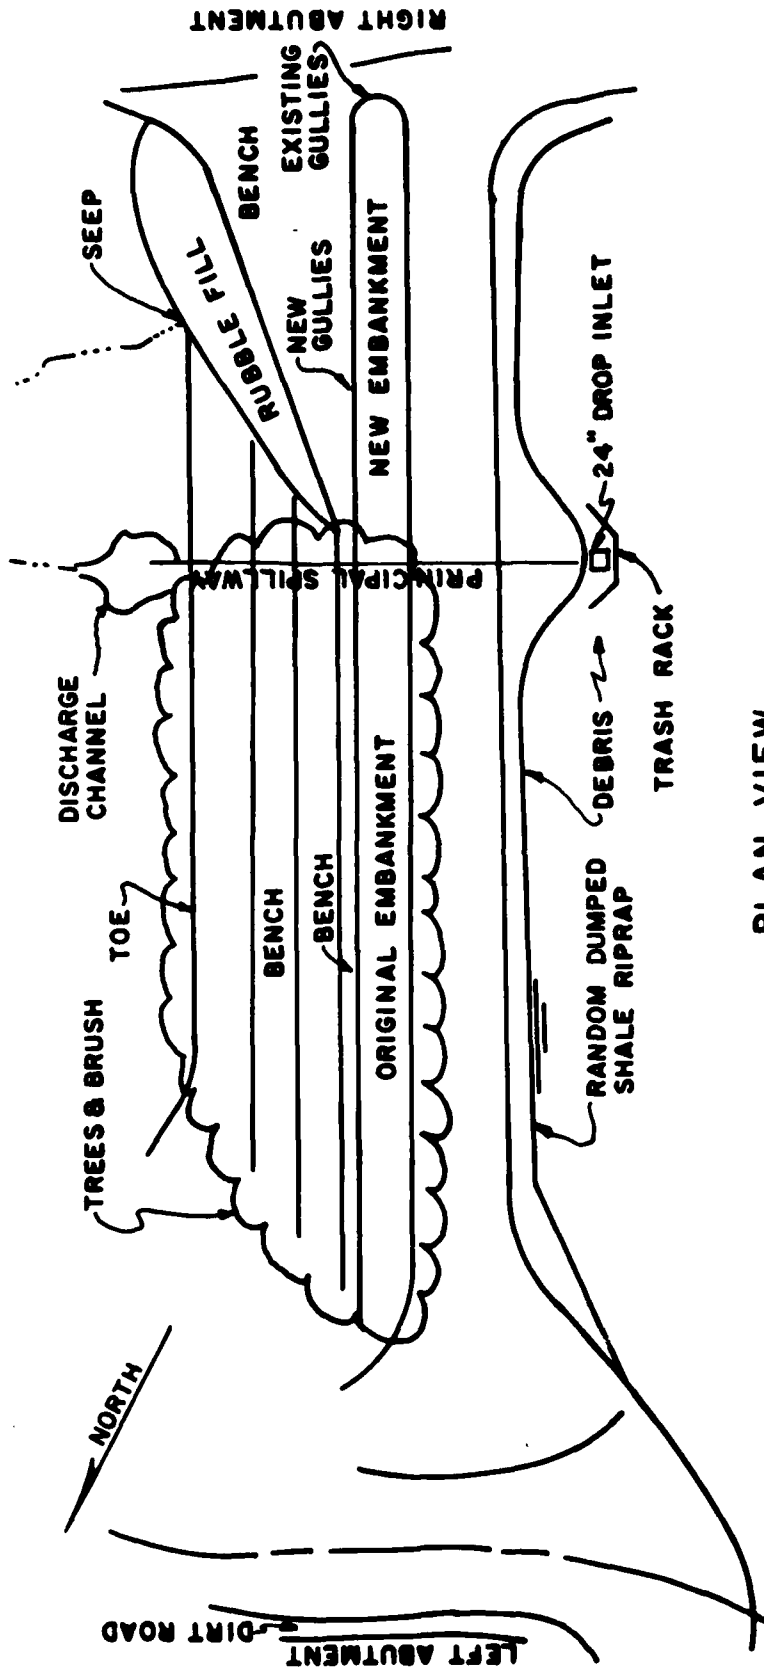
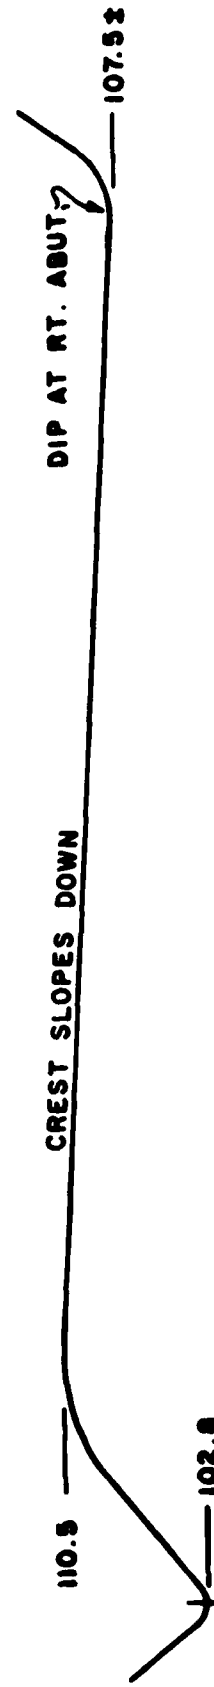
PLAN VIEW

There is one seep located at the base of the dam at the right abutment as shown on Plate II. The origin was not found because of vegetation and boulders inhibiting the inspection in the area. The owner representative said he had checked the spring monthly for the past two years and had noted no changes. Flow is clear. No estimate of the quantity was made. The source and age are unknown.

d. Maintain regular inspection of the seep on the right downstream abutment. Should flow suddenly increase and/or become turbid without explanation contact a geotechnical engineering consultant for further evaluation.
