NEW YORK STATE DEPT OF ENVIRONMENTAL CONSERVATION ALBANY F/6 13/13
NATIONAL DAM SAFETY PROGRAM. ROME CITY DAM (FISH CREEK) (INVENT--ETC(U)
JUL 80 J B STETSON

REPORT DOCUMENTATION PAGE		READ INSTRUCTIONS BEFORE COMPLETING FORM
1. REPORT NUMBER	2. GOVT. ACCESSION NO.	3. RECIPIENT'S CATALOG NUMBER
4. TITLE (and Subtitle) Phase I Inspection Report Rome City Dam (Fish Creek) Oswego River Basin, Lewis County, NY Inventory No. 558		5. TYPE OF REPORT & PERIOD COVERED Phase I Inspection Report National Dam Safety Program

PHASE I INSPECTION REPORT
NATIONAL DAM SAFETY PROGRAM
NAME OF DAM - ROME CITY DAM (FISH CREEK) ID# - NY 558

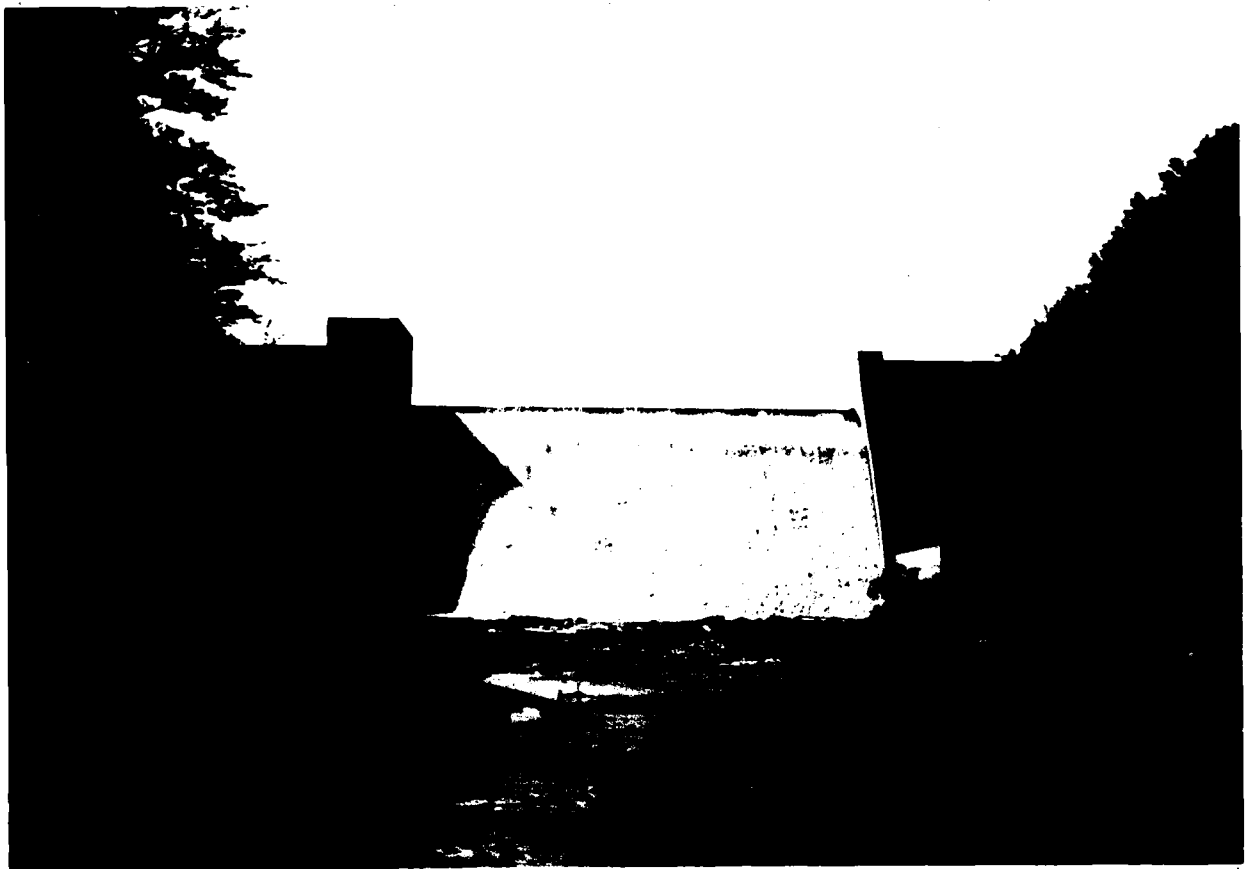
1. Overview of Rome City Dam (Fish Creek)

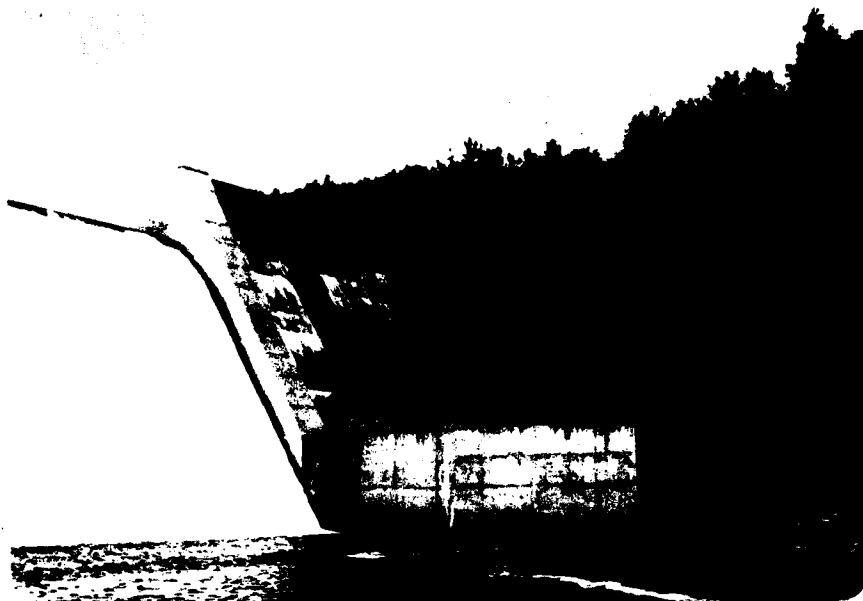
2. View of left abutment.
Note seepage on face
of non-overflow section
and seepage flow over
training wall of plunge
pool.

The visual inspection revealed that the dam is generally in good condition with only minor surface spalling of the concrete surfaces. No misalignment of structural elements of the dam were detected in the visual inspection. The seepage near the left abutment should be kept under surveillance. The flow which was observed on the downstream face of the concrete dam was not severe. However, this flow would not account for the quantity of water detected on the ground and flowing over the face of the training wall. It would appear that additional and more substantial seepage is occurring below the ground line. Further surveillance should be maintained regarding the quantity and severity of this seepage to detect any change in the quantity of the flow. Immediate remedial action should be taken should the flow increase.

Though the visual inspection and engineering analysis indicate no immediate stability problem, the through-the-dam leakage does imply the presence of structural discontinuities and/or deterioration. It is recommended that further surveillance be maintained to determine the extent of the noted leakage. In the event that conditions in this area become more severe, immediate investigations should be undertaken to determine the source and cause of this seepage and the necessary remedial actions should be promptly completed.

1. The seepage near the left abutment should be kept under surveillance to detect any worsening of this condition. Inspections of the area should be made at least four times yearly and photographs taken of the site. The quantity of the flow should be measured as an attempt to detect any worsening of the seepage. Formal reports should be made of these inspections and copies submitted to the New York State Department of Environmental Conservation Dam Safety Section for their review.
