An Investigation of Safety Hazards and Reliability Problems in Aerial Refueling Stores

by
Leo D. Budd
Fuze and Sensors Department

AUGUST 1980

NAVAL WEAPONS CENTER
CHINA LAKE, CALIFORNIA 93555

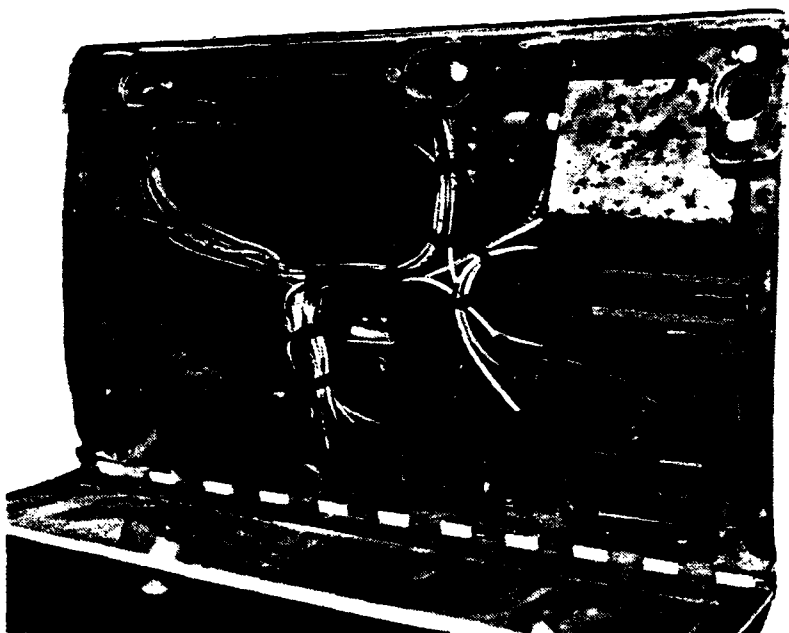
to a dimming resistor for the tailcone indicator lights (Figure 4). Most wiring was intact, and insulation on the wires was sound. The large number of spliced wires indicated several past problems.

FIGURE 4. Transformer-Rectifier Assembly; Broken Wire at Dimming Resistor.
