**CHROMATE FILM USED FOR CHEMICAL CORROSION CONTROL
ON GOLD-PLATED PCB CONNECTORS**

E.G. SHAFRIN, J.S. MURDAY

Naval Research Laboratory, Washington, DC 20375, USA

J.D. GUTTENPLAN, L.N. HASHIMOTO

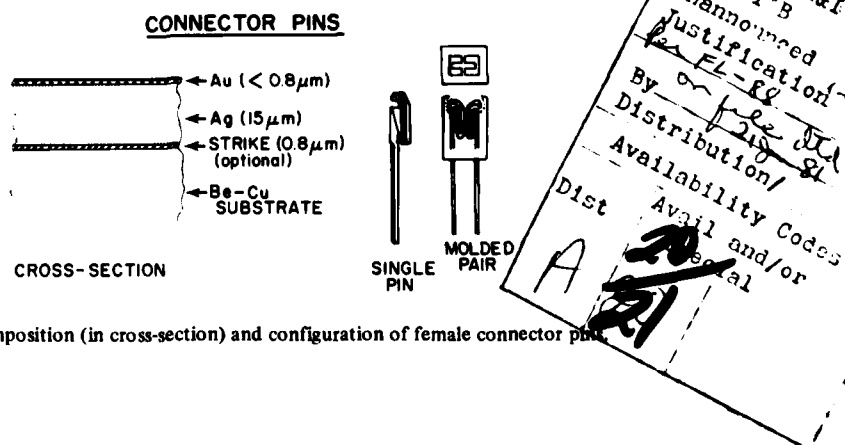
The bellow-form spring female pins (fig. 1) in the electrical connectors are fabricated principally from a resilient beryllium-copper alloy, but rely for their corrosion protection on the thin surface coatings shown in the cross-section. The purpose of the gold plate is to prevent tarnish formation by the silver and thereby maintain a contact surface of low resistance. However, it is well known that defects in the Au film can lead to formation of silver sulfide with subsequent rapid migration across the gold surface [4,5,6]. This tarnish is forming on the MARDAN contacts and its deleterious effect is augmented by the presence of accumulated organic material.

Fig. 1. Composition (in cross-section) and configuration of female connector pins.

The most obvious solution for reducing the tarnish is to replace the connector pins with new ones which have no silver between the copper and its gold coating. In fact, new female connectors for use in the MARDAN unit do not contain the silver layer. However, the cost of a retrofit is prohibitively expensive. Rather, some preventative measure amenable to application to the in-place connectors had to be developed. One such measure, based on chromate conversion technology, has been developed and proven effective in extending useful service life [1]. The present work examines some of the phenomena associated with this treatment.
