ESL-TR-80-45

## FLUSH AM-2 MAT PATCH FOR RAPID RUNWAY REPAIR

JAMES L. GREENE

SEPTEMBER 1980

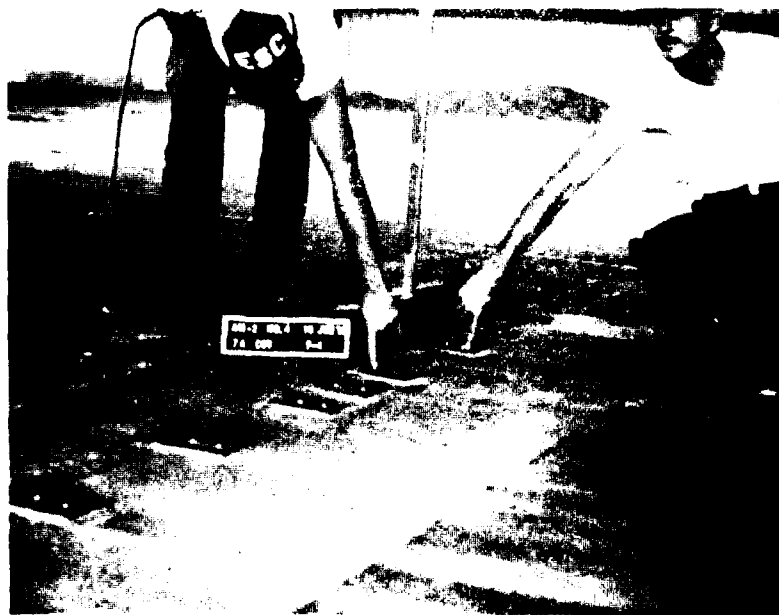
- (5) 74 Coverages: Some nails had to be hammered back in. The spalled concrete was swept from the traffic lane.
- (6) 80 Coverages: Spalling of the Silikal® had increased. Many clips in the traffic lane were loose. Nails were constantly being hammered in to prevent damage to the tire.

Figure 39. Test 1 (Z-C 11) - 24 Coverages of F-4  
(Loose Nails)

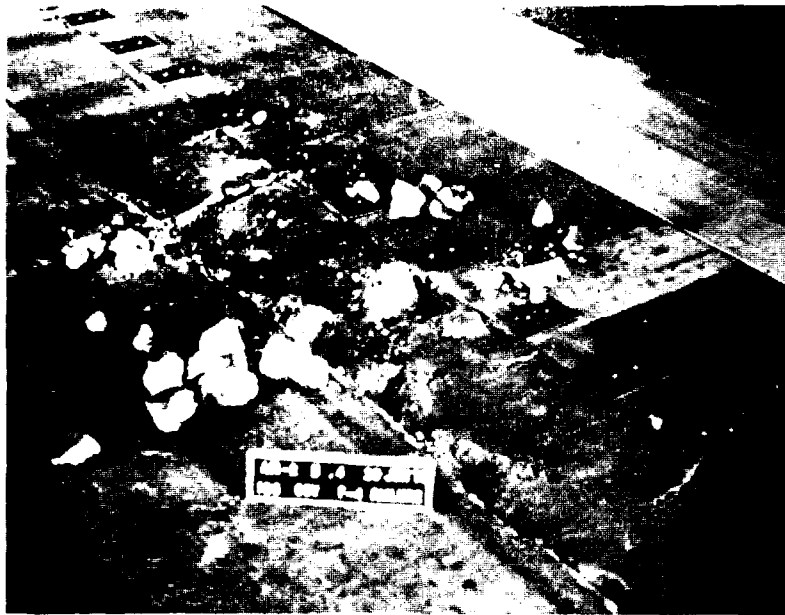
(7) 126 Coverages: Structural failure of the patch had occurred. The Silikal® was badly spalled with 3- or 4-inch pieces readily removed by hand. A sizeable deflection of the panels was noted as the load cart crossed.

Figure 40. Test 1 (Z-Clip)-126 Coverages of F-4  
(Failure)

At this point, it was decided to repair the badly spalled areas in order to get 150 coverages of the F-4 and the required coverages of the C-141 load cart. Two bags of Silikal® were required to complete the repair.
