# FIELD EVALUATION OF BUILT-IN TEST EQUIPMENT (BITE) FOR VEHICLE OIL AND AIR CONTAMINATION

FINAL REPORT No. MED125

By Ruben A. Alvarez John D. Tosh John A. Russell Frank M. Newman Mobile Energy Division Southwest Research Institute San Antonio, Texas

July 1981

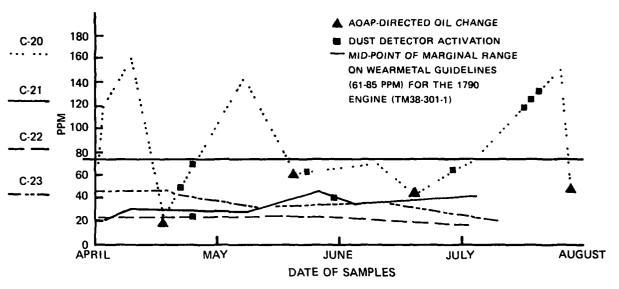
FIGURE 12. SILICON ANALYSIS FOR M60 TEST VEHICLES

A detailed comparison of the AOAP laboratory's analyses of silicon levels expressed in parts per million was made on the four test and four control vehicles. The comparisons are based solely on silicon analyses conducted by the AOAP laboratory at Fort Hood, TX. The results of all the oil samples submitted on the test and control vehicles and analyzed by the laboratory from 1 April to 31 July 1980 are depicted in Figures 12 and 13. As evidenced by Figure 12, with the exception of vehicle C-20, all the test vehicles operated well below the marginal range of silicon level established by TM38-301-1 (Joint Oil Analysis Program Laboratory Manual for Nonaeronautical Equipment). The control vehicles, however, as seen in Figure 13, operated in the marginal, high, and abnormal range for several days within the 4-month period. Also, all the control vehicles required AOAP-directed oil changes while in the test vehicles only vehicle C-20 required an oil changes. It should be noted that vehicle C-20 operated with an undetected air  $i_{i}$  tion leak before and after the span of time depicted in the graph. As can be seen in Figure 12, this vehicle's behavior was far more aberrant than the other three vehicles.

The engine on vehicle C-20 failed on 2 September 1980, shortly after the comparison test. Cause of failure was attributed to a faulty air induction system. Based on the number of dust detector activations (Figure 12), if proper corrective action had been effected, the damage to the engine could have been prevented. Appendices D and E reference the cause of failure.
