DELAWARE RIVER BASIN  
GREEN VALLEY FARMS DAM  
MRS. ELEANOR M. REYNOLDS

NDI NO. PA-01101  
DER NO. 15-307

PHASE I INSPECTION REPORT  
NATIONAL DAM INSPECTION PROGRAM

PHASE I REPORT  
NATIONAL DAM INSPECTION PROGRAM  
BRIEF ASSESSMENT OF GENERAL CONDITIONS  
AND RECOMMENDATIONS

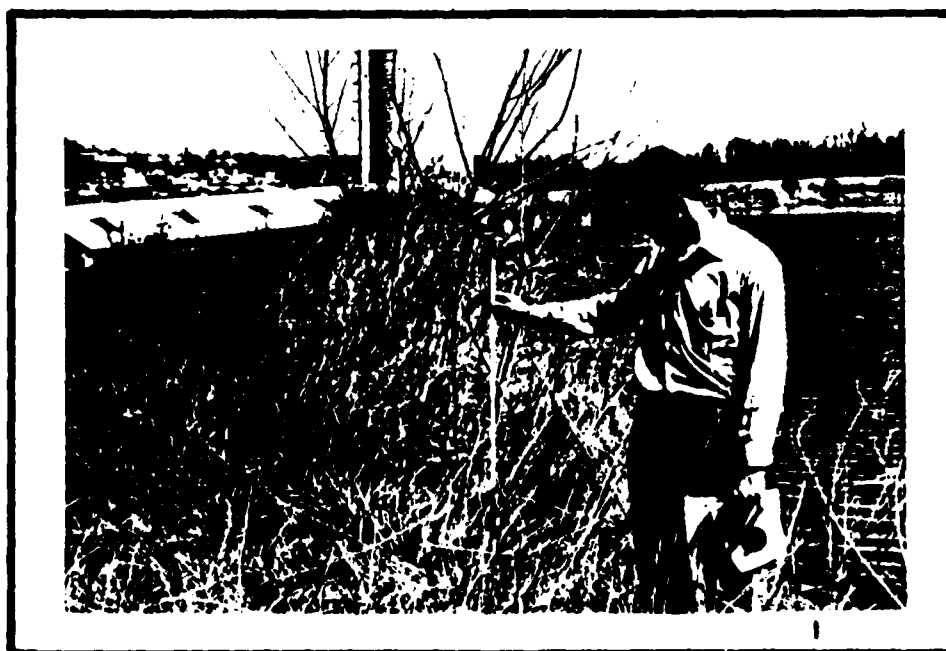
The visual inspection of Green Valley Farms Dam did not detect any signs of seepage through the embankment. A drainage system at the toe was installed in 1970 or 1971 to intercept subsurface flow toward lagoons located further downstream. This system was installed for the protection of the lagoons. The stability of the dam was not threatened. The downstream slope of 3.8H to 1V is considered adequate for this type of embankment and there were no signs of sloughs or surface cracks. The upstream slope, although apparently stable, is unprotected and has been eroded by wave action.

UPSTREAM SLOPE - NO. 5

NOTE: WEEDS, BRUSH AND EROSION FROM WAVE ACTION
