1. Report No. USCG 16732/93261		2. Government Accession No. AD-A207 642		3. Recipient's Catalog No.	
4. Title and Subtitle Marine Casualty Report Uninspected Self-Elevating Mobile Drilling Unit RANGER I: collapse and sinking in the Gulf of Mexico on 10 May 1979 with loss of life				5. Report Date 13 May 1981

COLLAPSE AND SINKING OF MOBILE OFFSHORE DRILLING
UNIT RANGER I IN THE GULF OF MEXICO ON 10 MAY 1979
WITH LOSS OF LIFE

Commandant's Action

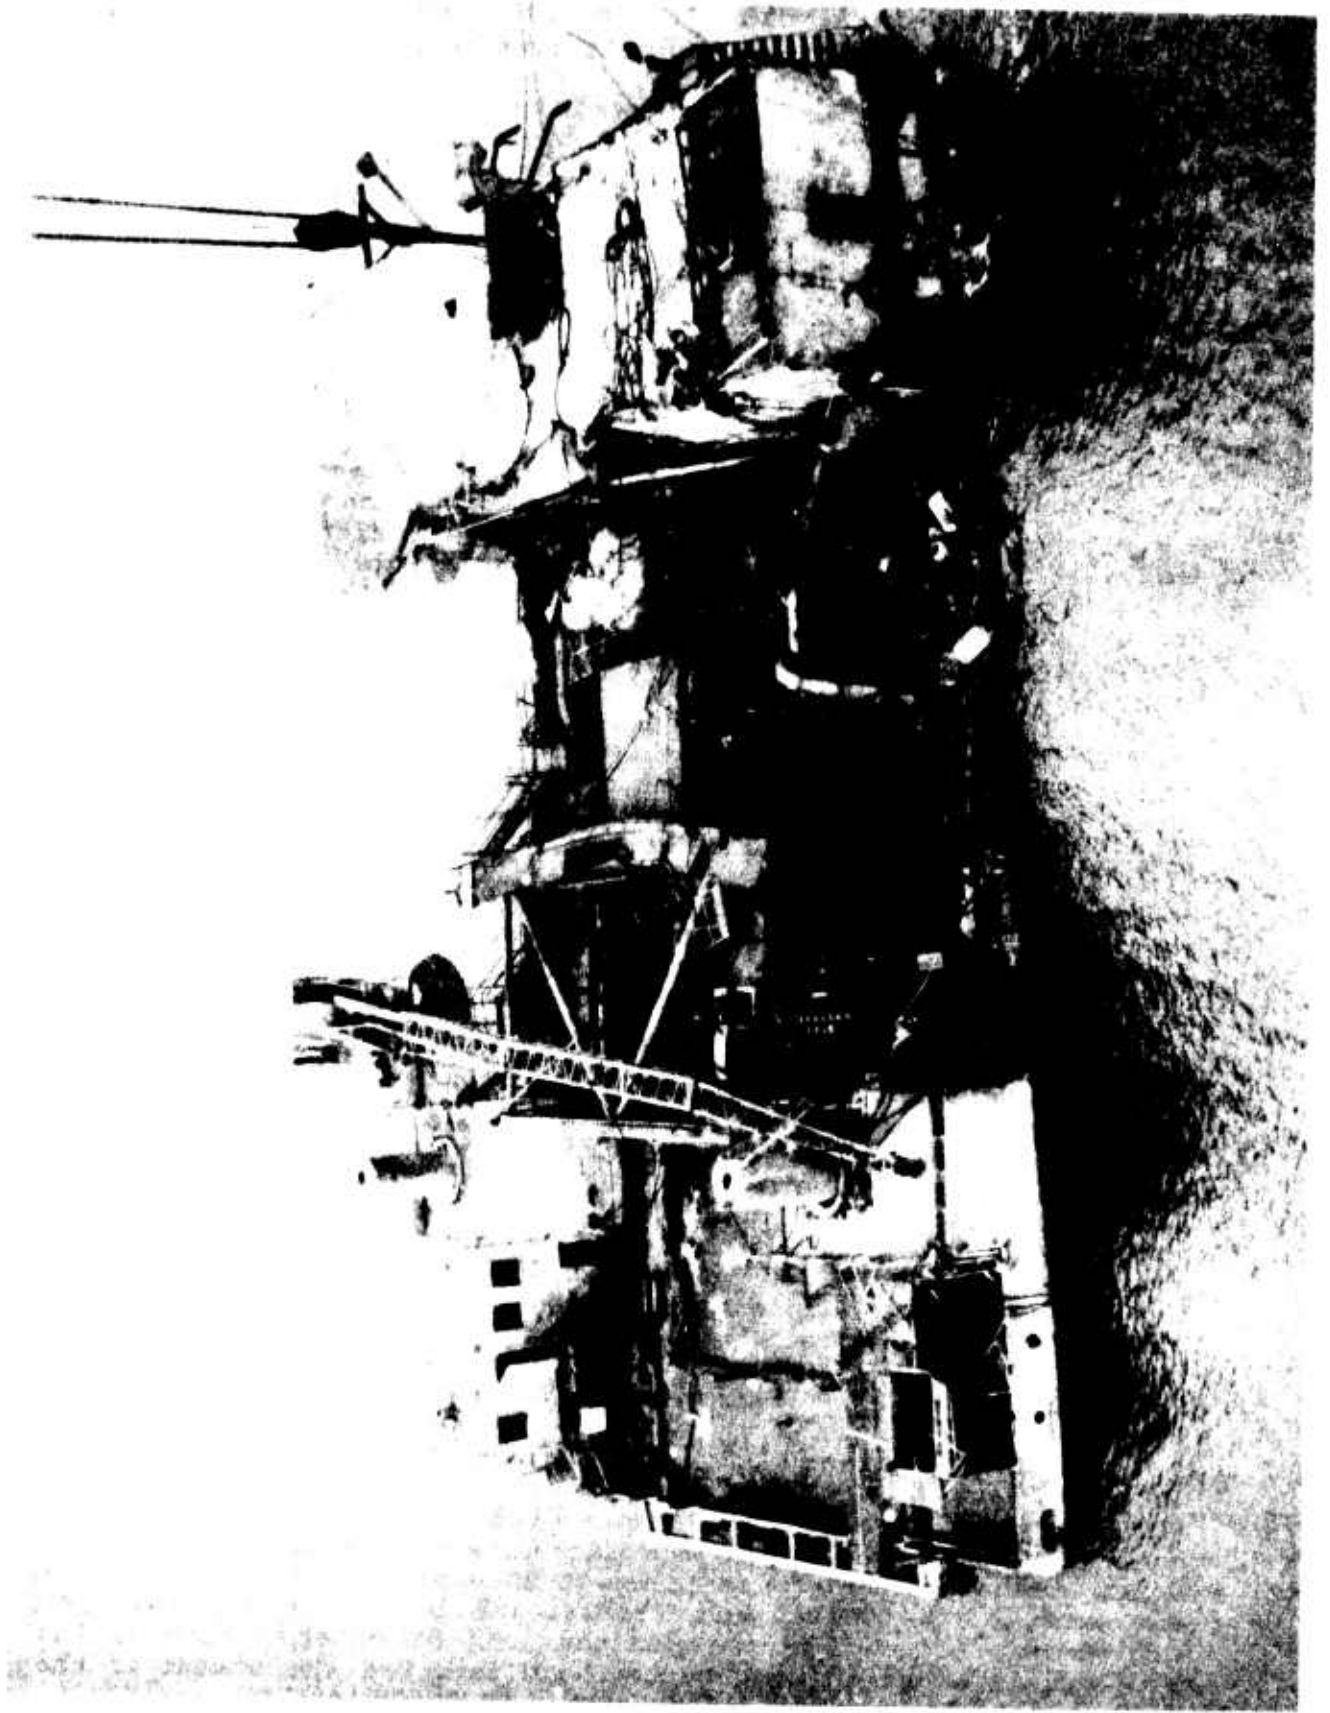
FIGURE 5

On 15 July, the RIPTIDE II, owned by Tidex, Inc. arrived to assist in recovering debris. The upper hull was raised on 14 August, towed to Pelican Island and beached. Heavy currents and high seas hampered diving operations and delayed wreckage removal. The remaining debris was removed and a site survey using a side scan sonar and magnetometer was completed on 6 September by the PROTON. RANGER I's upper hull was drydocked in Galveston, debris removed and major deficiencies repaired. The upper hull was towed from Galveston on 9 September for conversion to a salvage vessel. (See figure 5)

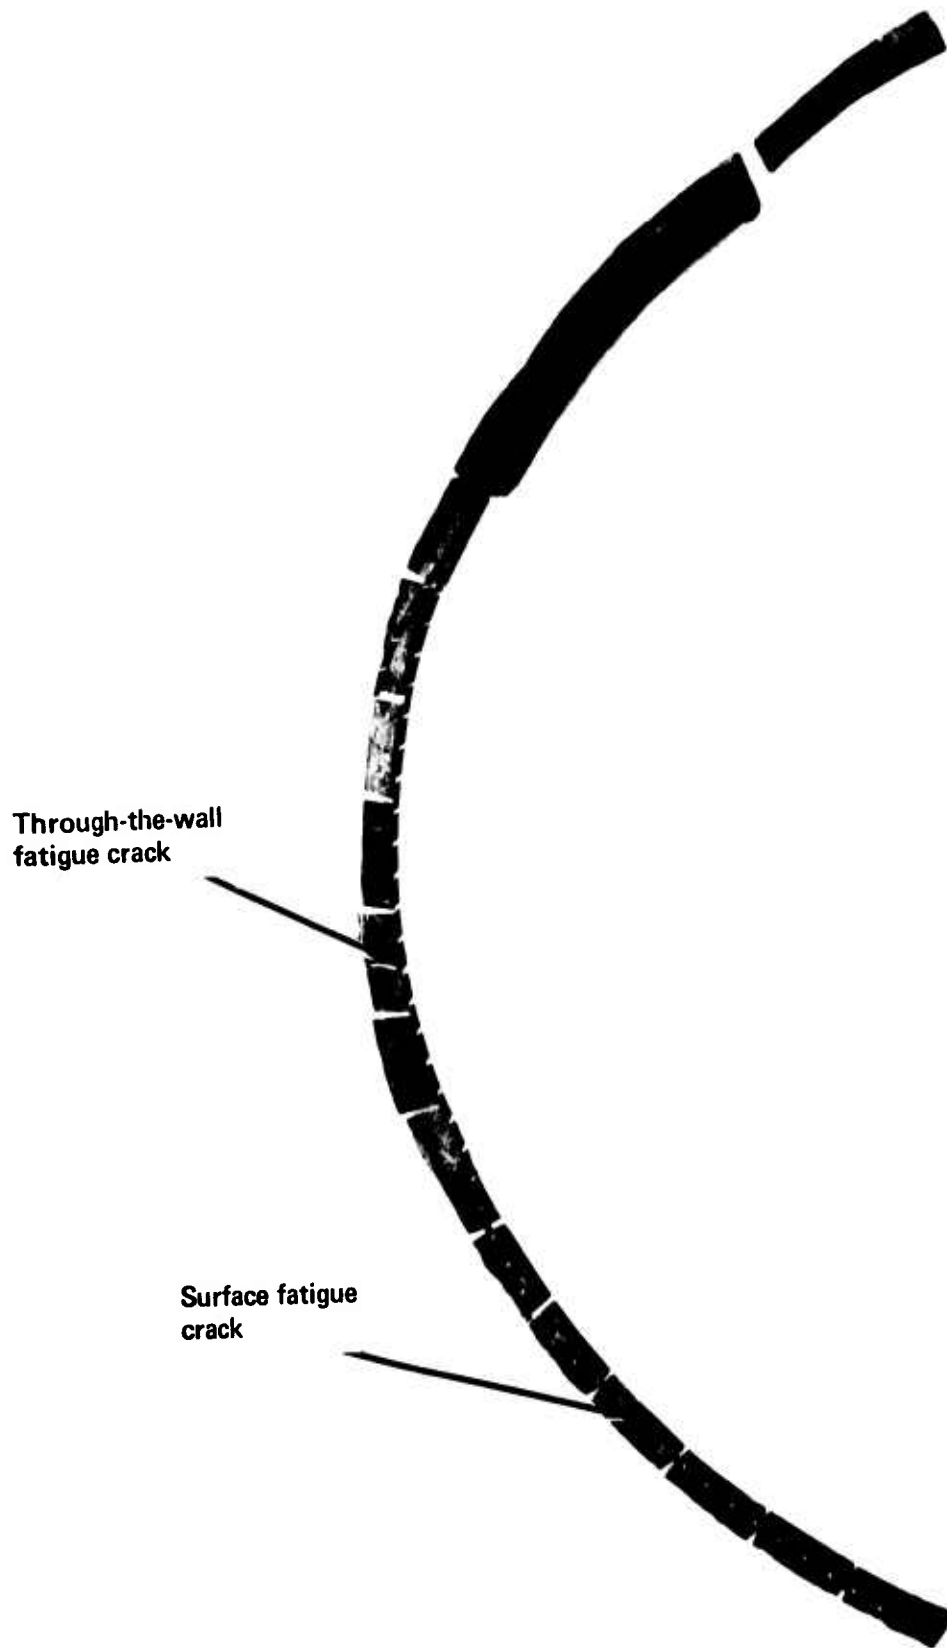
SEM studies were inconclusive in identifying fatigue on the catastrophic fracture surface because of heavy oxide and surface deposits. However, TEM studies showed a through-the-wall fatigue crack of about 23 inches centered on the port side of the stern leg and a surface crack of about 14 inches centered on the after port side of the stern leg. The two fatigue cracks joined on the port side. The surface crack extended 50 to 70 percent through-the-wall of the stern leg. Also, the TEM studies were used to count fatigue striations on the surface of the catastrophic

fracture. Although fine fatigue striations were removed by corrosive action of the sea water, the studies showed that the 23 inch fatigue crack was propagating for at least 400 days. TEM studies of the starboard side of the catastrophic fracture showed a quasi-cleavage mode of failure. (See figure 7)

FIGURE 7 – CATASTROPHIC FRACTURE SURFACE OF PORT SIDE OF STERN LEG.
