# ROCKAFELLOWS MILLS DAM

## NJ 00568

### PHASE 1 INSPECTION REPORT NATIONAL DAM SAFETY PROGRAM

JULY 1981

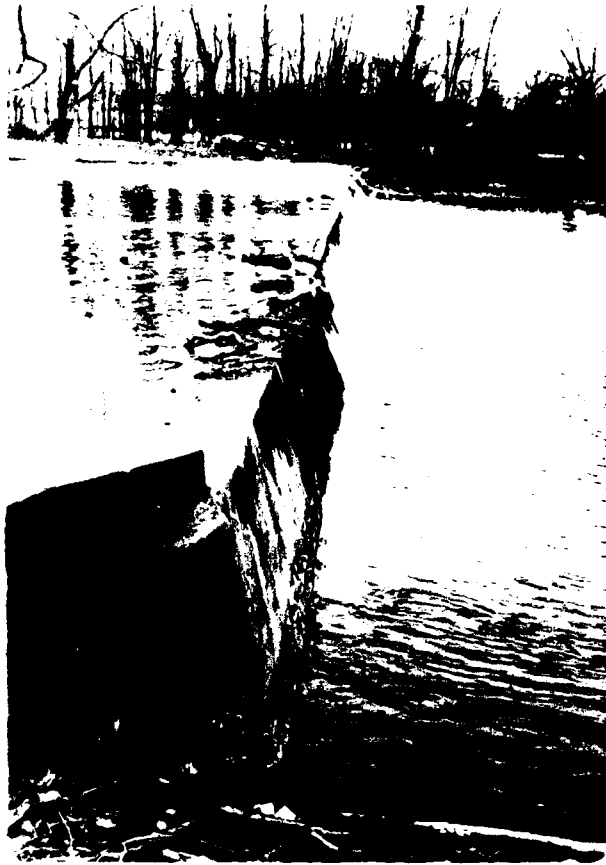
Photo 1 - View of dam looking towards the left end. Dry area of spillway is section repaired in 1978.

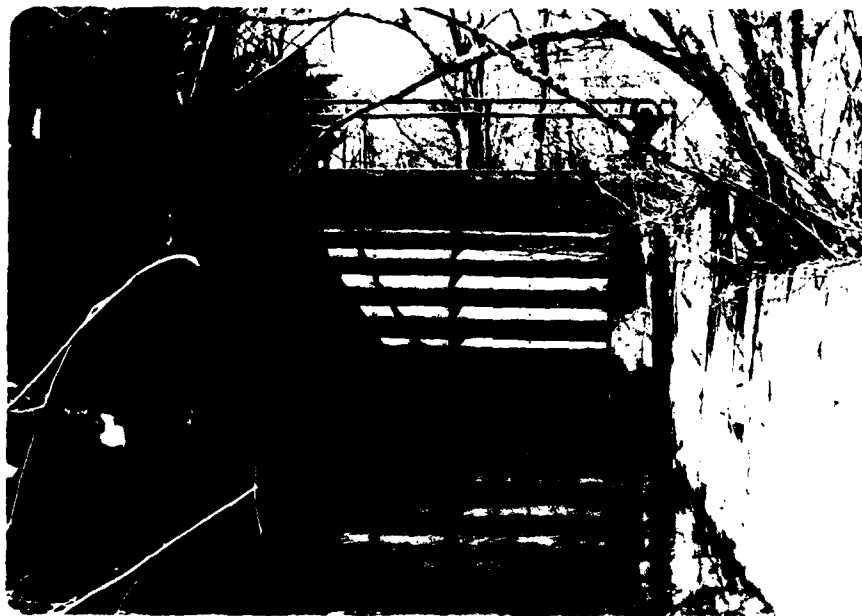
Photo 7 - View of water wheel from downstream.
