FAA-AM-81-10

IMPROVING THE CRASHWORTHINESS OF GENERAL  
AVIATION AIRCRAFT BY CRASH INJURY INVESTIGATIONS

William R. Kirkham, M.D., Ph.D.  
Civil Aeromedical Institute  
Federal Aviation Administration  
Oklahoma City, Oklahoma

MAY 1981

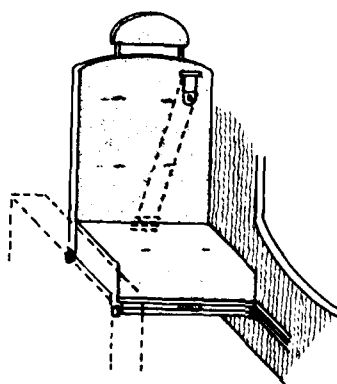
seat back and attaches to the lapbelt. The strength of the shoulder harness depends upon the strength of the seat-back latch to keep the seat upright during an impact. If the seat back were to break forward the shoulder harness would be of reduced value. Furthermore, the seat is mounted on rollers that extend from the seat frame to tracks on the sidewall and a center console (Figure VII). There are no legs or pedestals under this seat. The seat and upper torso restraint arrangement is such that the forward decelerative forces of the occupant transmitted to the shoulder harness must be borne by the seat attachment.

Figure VII. Schematic of side-mounted seat.

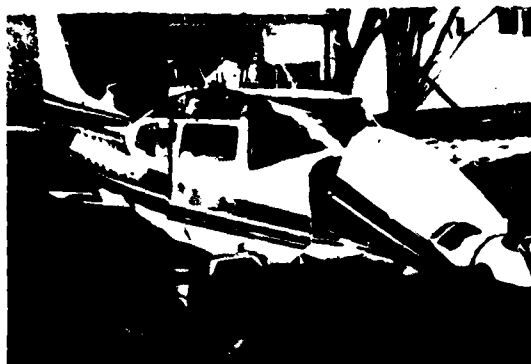
application aircraft as illustrated in Figure XII. The six people in this aircraft all received moderate to severe injuries. The pilot and person in the copilot position had facial injuries and spine fractures. The forward four seats were partially or completely separated from the seat tracks and the pilot's and copilot's seats had fractured seat pedestals as shown in the figure. Cast seat legs and parts are strong and meet all FAA requirements but in accidents when the failure point is reached they appear to break exposing the occupant to possible high peak decelerative forces in secondary impacts rather than deforming under the occupant and attenuating the energy of impact. At present we do not know how pervasive failures of seats are in general aviation aircraft or how such failures add to the severity of injuries. This is a matter of continuing crashworthiness investigations.

Figure XII. On impact, the occupants of this aircraft received serious injuries. Cast alloy seat pedestals were found to be fractured as can be seen in photograph.
