# SHAWS MILL POND DAM NJ 00075

PHASE 1 INSPECTION REPORT  
NATIONAL DAM SAFETY PROGRAM

REPT. NO: DAEN/NAP-53842/NJ00075-81/07

National Dam Safety Program. Shaws Mill Pond Dam (NJ 00075), Atlantic Coast Basin, Pages Run, Cumberland County, New Jersey. Phase I Inspection Report.

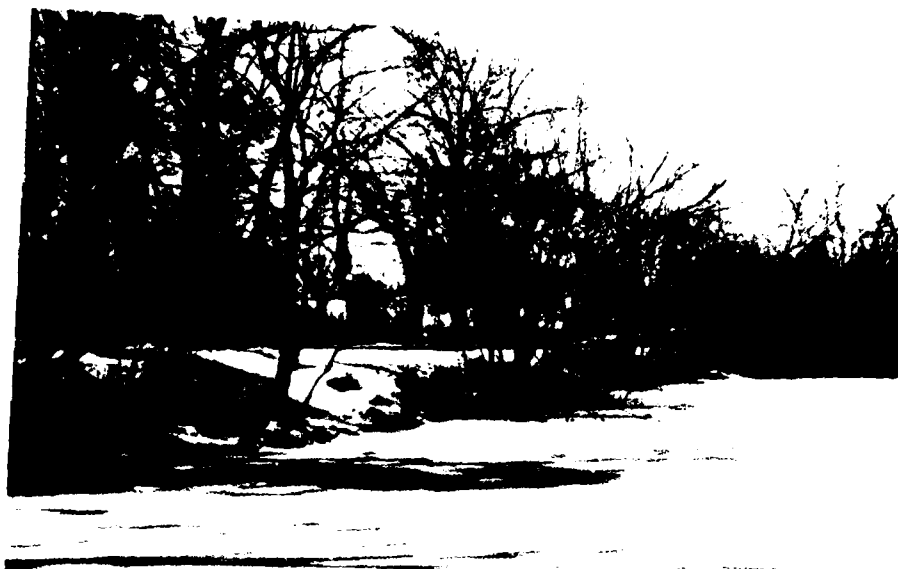
The paved roadway was in generally satisfactory condition. The upstream face of the dam was covered with grass bushes, briars and trees. The trees ranged in size from 2 inches to 12 inches. Also the alignment of the upstream face was somewhat irregular, with grooves or indentations which appeared to be due to pedestrian activity. The downstream face was covered with leaves, briars, bushes and trees. The trees ranged in size from 2 inches to about 30 inches. The downstream face alignment was also somewhat irregular. It contained gulleys due to a combination of surface runoff and pedestrian activity. There were numerous paths running along the downstream side of the dam indicating considerable pedestrian activity on the dam (See Section 3.1.f). On the downstream side of the dam near

Erosion was observed on the upstream face of the dam just to the left of the upstream headwall of the spillway. It appeared to be due to surface runoff and possibly pedestrian activity. There was also considerable erosion on the left side of the downstream wingwall in two areas. One area consisted of a deep gully approximately 2 feet deep and 18 inches wide with roots exposed. It appeared to be due to surface runoff and pedestrian activity. The upstream end of this erosion had been stabilized by some concrete curbing although some sections of the curbing were leaning in a downstream direction. The whole area should be filled and properly stabilized. It appeared

PHOTO 5  
UPSTREAM FACE OF DAM

(1) Eroded areas of the upstream and downstream face of dam especially in the vicinity of the spillway should be properly stabilized.

(3) Trees and adverse vegetation on the embankment should be removed.
