LAKE JA-HA DAM  
MILLER COUNTY, MISSOURI  
MO 30251

## PHASE 1 INSPECTION REPORT NATIONAL DAM SAFETY PROGRAM

AUGUST, 1980

Anderson Engineering, Inc., Springfield, Missouri  
Hanson Engineers, Inc., Springfield, Illinois

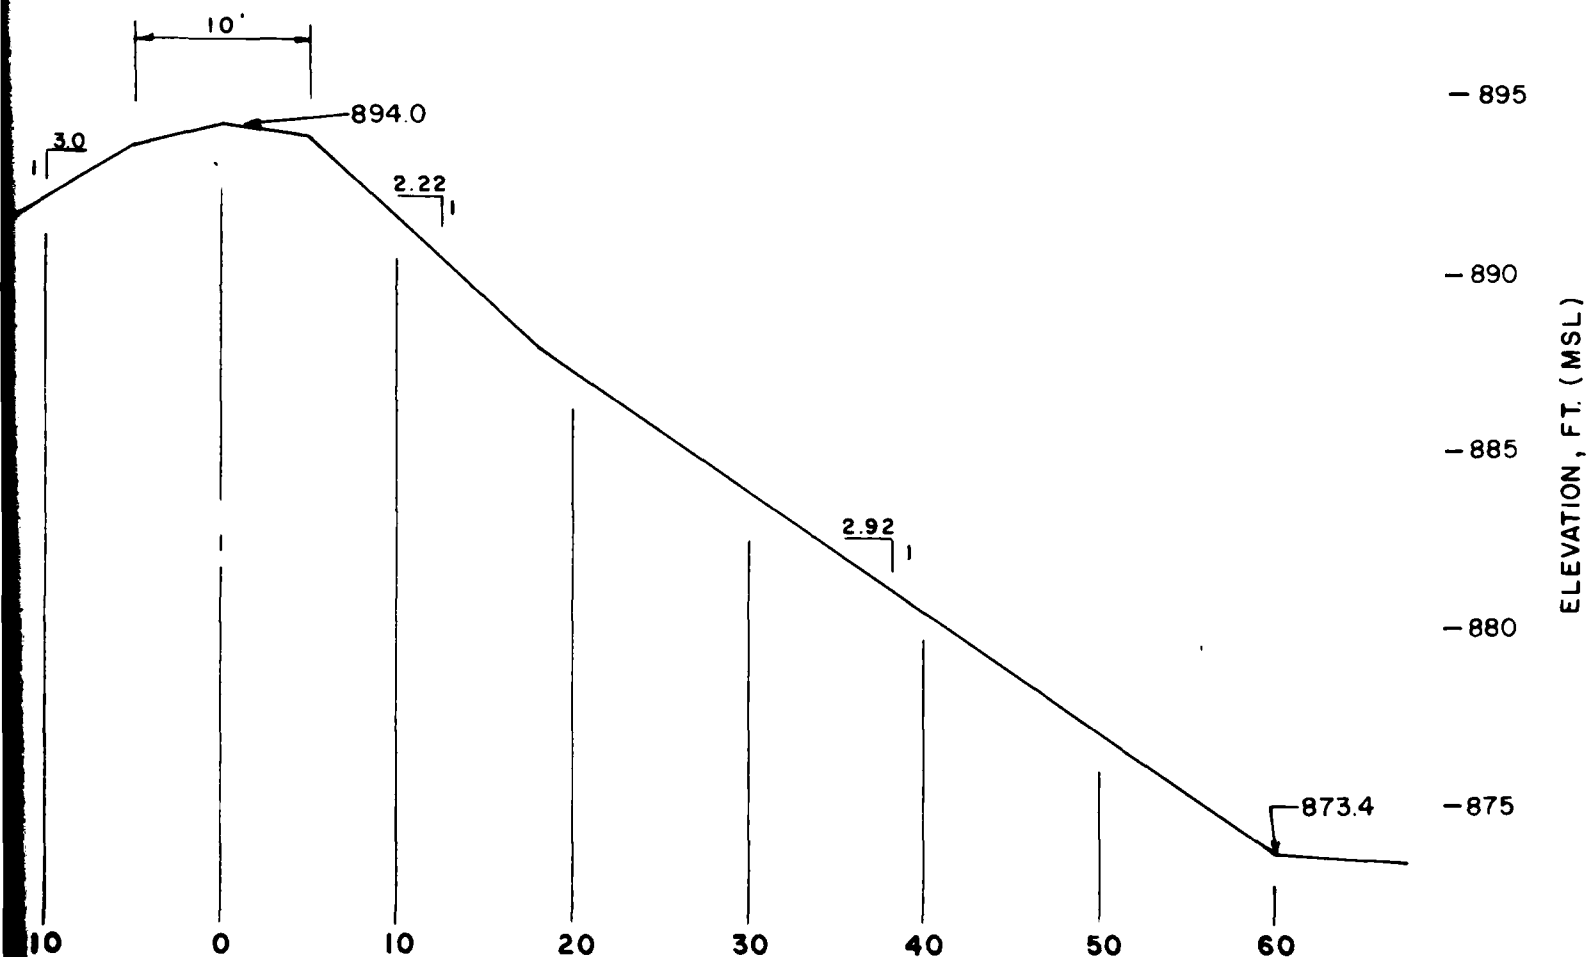
## SECTION A-A STA 5+00

The dam appears to be in generally good condition. The downstream embankment face is heavily overgrown with brush and trees. A small seepage area was noted on the embankment face at about Station 5+00. This area was located about mid-way between the crest and toe and was soft and wet. No obvious flows were observed, and it did not appear that soil particles had been transported from this area. In addition, seepage was observed along a major portion of the embankment toe (see Sheet 4, Appendix A).

- (3) The seepage areas noted on the downstream face and along the embankment toe should be investigated by an engineer experienced in the design and construction of dams. Remedial measures may be required. As a minimum, these areas should be inspected periodically in an effort to detect an increase in the quantity of seepage or any indication that soil particles are being carried by the water. In this event, an experienced engineer should be contacted immediately.

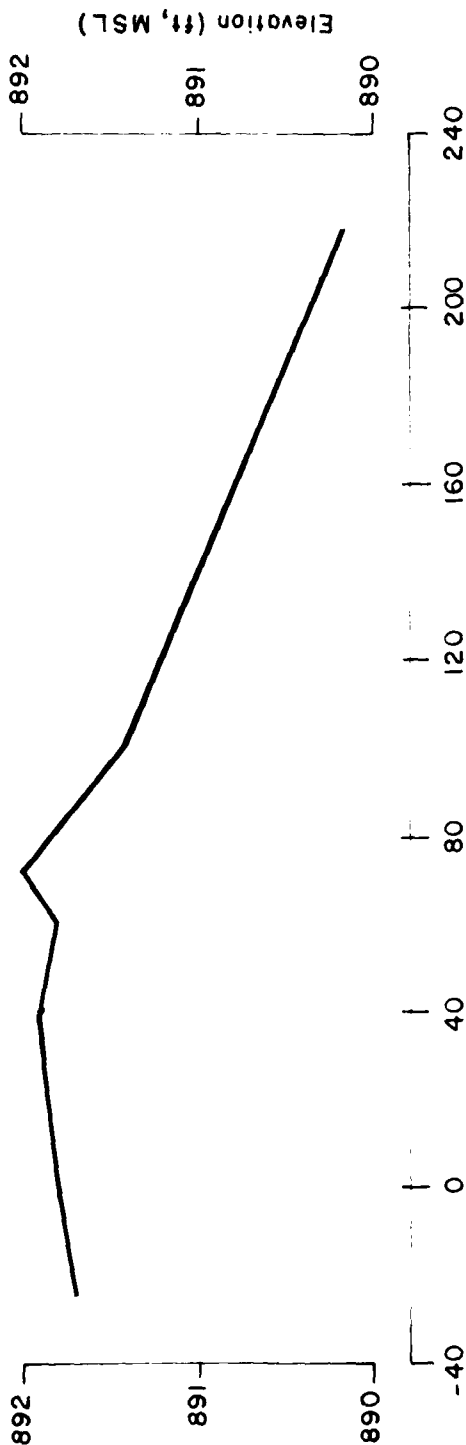
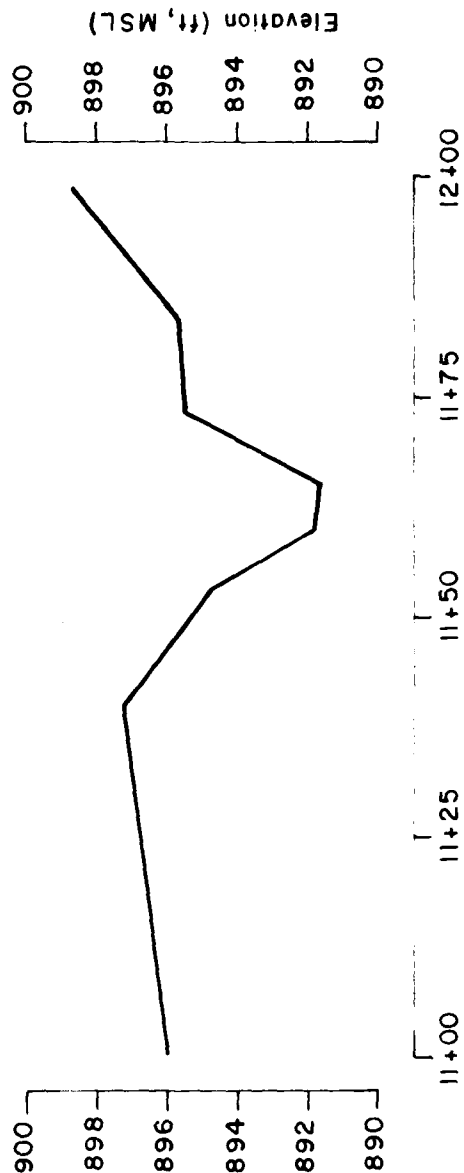
**Profile and Section of Spillway**

The approach area to the spillway was clear. No non-erodible control section exists for the spillway. The spillway outlet passes along the toe of the embankment to the downstream channel. The outlet channel is only discernible for a few hundred feet past the spillway crest; beyond, the outlet channel is very shallow and is grass-covered. No significant erosion was noted in the outlet area.

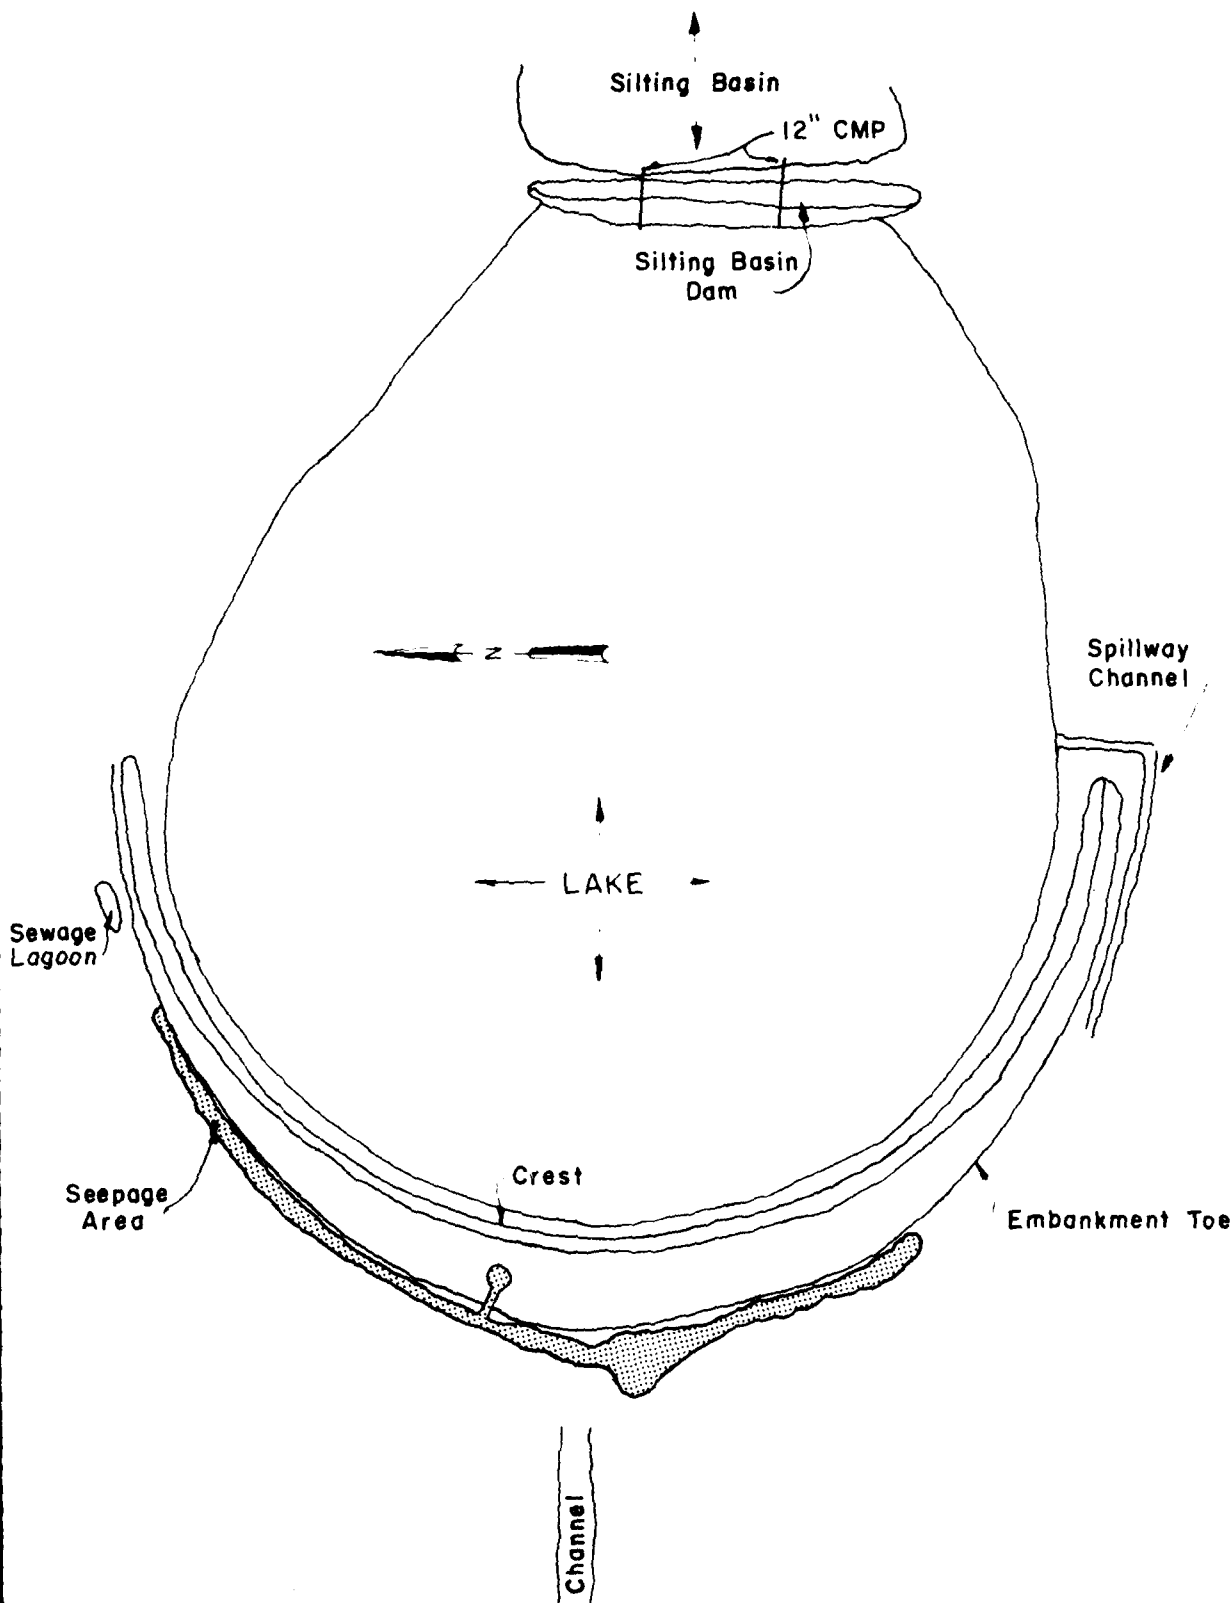
Plan Sketch of Dam

A small sewage lagoon, serving the five homes on the shore of the lake, is located just beyond the embankment toe near the right abutment (see Photo 16). The embankment in this area is only a few feet high. Sheet 5 of Appendix A presents a plan sketch of the dam showing observed features.
