| REPORT DOCUMENTATION PAGE | | READ INSTRUCTIONS<br>BEFORE COMPLETING FORM |
|---|---|---|
| 4. TITLE (and Subtitle)<br>Phase I Dam Inspection Report<br>National Dam Safety Program<br>Lake Montowese Dam (MO 30151)<br>Jefferson County, Missouri | | 5. TYPE OF REPORT & PERIOD COVERED<br>Final Report. |
| 9. PERFORMING ORGANIZATION NAME AND ADDRESS<br>U.S. Army Engineer District, St. Louis<br>Dam Inventory and Inspection Section, LMSED-PD<br>210 Tucker Blvd., North, St. Louis, Mo. 63101 | | 8. CONTRACT OR GRANT NUMBER(s)<br>DACW43-78-C-0143 |

PHASE I INSPECTION REPORT  
NATIONAL DAM SAFETY PROGRAM  
LAKE MONTOWESE DAM - ID NO. 30151

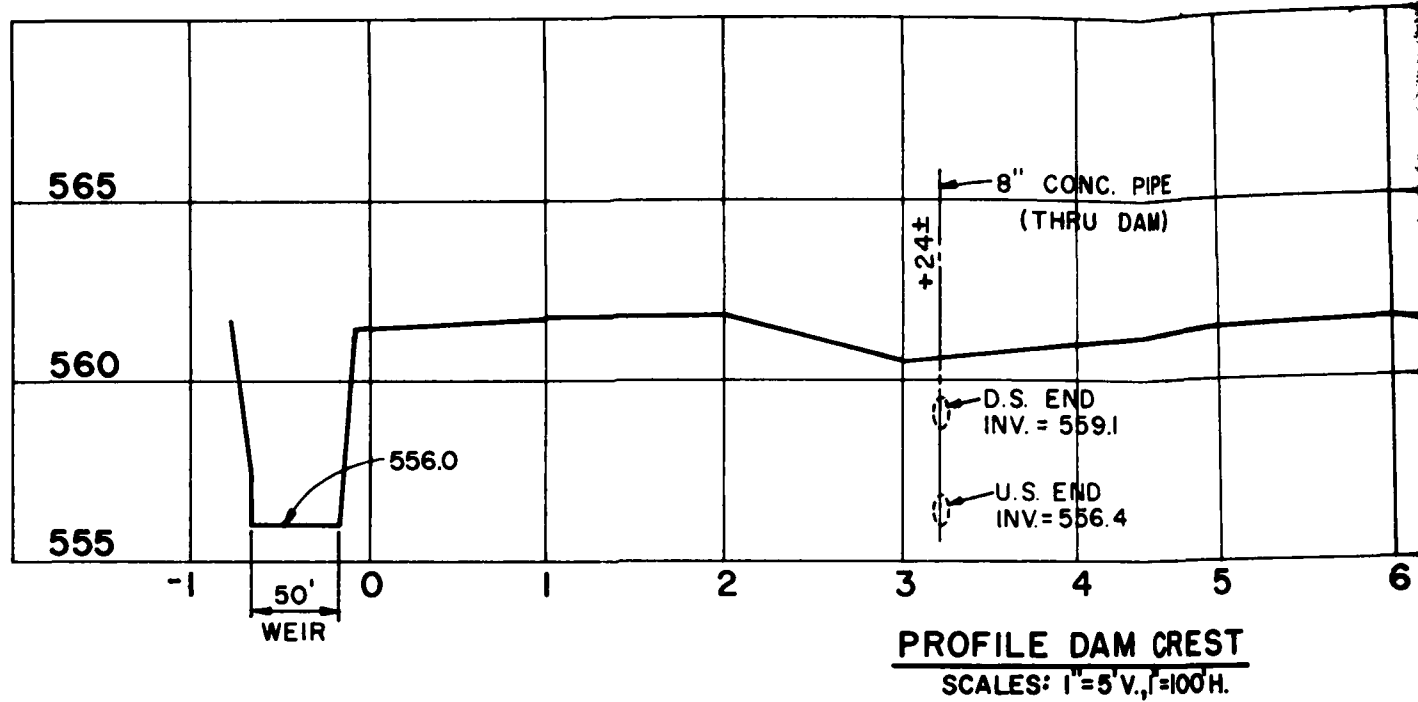
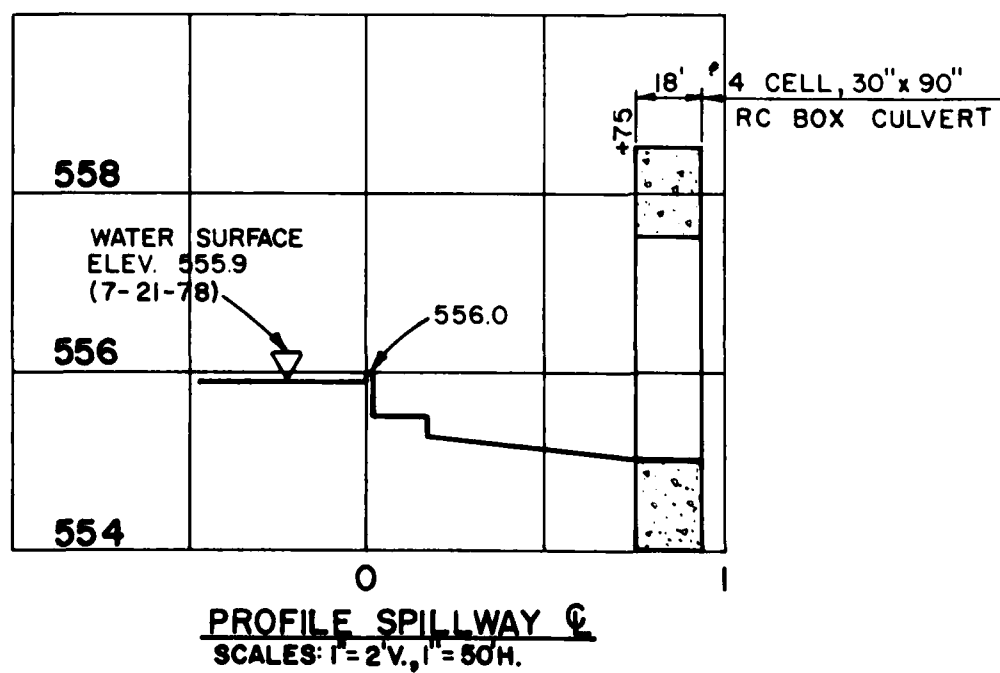
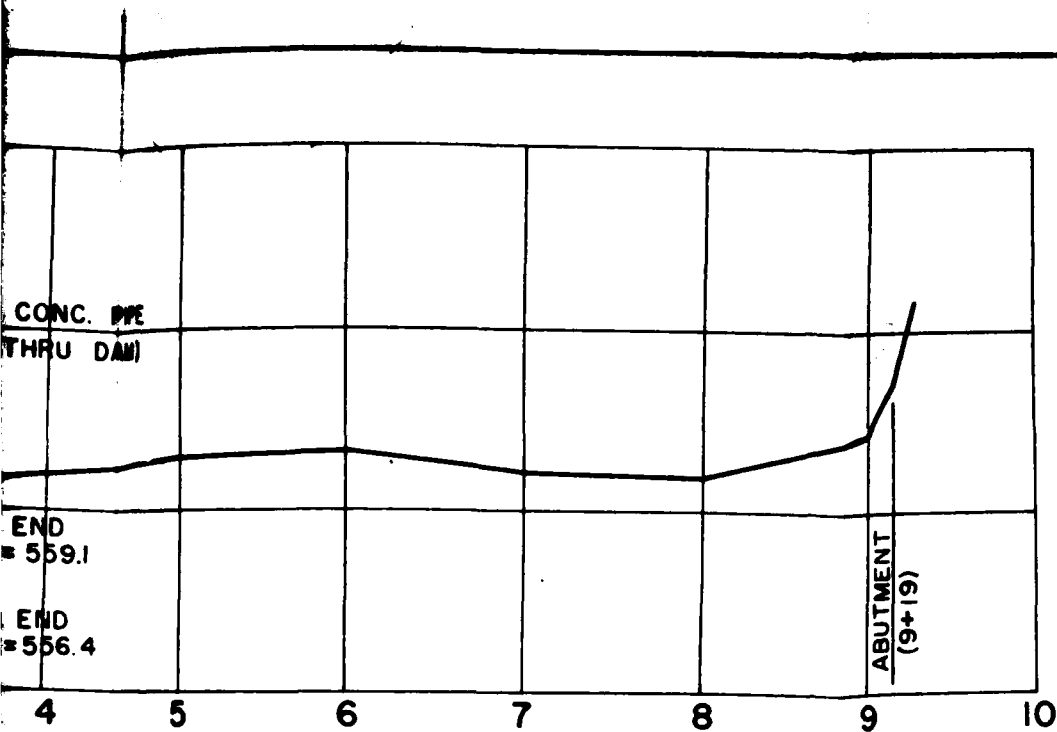
LAKE MONTOWESE  
DAM & SPILLWAY PROFILES  
Horner & Shifrin, Inc. August 1978

The elevation of the top of the dam, as determined by survey, was found to vary by about 1.3 feet with the lowest point located approximately 320 feet from the spillway. A profile of the dam crest extending through the spillway is shown on Plate 4.
