| REPORT DOCUMENTATION PAGE | | READ INSTRUCTIONS<br>BEFORE COMPLETING FORM |
|---|---|---|
| 4. TITLE (and Subtitle)<br>Phase I Dam Inspection Report<br>National Dam Safety Program<br>Spring Lake Dam (MO 31180)<br>Cape Girardeau County, Missouri | | 5. TYPE OF REPORT & PERIOD COVERED<br>Final Report |

PHASE I INSPECTION REPORT  
NATIONAL DAM SAFETY PROGRAM  
SPRING LAKE DAM  
MISSOURI INVENTORY NO. 31180

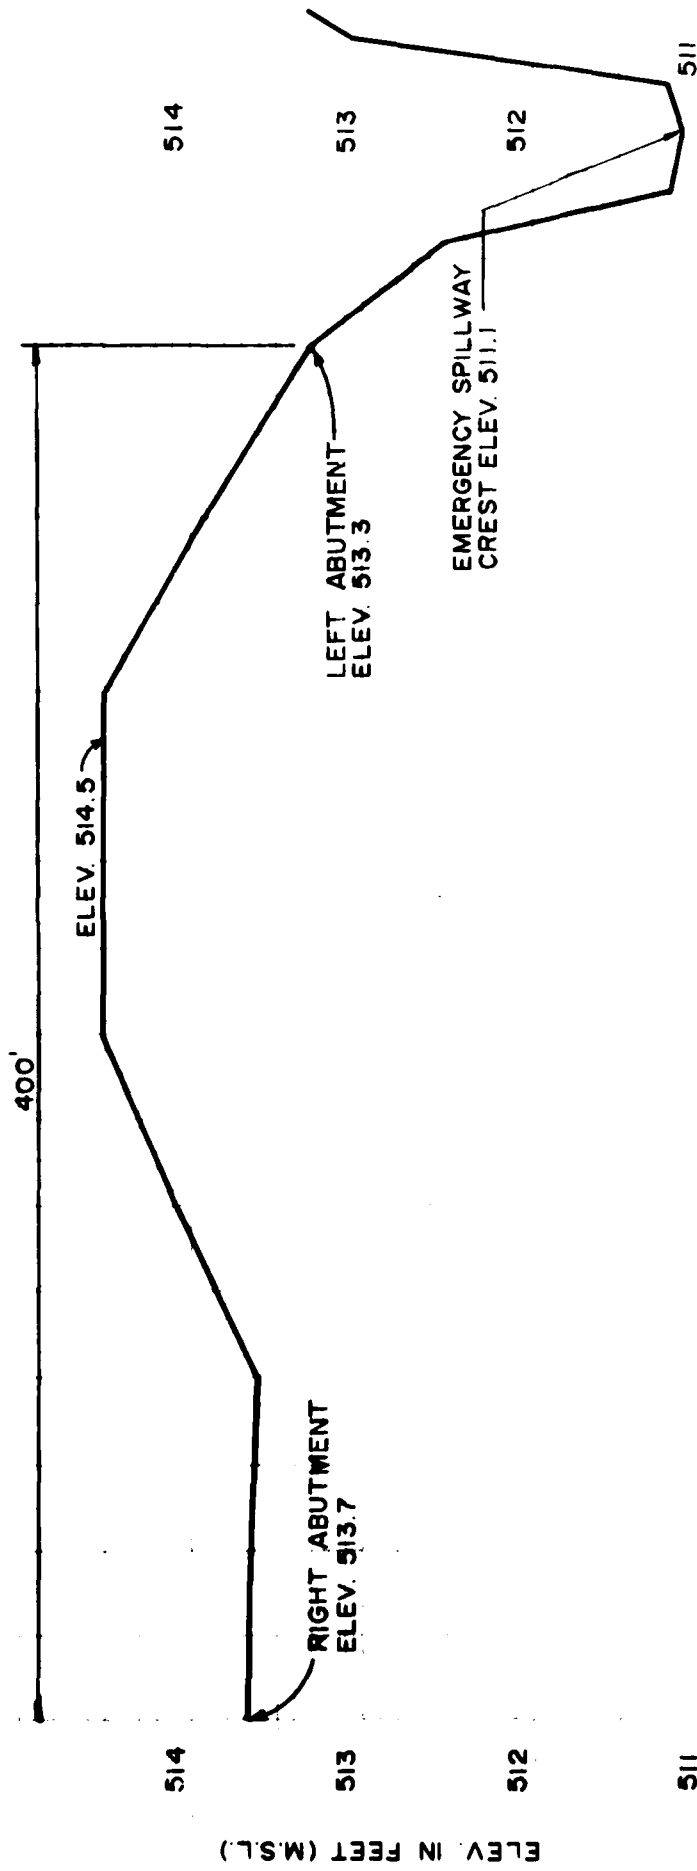
EXHIBIT 3

The embankment appears to be in fair condition. The horizontal alignment of the embankment (though curved) is good. The vertical alignment is erratic (see Exhibit 3 of Appendix C). It is believed this irregularity was primarily the result of grading for the roadway which extends across the crest of the dam. (See Photo 2 of Appendix C).
