LAKE BOUTIN DAM
CAPE GIRARDEAU COUNTY, MISSOURI
MO 40008

PHASE 1 INSPECTION REPORT NATIONAL DAM SAFETY PROGRAM

FEBRUARY 1981

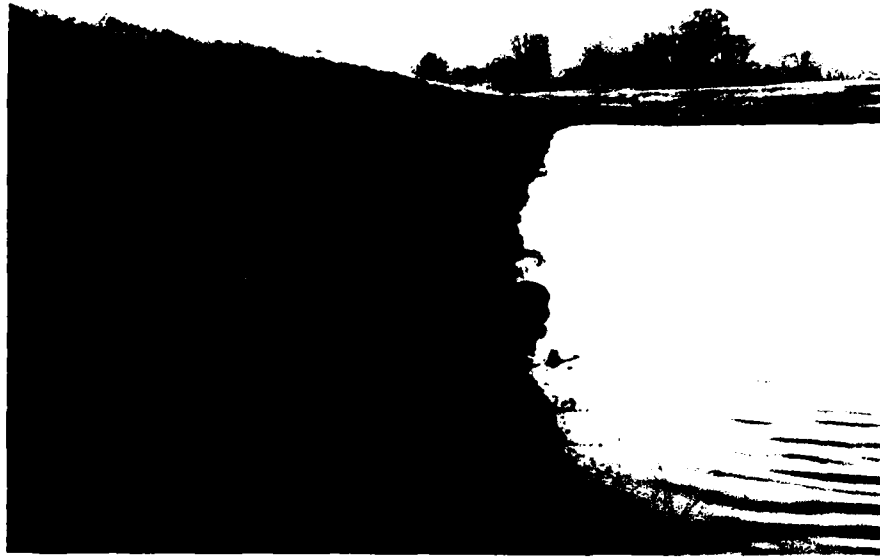
There is a paved gutter at the right abutment on the downstream slope which carries surface runoff from the crest to beyond the toe of the dam. This gutter has been undermined apparently along its entire length and has many cracks and several holes in the concrete as seen in Photographs 9 and 10. There is an erosion gully which is approximately 3 feet deep at its deepest point located on the hillside just downstream of the left abutment. It can be seen in Photograph 11. Riprap lined the upstream face of the dam from elevation 547.6 to just below the water surface on the day of inspection which was at elevation 545.0. The riprap consists of 4-inch to 12-inch diameter stone and is rather sparse the entire length of the dam, but erosion from wave action is minimal. The riprap can be seen in the overview photograph at the beginning of this report and on Photograph 2.

Photograph 2. Upstream slope of dam viewed from the left abutment.
