BOWLING GREEN DAM
PIKE COUNTY, MISSOURI
MO 10262

PHASE I INSPECTION REPORT NATIONAL DAM SAFETY PROGRAM

DECEMBER 1978

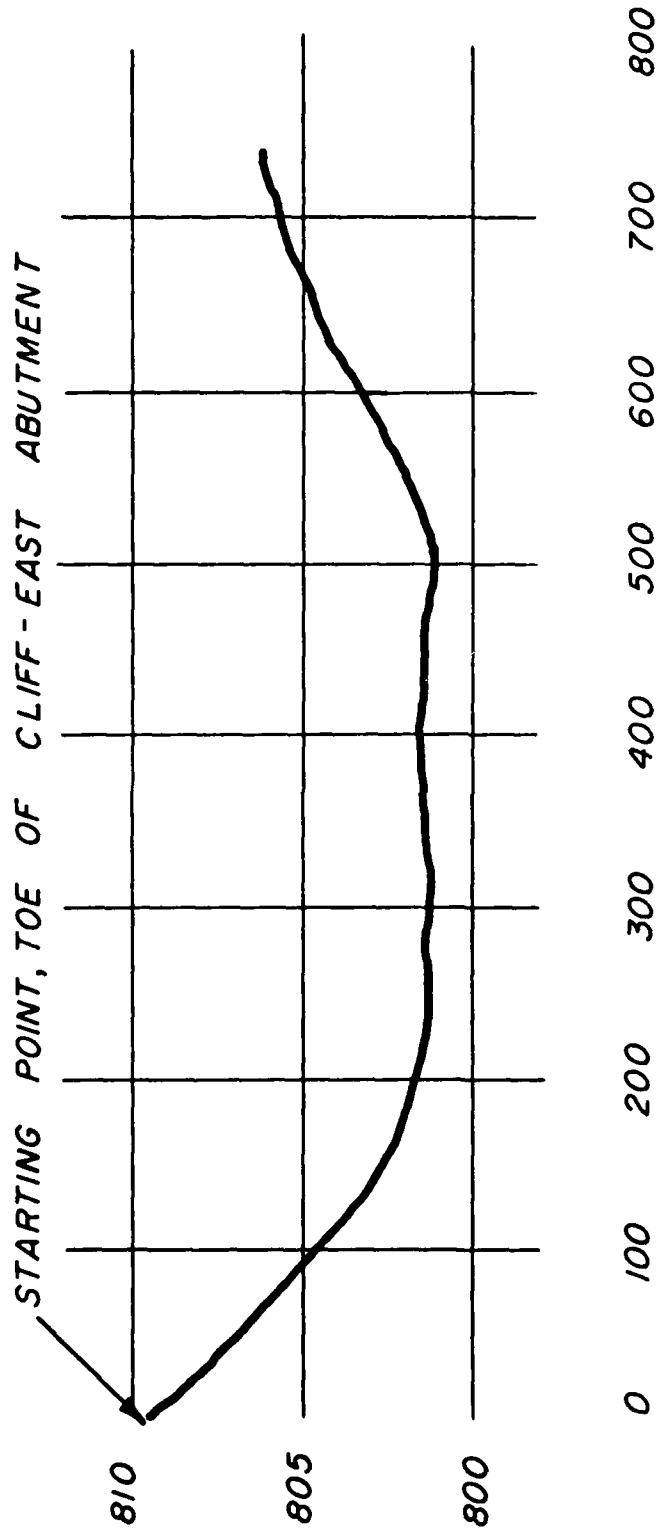
EXISTING TOP OF DAM PROFILE

The horizontal alignment of the dam appeared as shown on the plans. There is a shallow depression in the crest near the west abutment. No surface cracking or unusual movement was obvious. It should be noted, however, that the elevations along the top of the dam which were obtained in

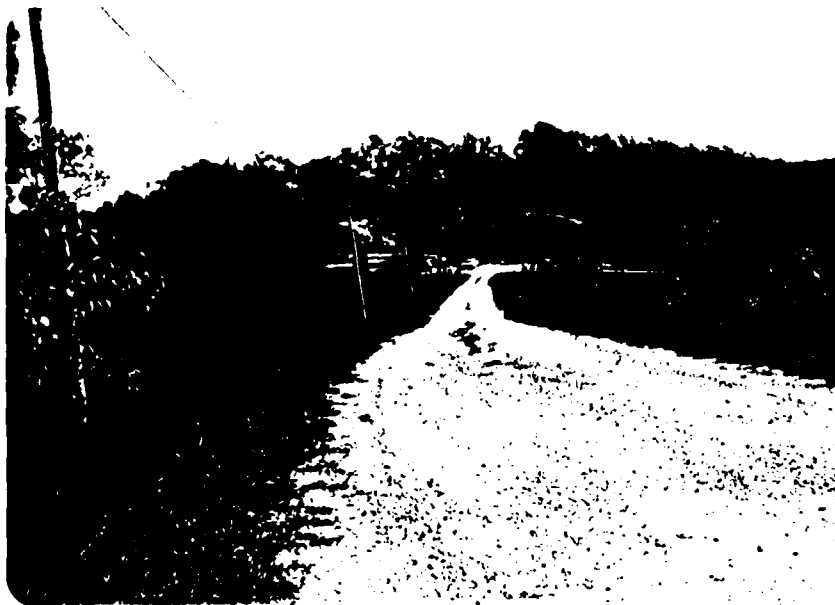
Crest of Dam - Looking East
