**USSARY DAM**

**BUCHANAN COUNTY, MISSOURI**

**MO. 10698**

**PHASE 1 INSPECTION REPORT**  
**NATIONAL DAM SAFETY PROGRAM.**

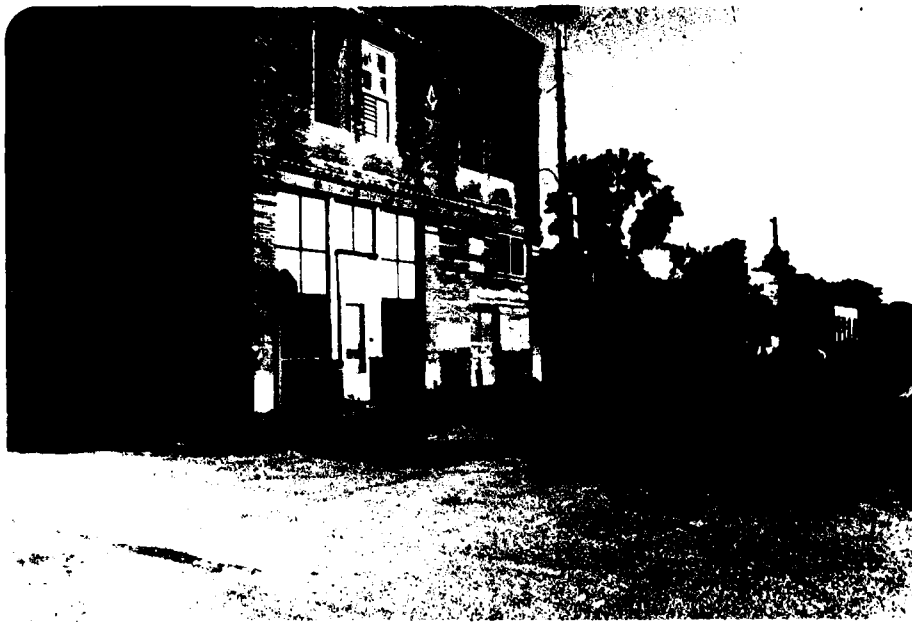
PHOTO NO. 20 - BUILDING IN AGENCY. NOTE HIGH WATER MARKS
