LAKEVIEW PARK DAM

ST. FRANCOIS COUNTY, MISSOURI

MO 30288

**PHASE 1 INSPECTION REPORT
NATIONAL DAM SAFETY PROGRAM**

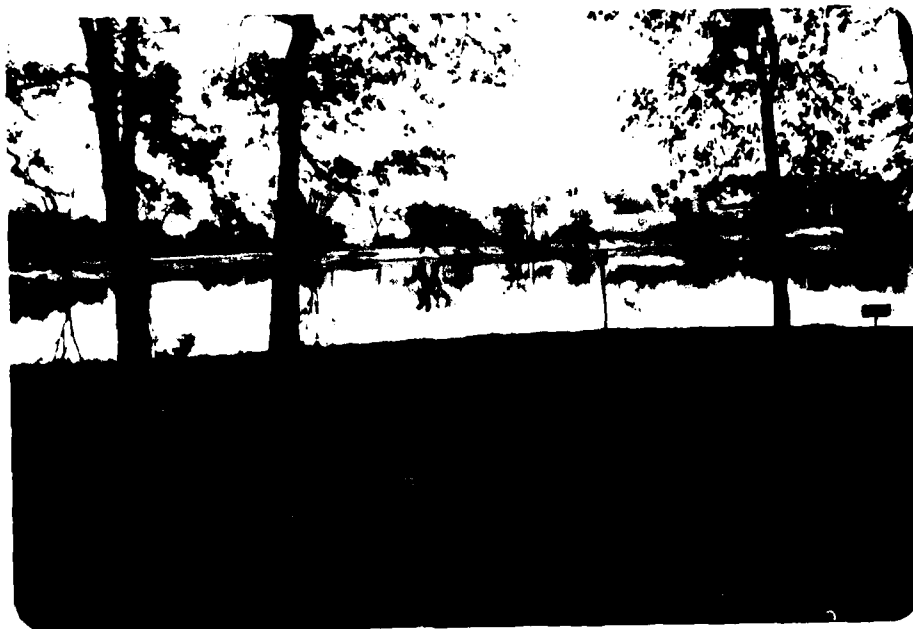
PHOTO NO. 2 - OVERVIEW FROM LEFT UPSTREAM BANK

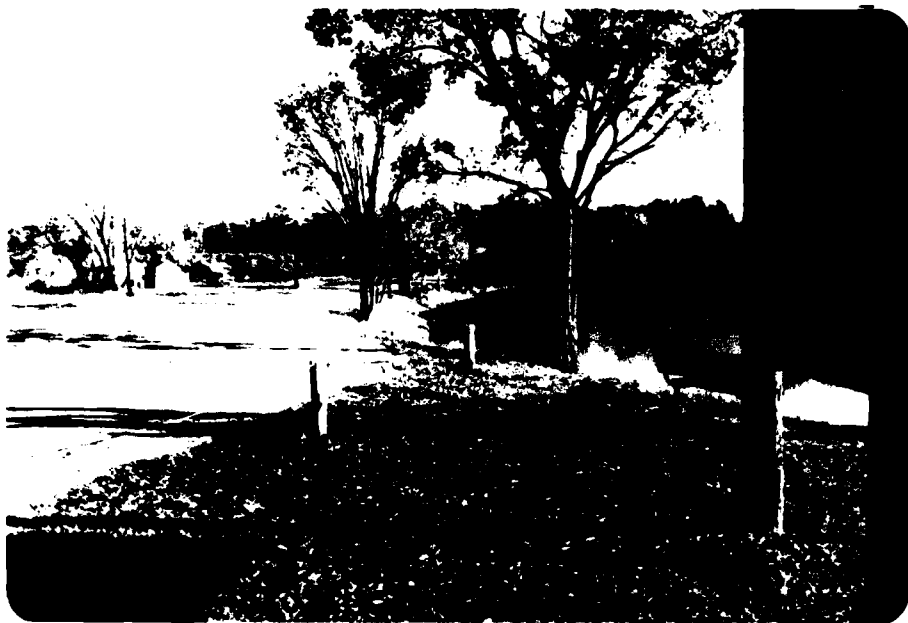
- (1) Principal Spillway. The approach channel to the highway culvert is becoming channelized and blocked with leaves, tall grass, and other debris. The headwall to the culvert is made of stone and mortar and appears to be in good condition. The downstream end of the 15-inch culvert was exposed and appears to be in fair condition. Photos 5 and 6 show the approach channel and Photo No. 7 shows the entrance to the culvert.
- (2) Emergency Spillway. The upstream approach to the emergency spillway (Station 0+50± to Station 4+00±) is across well vegetated, gently sloping terrain to a graveled roadside parking area that leads to the asphalt-surfaced road that traverses the length of the dam. The approach channel to the principal spillway is cut through the left side of this area and serves as a channel to the emergency spillway as well. Photos 4, 5

and 6 show portions of the approach. Station 4+00 is located approximately midway between the two trees in the center of Photo No. 4 where the shoreline of the lake begins turning away from the road. The graveled section of the widened road is in very good condition with no signs of distress. The asphalt surfaced road is in good condition.

PHOTO NO. 4 - UPSTREAM FACE FROM LEFT END

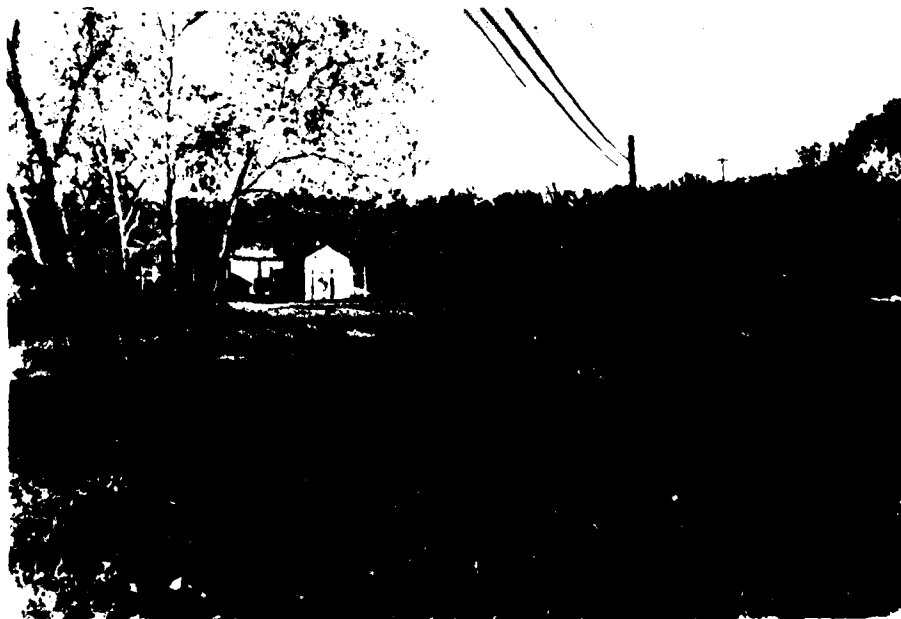
- (3) Crest. The profile of the crest is uniform in grade, reflecting the use of the dam as a paved road. The high point in the profile is on the right (south) side and is dictated by the elevation of the railroad crossing on the east. The low point is on the left (north) side at the principal spillway location. Plate C-1 shows the plan and profile of the dam. The asphaltic concrete road traversing the length of the dam is 22 feet \pm in width and is in good condition with no visible signs of distress. The crest width is unusually wide and varies from 50 to 180 feet \pm . In addition to the paved road, an overhead power line and a natural gas pipeline also traverse the length of the dam. A gas pressure regulating station is located at the widest point of the crest (Station 7+00 \pm). There was no evidence of cracking or unequal settlement in the crest nor was there any rodent activity. The materials on either side of the paved road consist of ML and MH-CH with chert and limestone gravel. Views of the crest are shown in Photos 3, 4, 11 and 18.

PHOTO NO. 11 - VIEW SHOWING WIDENING OF THE CREST
STARTING AT ABOUT STATION 5+00
