JUNIOR LAKE DAM  
CALLAWAY COUNTY, MO.  
MO 11526

**PHASE 1 INSPECTION REPORT  
NATIONAL DAM SAFETY PROGRAM**

JUNIOR LAKE DAM  
CALLAWAY COUNTY, MISSOURI  
MISSOURI INVENTORY NO. MO 11526

PHASE I INSPECTION REPORT  
NATIONAL DAM SAFETY PROGRAM

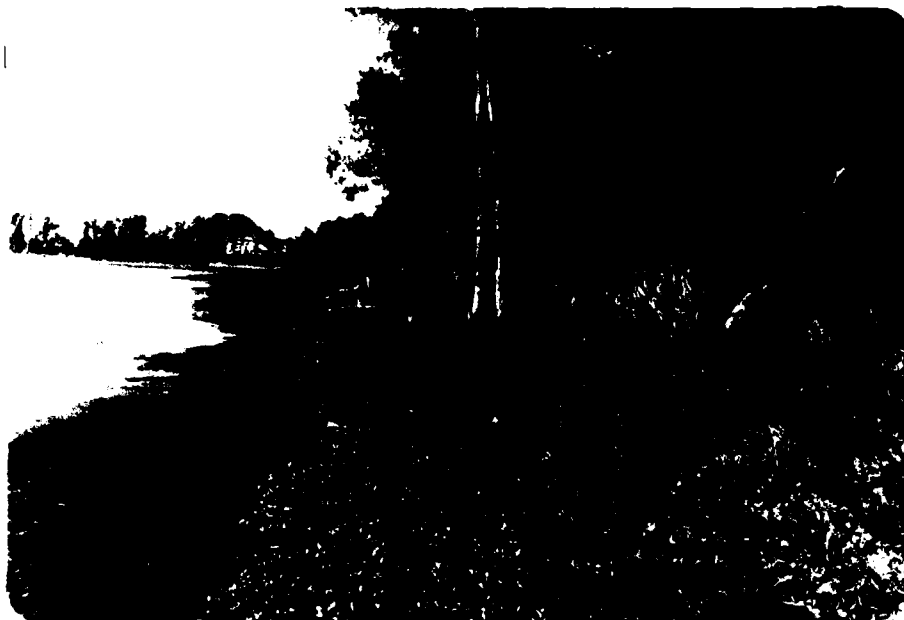
The embankment is in very poor condition. Wave erosion has removed much of the upstream slope of the east leg and has reduced the crest width to 2 or 3 feet in some sections. Most of the embankment is covered with trees and brush, and tree roots extend from the upstream slope through sections of the crest. Rodent holes have contributed to erosion of the crest. Some of the low spots on the crest line of the east leg are only 1.6 feet  $\pm$  above the spillway elevation. No evidence of any recent overtopping was observed. However, the depths of flow over the spillway, as reported by Mr. Martin, would indicate that the low points along the east leg of the dam have been very near to overtopping. The spillway is in fair condition. However, the major cracks and spalling should be repaired to minimize future deterioration. Trees in the spillway outlet section should be removed.

PHOTO NO. 6 - THE UPSTREAM SLOPE AND CREST OF THE EAST LEG  
LOOKING NORTH. THE UPSTREAM SLOPE IS BADLY  
ERODED

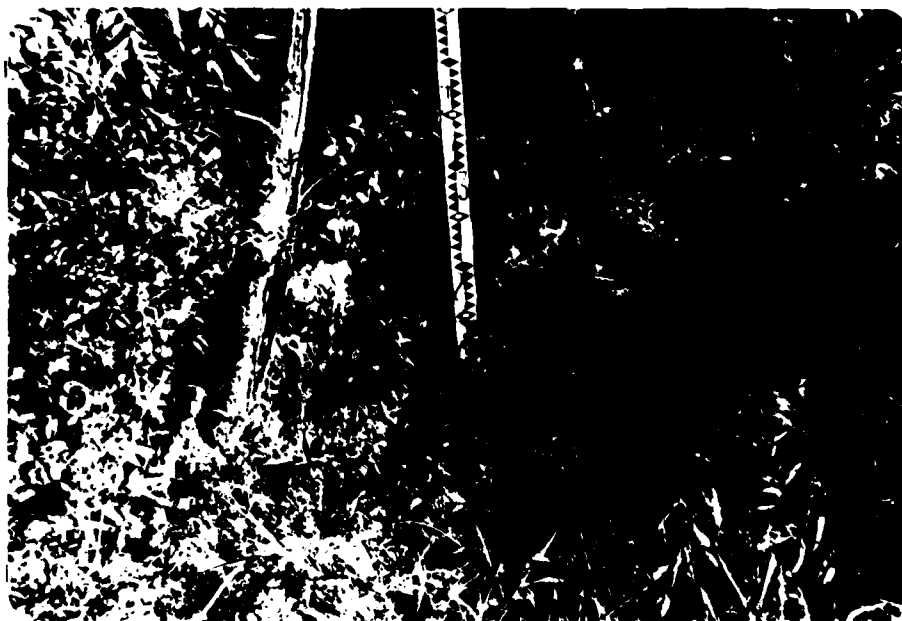
PHOTO NO. 15 - EROSION OF THE UPSTREAM FACE AT STATION  
3+00

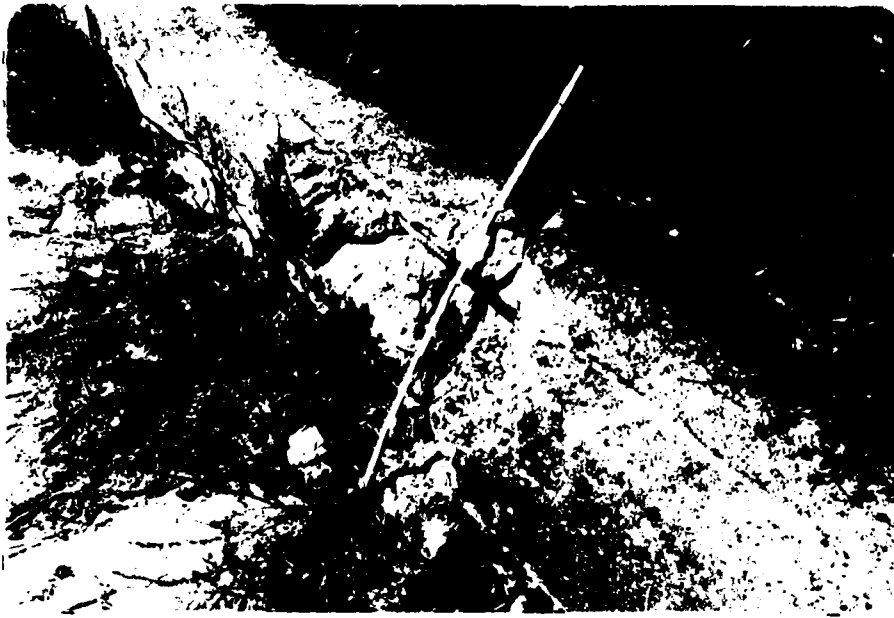
- (2) The concrete weir and spillway has some bad cracks. Photo 20 shows a crack through the weir section. Spalling of the concrete at this crack has exposed the reinforcing steel. Photo 21 shows a 2-inch wide crack in the ogee spillway section downstream from the weir. The small willow tree is growing in the crack. Photo 19 shows the open construction joint between the ogee spillway section and the weir.

PHOTO NO. 20 - A BAD CRACK EXPOSING REINFORCING STEEL IN THE WEIR SECTION ABOUT 40 FEET FROM THE LEFT END OF THE WEIR

- (3) Rodent burrows in the embankment should be eliminated.
- (4) Cracks and spalls in the concrete spillway should be repaired.
- (5) The water level should be lowered and/or the reservoir should be drained in order to facilitate the rehabilitation of the reservoir and the modification of the dam.
