SWISS LAKE ESTATES DAM

GASCONADE COUNTY, MISSOURI

MO. 30109

PHASE 1 INSPECTION REPORT NATIONAL DAM SAFETY PROGRAM

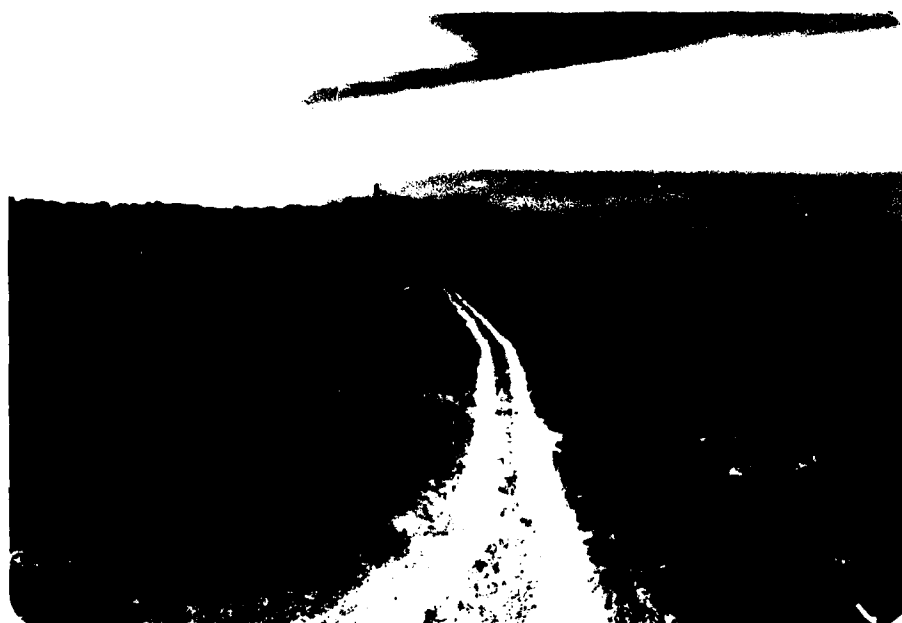
3. Crest. The roadway across the crest is well graveled with cherty limestone. The remainder of the crest is well vegetated. No pot holes, slides or slumps were noted along the crest. A few drying cracks were observed which would be expected from the plastic materials used to construct the dam. Measurements on the crest indicate that the dam was constructed essentially as shown on the plans with the constructed top elevation 1 to 1.5 feet higher than the settled elevation (104' = 777') shown. This planned 5% settlement apparently has not occurred to date.

4. Downstream Slope. The downstream slope is well vegetated with adapted grasses and no erosion was noted. A few small cedar trees are growing on the slope. No cracks, slides, slumps or other deformations were observed on the slope or at the toe. There was no indication of emer-

PHOTO NO. 5 - CREST AND DOWNSTREAM SLOPE FROM LEFT

- (1) The trees and shrubs should be removed from the embankment slopes and from the inlet of the emergency spillway, and the trash rack (screen) on the principal spillway should be rehabilitated. A program of regular inspection and maintenance should be initiated to prevent their recurrence.

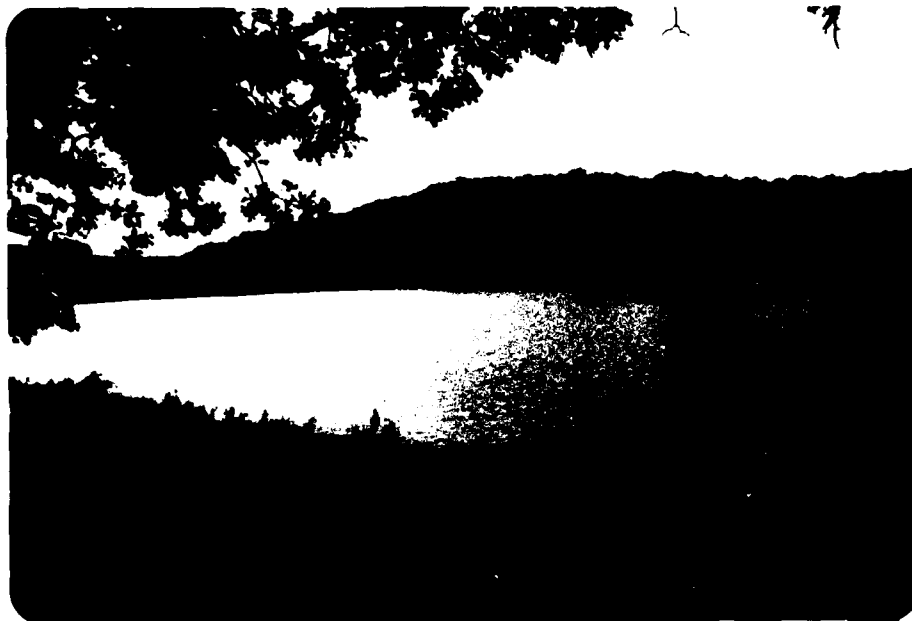
PHOTO NO. 12 - OVERVIEW FROM LEFT SIDE
