BIG FOUR MINE DAM

WASHINGTON COUNTY, MISSOURI

MO 30729

## PHASE 1 INSPECTION REPORT NATIONAL DAM SAFETY INSPECTION

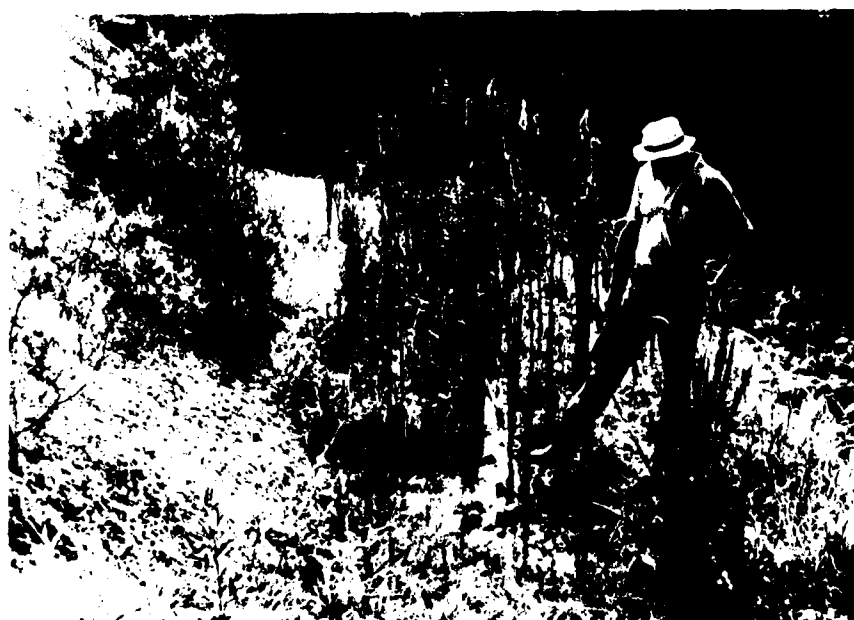
Clear seepage was noted flowing from many locations along the dam toe (see Photo 6; Appendix A). At each location, the quantity ranged from less than 1 to about 3 gal/min. From the toe, the seepage flowed into the downstream channel (see Photos 5 and 8; Appendix A). Aggregate volume of seepage was 30 to 50 gal/min. Observed seepage was not causing erosion or piping of the dam at the time of inspection.

The clear seepage noted at the time of our inspection is not considered to be a serious threat to the stability of the dam at this time. A portion of the clear seepage may be a result of consolidation of the fine-grained tailings. The amount and nature of the seepage should be monitored by future inspections.

6. Clear seepage from toe of about 2-4 gallons per minute. Typical of many seeps observed. Note discharge channel in background.

Removal of trees and brush on the slope and at the toe of the dam is recommended to facilitate observation of seepage and signs of possible distress. Removal of large trees should be done under the guidance of an engineer experienced in the design and construction of dams. Indiscriminate clearing could jeopardize the stability of the dam.

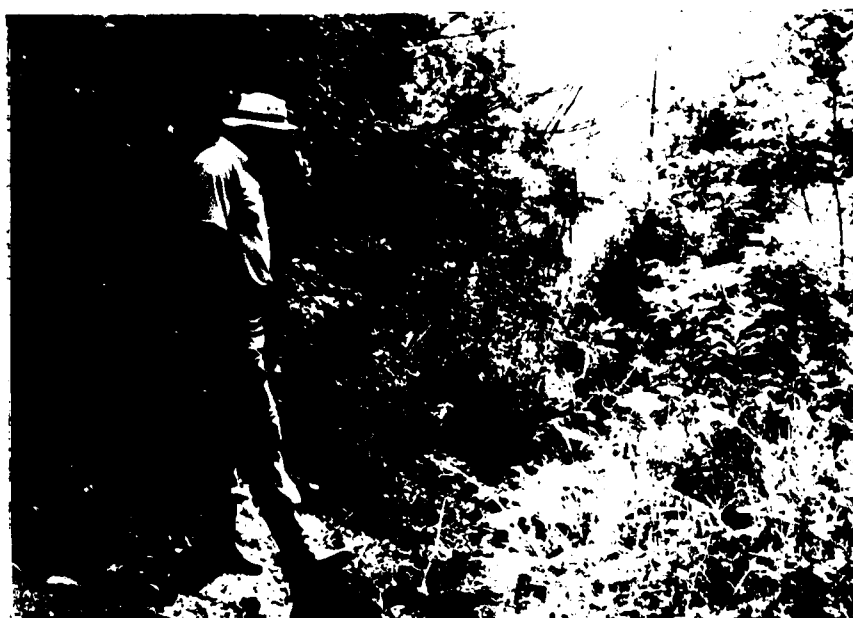
8. Discharge channel near maximum dam section. Flow is from seepage. Observer is standing on dam toe.
