LAKE CHAMPETRA DAM  
BOONE COUNTY, MISSOURI  
MO. 30880

PHASE 1 INSPECTION REPORT  
NATIONAL DAM SAFETY PROGRAM

MAY, 1979

PREPARED BY  
HOSKINS-WESTERN-SONDEREGGER, INC.  
CONSULTING ENGINEERS  
LINCOLN, NEBRASKA

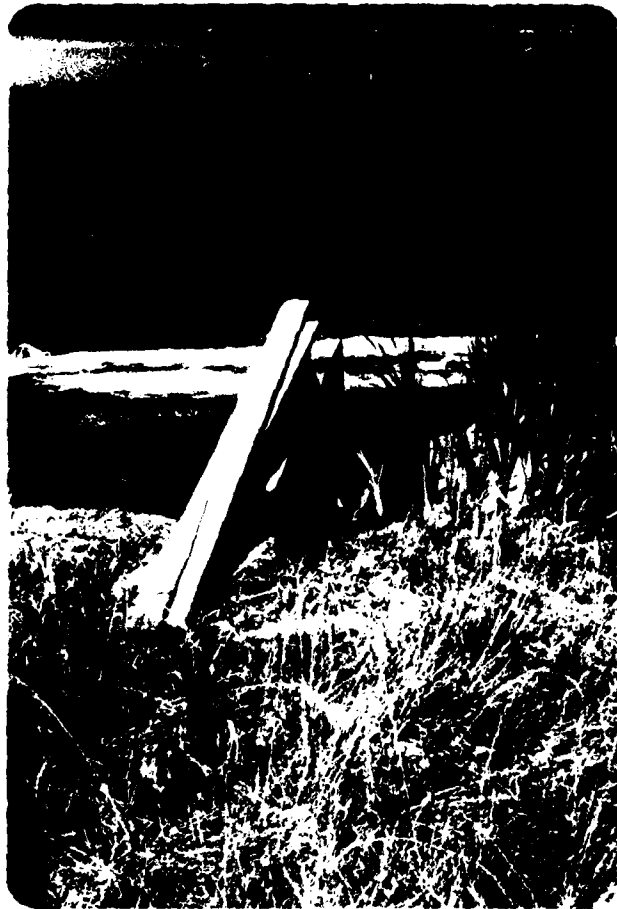
- (1) The principal spillway at the time of the inspection was not operating effectively. In fact, the top of the riser was submerged. A subsequent visit to the site showed that the inlet to the 12-inch steel pipe conduit at the bottom of the riser was almost completely plugged with a tree stump and trash. The owner was notified of this condition by letter. There is no trash rack over the top of the riser. No deterioration was noted in the steel riser or conduit.
- (2) The emergency spillway is well vegetated. The exit channel just downstream from the crest is partially blocked by the storage of a float boat or diving platform. It did not appear that the spillway had operated. No slides, slumps or erosion was noted in the spillway. Discharges from the spillway should not endanger the dam.

- c. Visual Observations.
  - (1) The steel pipe principal spillway was observed to be plugged with a tree stump and roots, severely limiting the spillway capacity. A letter was written to the owner strongly suggesting this condition be corrected.

PHOTO NO. 6 - INLET END  
OF PRINCIPAL SPILLWAY

There does not appear to be a maintenance plan for this structure. Maintenance of the spillways is deficient. The principal spillway should be opened, and a suitable trash rack should be installed to prevent future plugging. The obstruction in the emergency spillway channel should be removed. The trees should be removed from the downstream slope and measures taken to prevent their recurrence.

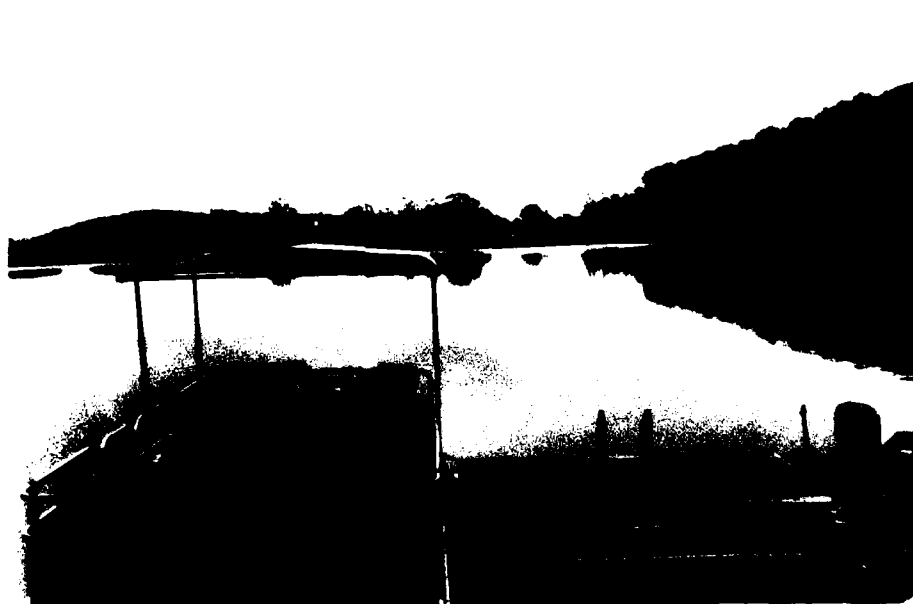
PHOTO NO. 15 - OVERVIEW TAKEN FROM UPSTREAM ON LEFT
